CLOSURE REPORT

BOPCO, L.P.
PLU #105 Flowline
Eddy County, New Mexico
Unit Letter "B", Section 36, Township 24 South, Range 30 East
Latitude 32.18573 North, Longitude 103.83154 West
NMOCD Reference #2RP-3225

RE: Final Closure Report
Bopco – PLU #105 Flowline
UL-B, Section 26, Township 24 South, Range 30 East
Eddy County, New Mexico
NMOCD Reference # 2RP 3225

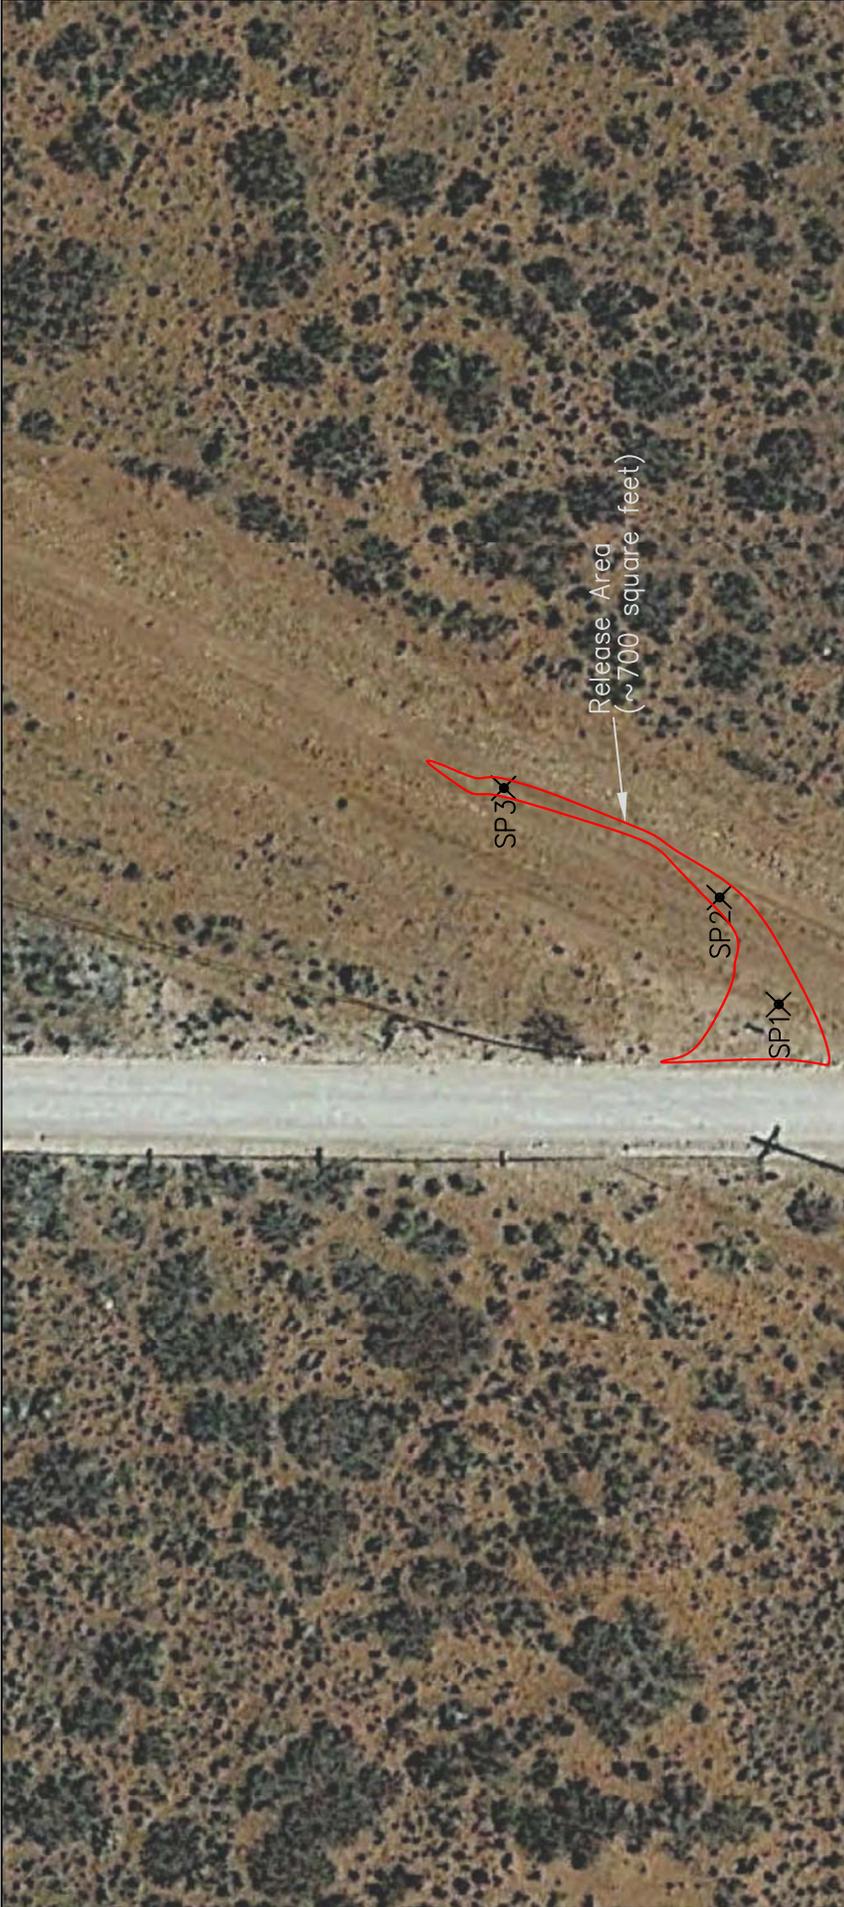
Figure 3
Site/Sample Map
Bopco, L.P.
PLU #105 Flowline

EPI personnel mobilized on the site on August 19, 2015 to collect soil samples via hand auger to determine the vertical extent of contamination. A total of thirteen (13) soil samples were collected from three (3) sample locations; SP1, SP2, SP3. On August 25, 2015 six (6) additional deeper soil samples were collected via backhoe from the sample locations. All samples were field tested for organic vapors and chloride concentrations. Soil samples were placed in self-sealing polyethylene bags and allowed to equilibrate to ~70° F. Soil samples were tested for organic vapors utilizing a Mini-Rae™ Photoionization Detector (PID) equipped with a 10.6 electron-volt (eV) lamp calibrated for benzene response. Chloride concentrations were determined via use of a LaMotte Chloride Kit (Titration Method). Field testing results indicate elevated Chloride concentrations in SP1 to five (5) bgs, SP2 to three (3) feet bgs, and SP3 to two (2) feet bgs. Field testing results indicate elevated organic vapors in SP1 to two (2) feet bgs, SP2 to one (1) foot bgs, and SP3 to two (2) feet bgs (reference *Figure 3* and *Table 2*).

Release Area
(~700 square feet)

On September 28 and 29, 2015, the release area was excavated to a depth of approximately two (2) feet bgs in the area of SP1; SP2 and SP3 were excavated to a depth of approximately one (1) foot bgs. Approximately 44 tons of contaminated soil was excavated and hauled to a state approved facility for disposal.

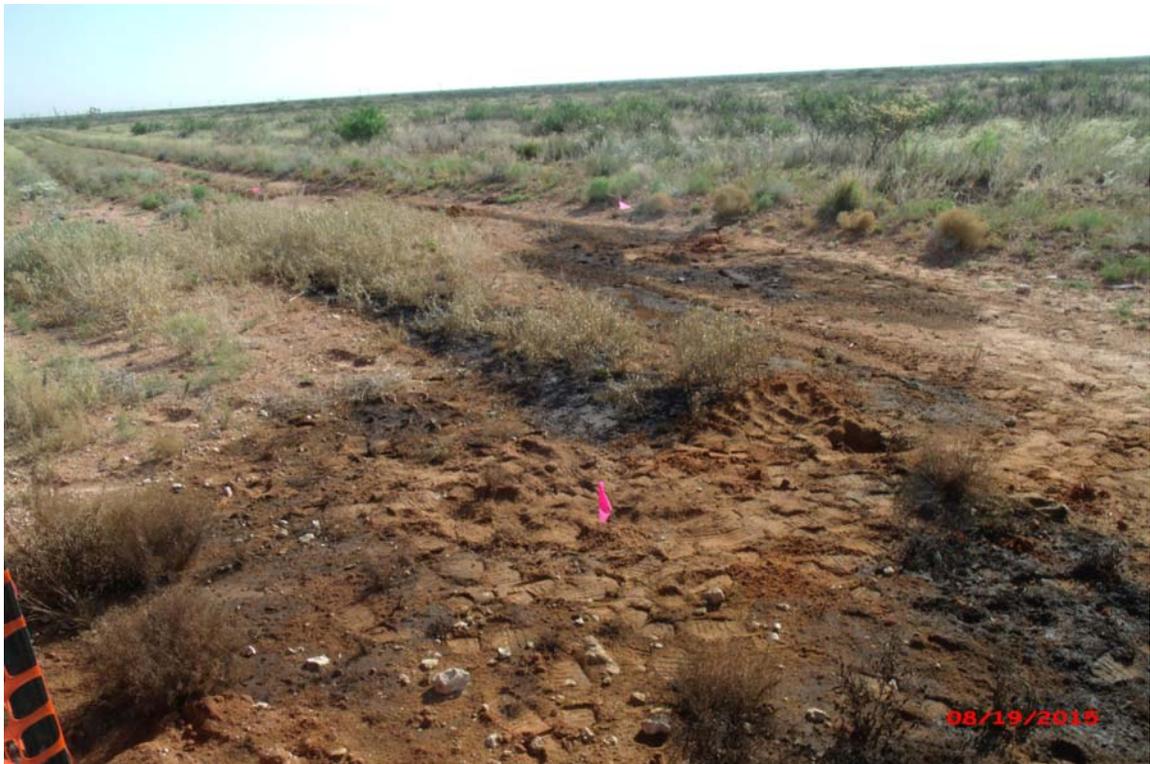
Photograph #2 – Looking across release area

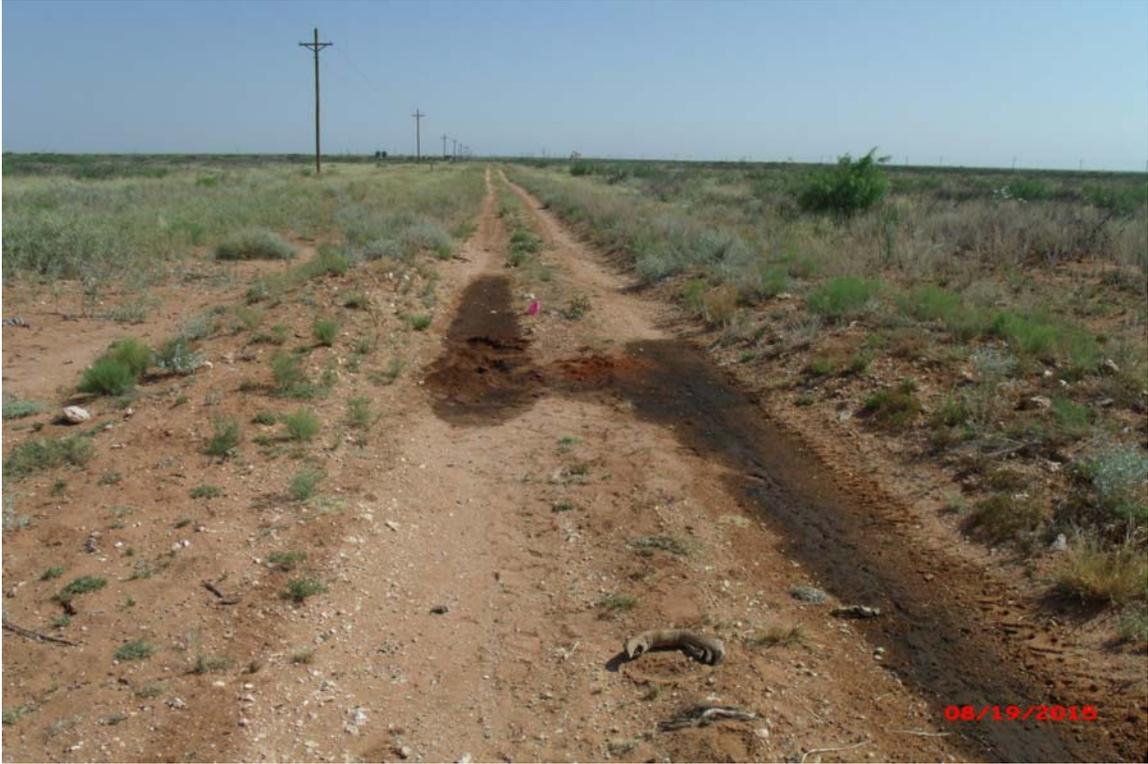
Photograph #3 – Looking across release area

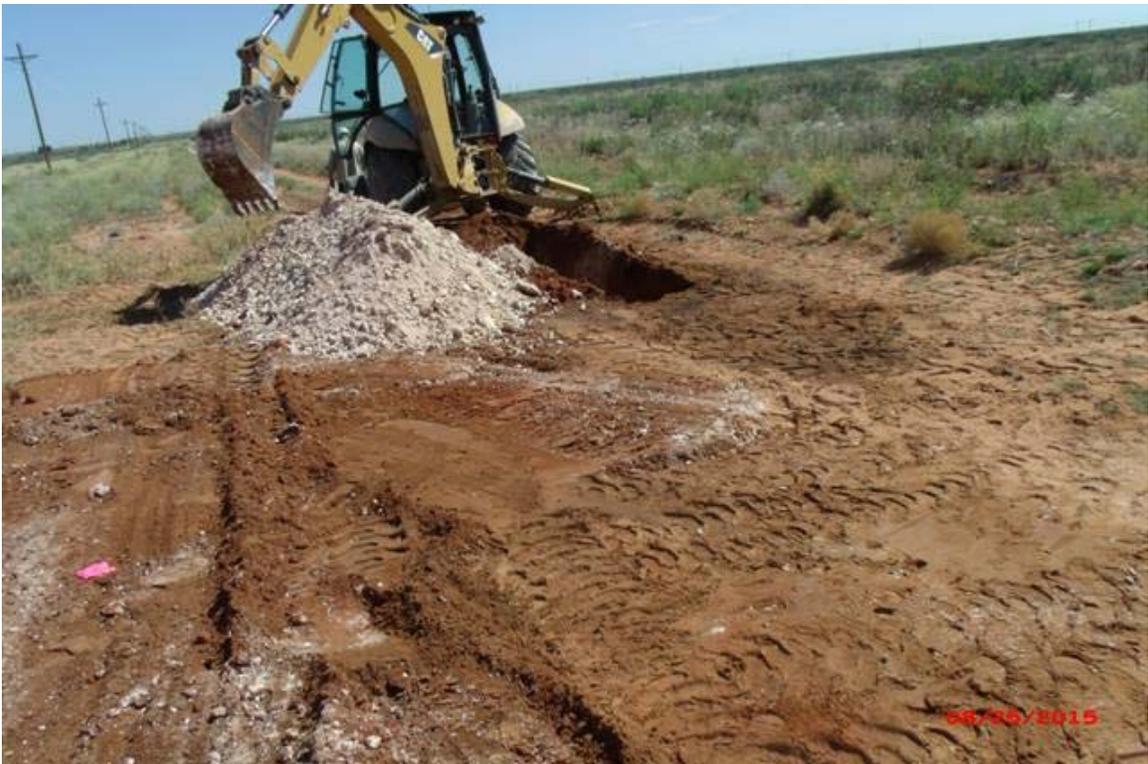
Photograph #4 – Collecting soil samples

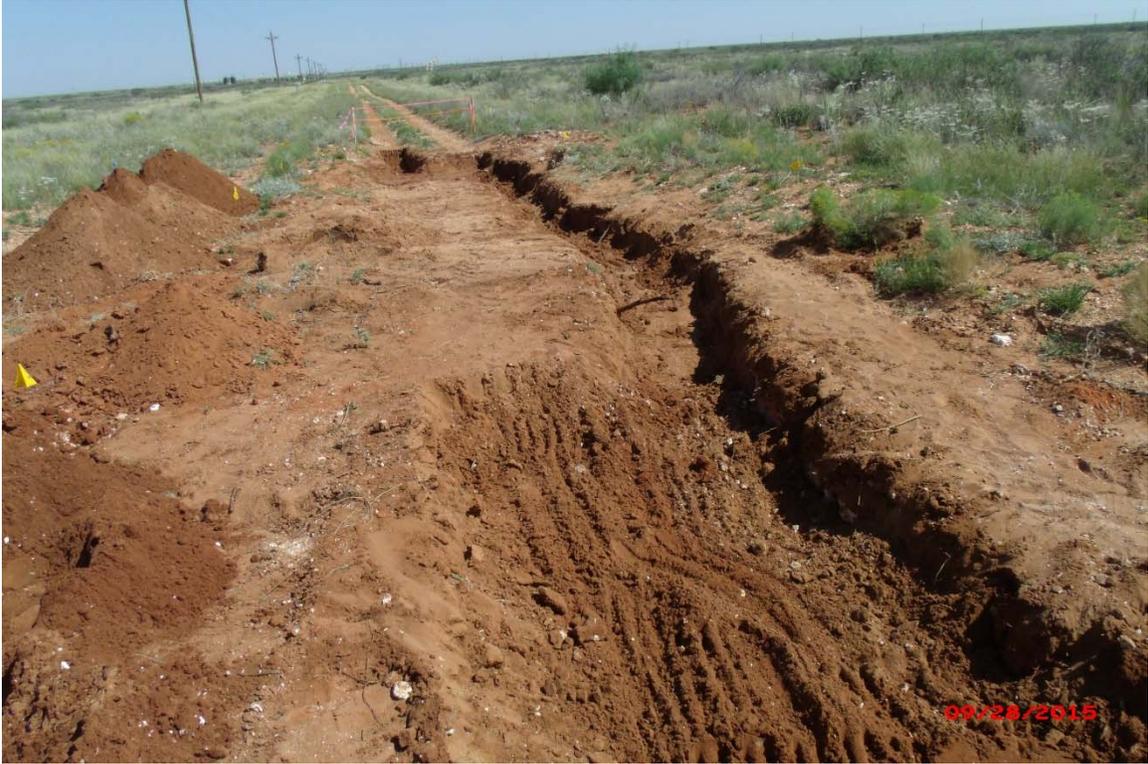
Photograph #5 – Excavated area

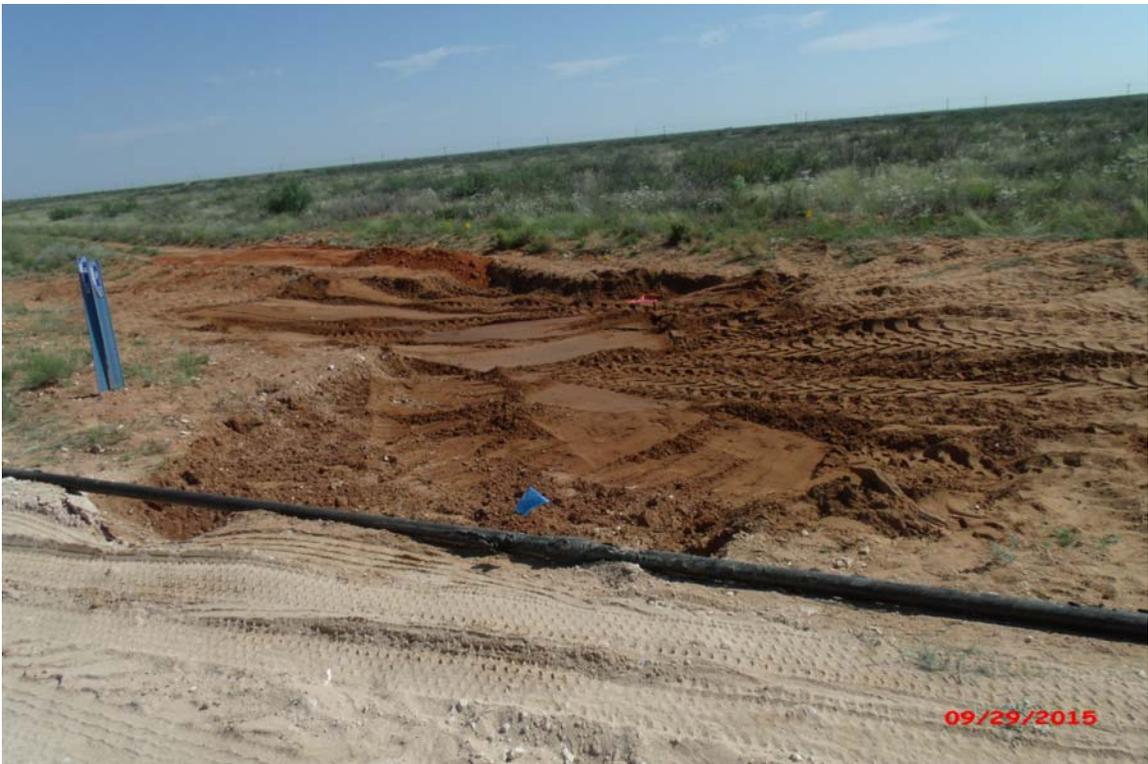
Photograph #6 – Excavated area

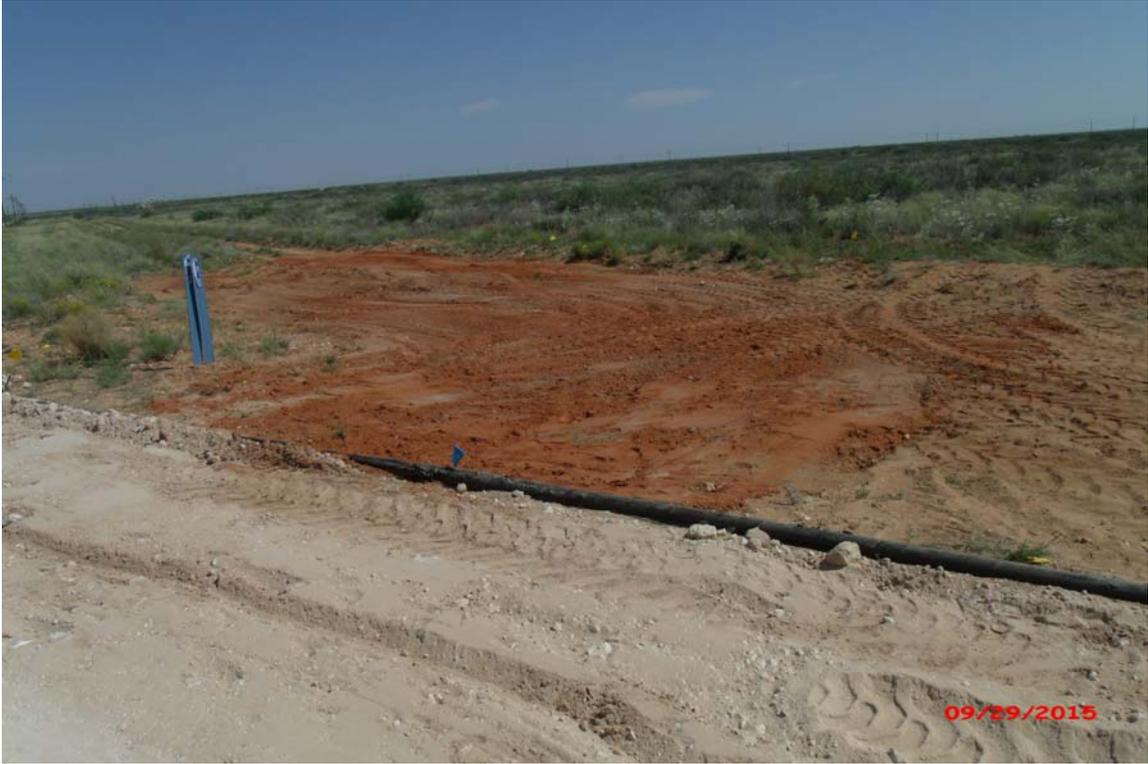
Photograph #7 – Backfilled area

With NMOCD approval the excavation was backfilled with approximately 44 tons of clean soil. All soil was free of rocks, clumps or deleterious material. The entire disturbed area was then contoured to blend with existing pasture area and protected against wind/water erosion.

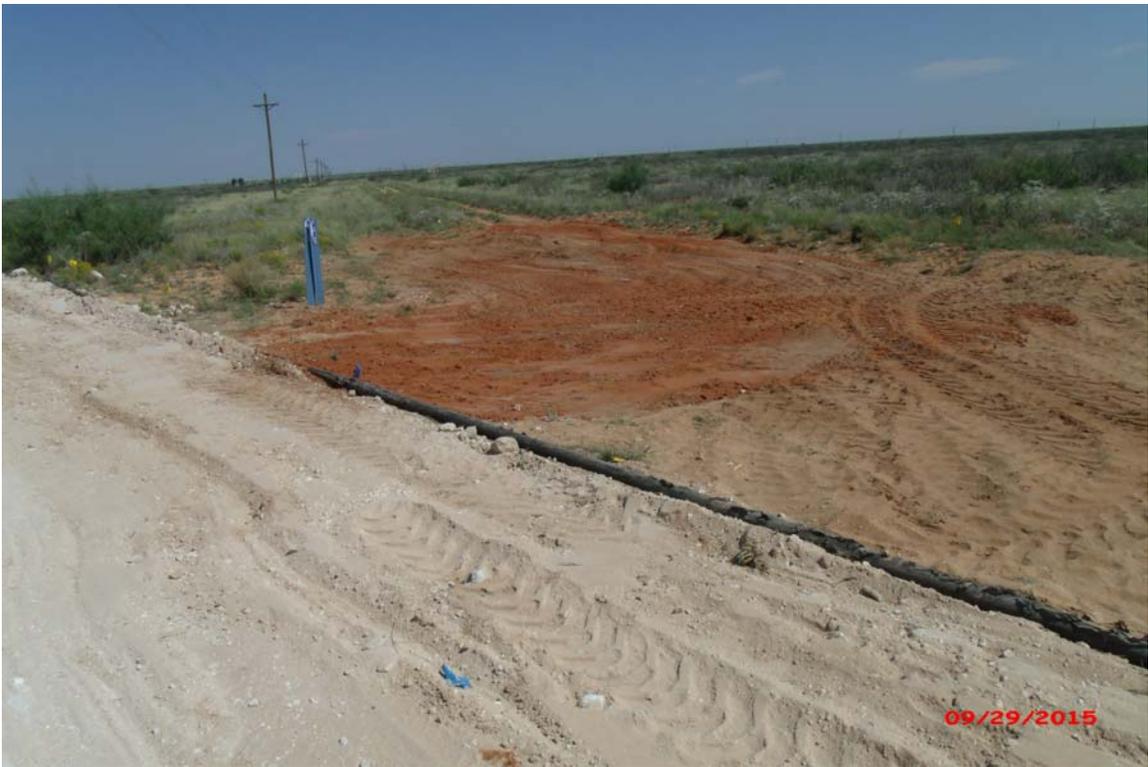
Photograph #8 – Backfilled area
