Site:	Willow A State #3					
Company:	COG Operating LLC					
Section, Township and Range	Unit J	Sec 3	T25S	R28E		
Lease Number:	API-30-015-33371					
County:	Eddy County					
GPS:	32.15771° N			104.07320° W		
Surface Owner:	State					
Mineral Owner:						
Directions:	On Hwy 285 at the Texas, New Mexico State line, travel north on Hwy 285 for 11.1 miles. Turn right onto lease road and travel 350', spill is in the pasture on the left side of road.

March 18, 2013

Re: Work Plan for the COG Operating LLC., Willow A State #3 Flow Line Leak, Unit J, Section 3, Township 25 South, Range 28 East, Eddy County, New Mexico.

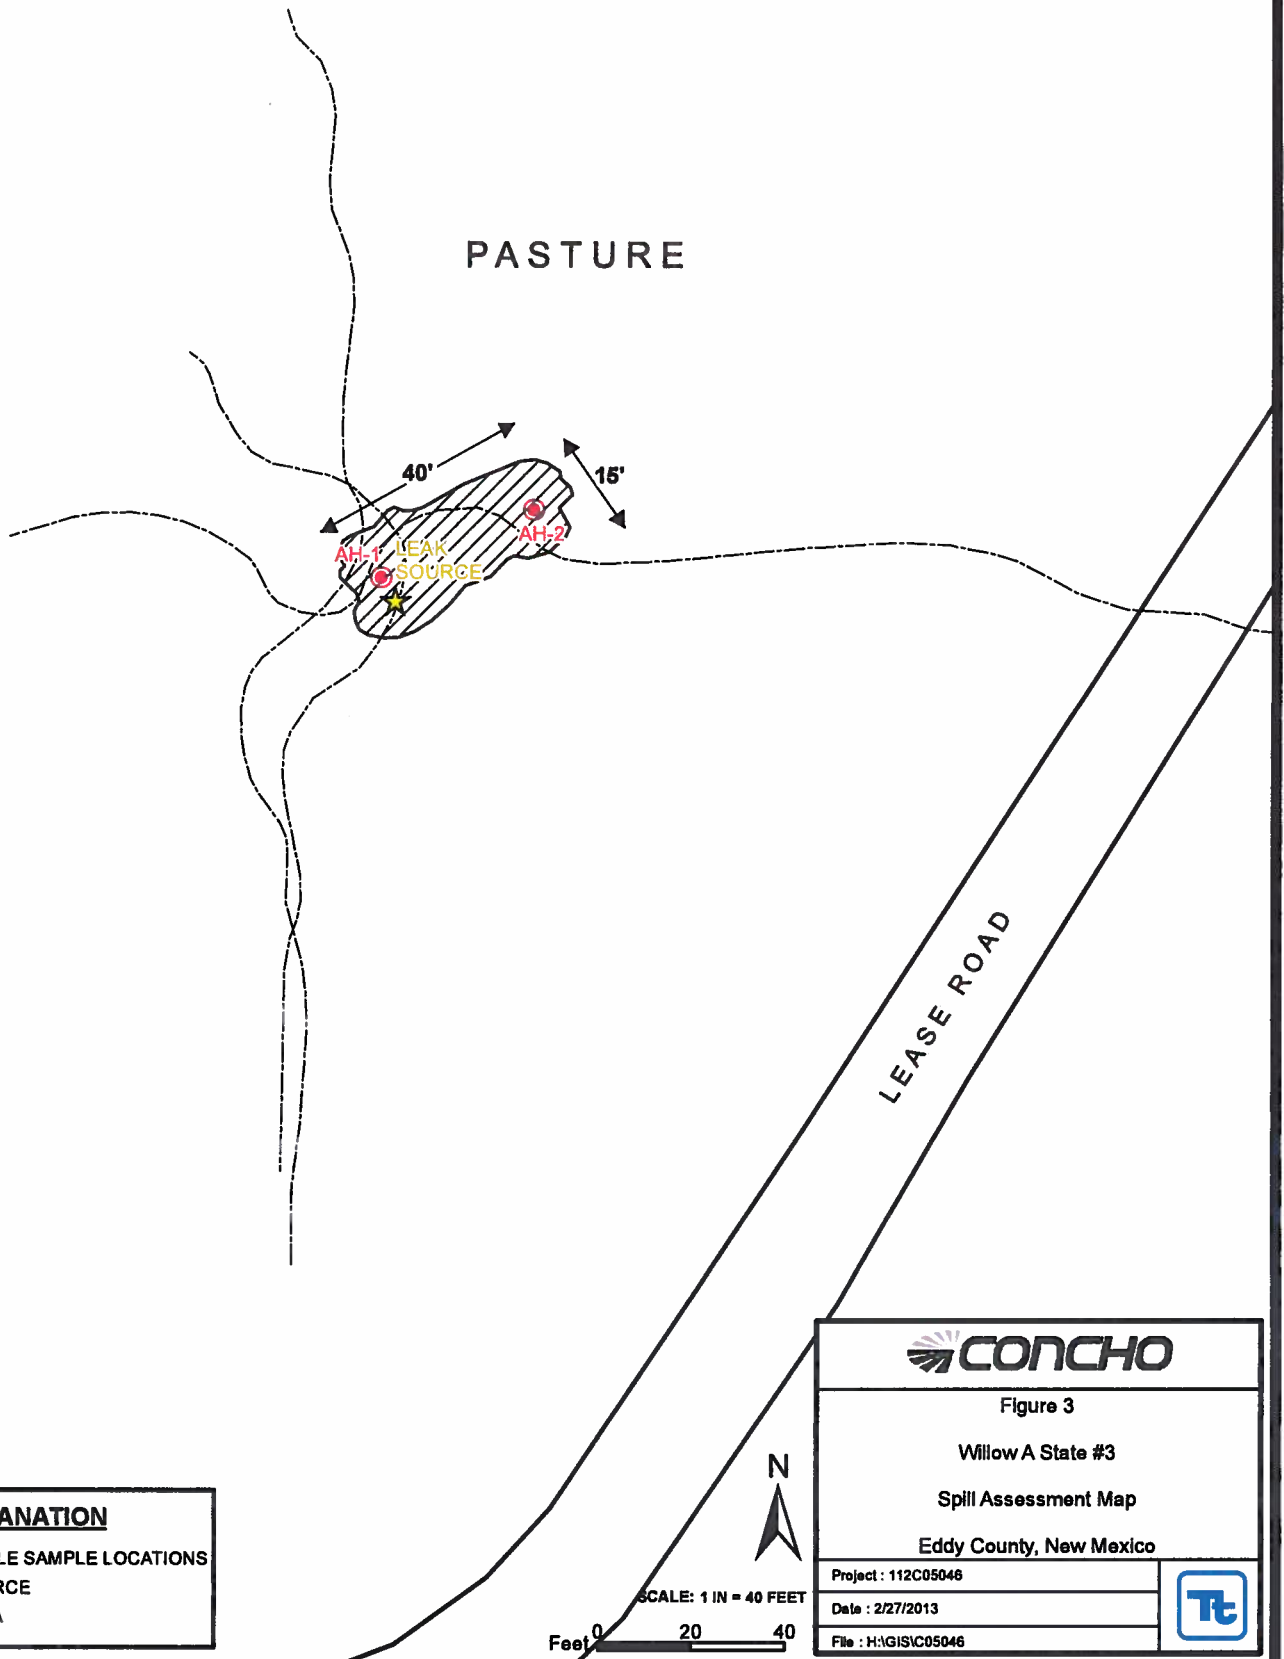
Figure 3

On January 8, 2013, Tetra Tech personnel inspected and sampled the spill area. Two (2) auger holes (AH-1, AH-2) and a background auger hole were installed using a stainless steel hand auger to assess the impacted soils. Selected samples were analyzed for TPH analysis by EPA method 8015 modified, BTEX by EPA Method 8021B and chloride by EPA method 300.0. Copies of laboratory analysis and chain-of-custody documentation are included in Appendix C. The results of the sampling are summarized in Table 1. The auger hole locations are shown on Figure 3.

Referring to Table 1, AH-1 exceeded the TPH RRAL of 163 mg/kg, but declined at 1.5' below RRAL. None of the auger holes exceeded the RRAL for benzene or total BTEX. Elevated chloride concentrations were detected in both auger holes (AH-1 and AH-2). Auger holes (AH-1) showed declining chloride concentrations, but was not vertically defined. AH-1 detected a chloride high of 19,400 mg/kg at 0-1' and declined to 1,980 mg/kg at 9-9.5' below surface. The chloride impact in the area of AH-2 showed a shallow impact and vertically defined at approximately 3.0' below surface.

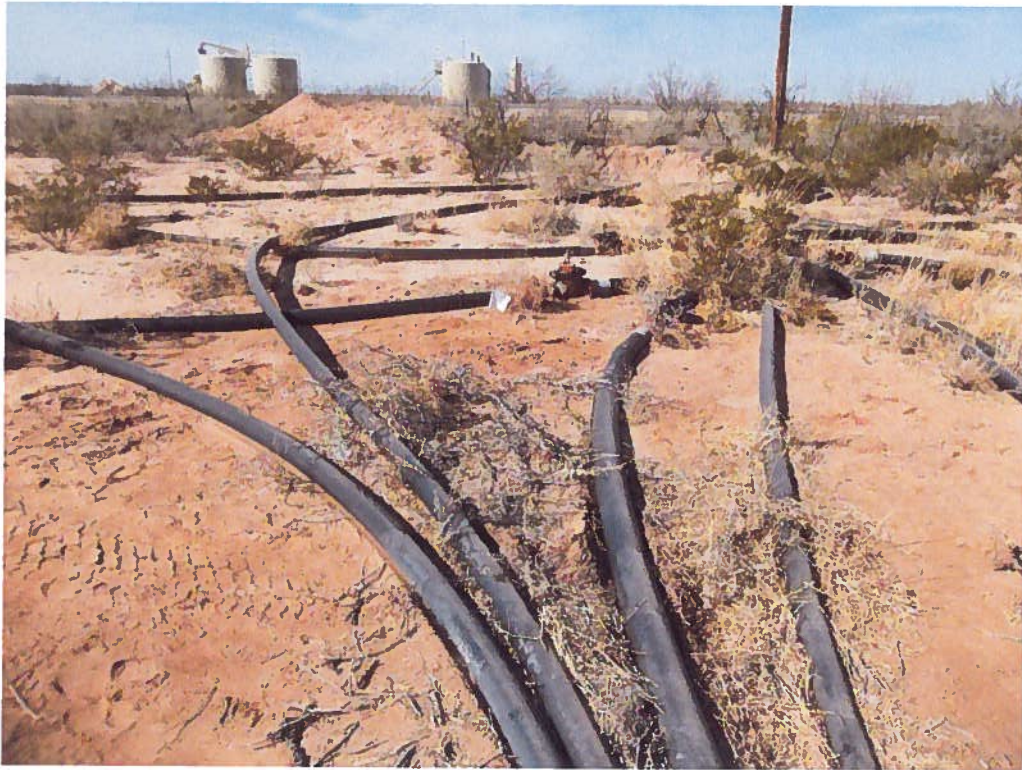
View West – Area of AH-1

COG proposes to remove the impacted material as highlighted (green) in Table 1 and shown on Figure 4. Due to multiple flow lines in the area, AH-1 will be excavated to approximate depth of 6.0' to 8.0' to remove the elevated chloride concentrations, if accessible. In addition, deeper samples will be collected for the excavation bottom (backhoe) to attempt to define the chloride extents. Once the appropriate depth is achieved, the excavated area will be capped with a 40 mil liner at 4.0' below surface and backfilled to grade. In addition, the area of AH-2 will be excavated to a depth of approximately 2.0' to 3.0' below surface and backfilled with clean soil. All of the excavated soil will be transported to proper disposal.

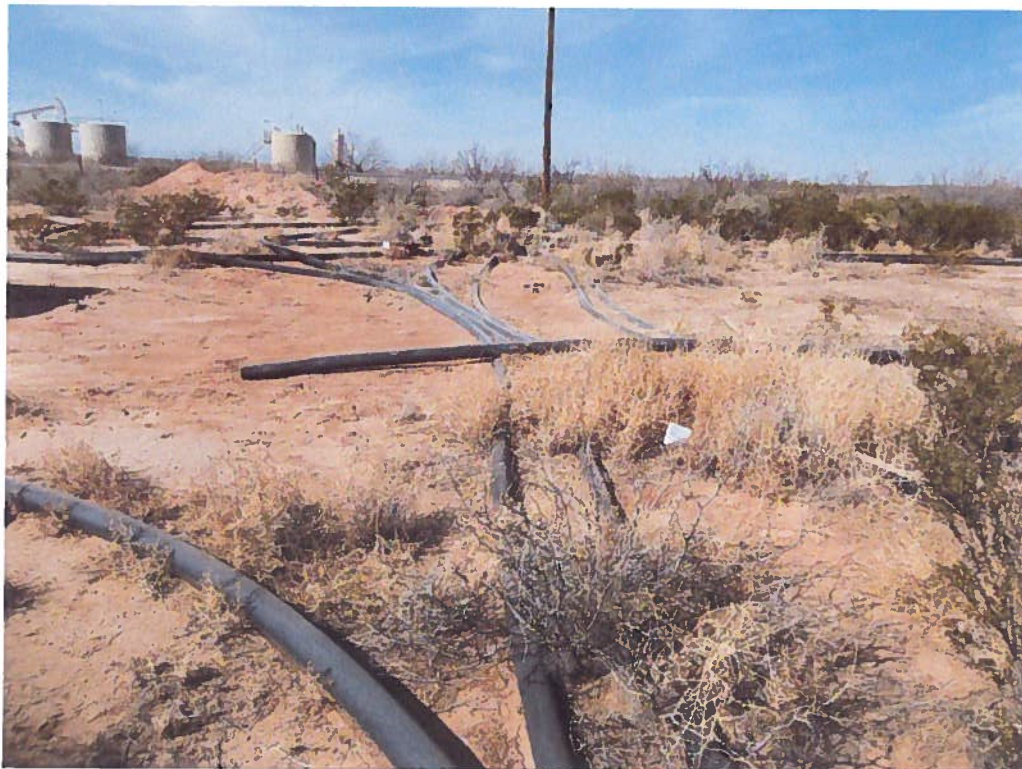
View West – Area of AH-2
