Rice Environmental Consulting & Safety

February 4th, 2014

**RE: Updated Corrective Action Plan
GP II Littlefield BO Federal #2 Battery (2RP-1738)
UL/A sec. 34 T26S R29E
API No. 30-015-24529**

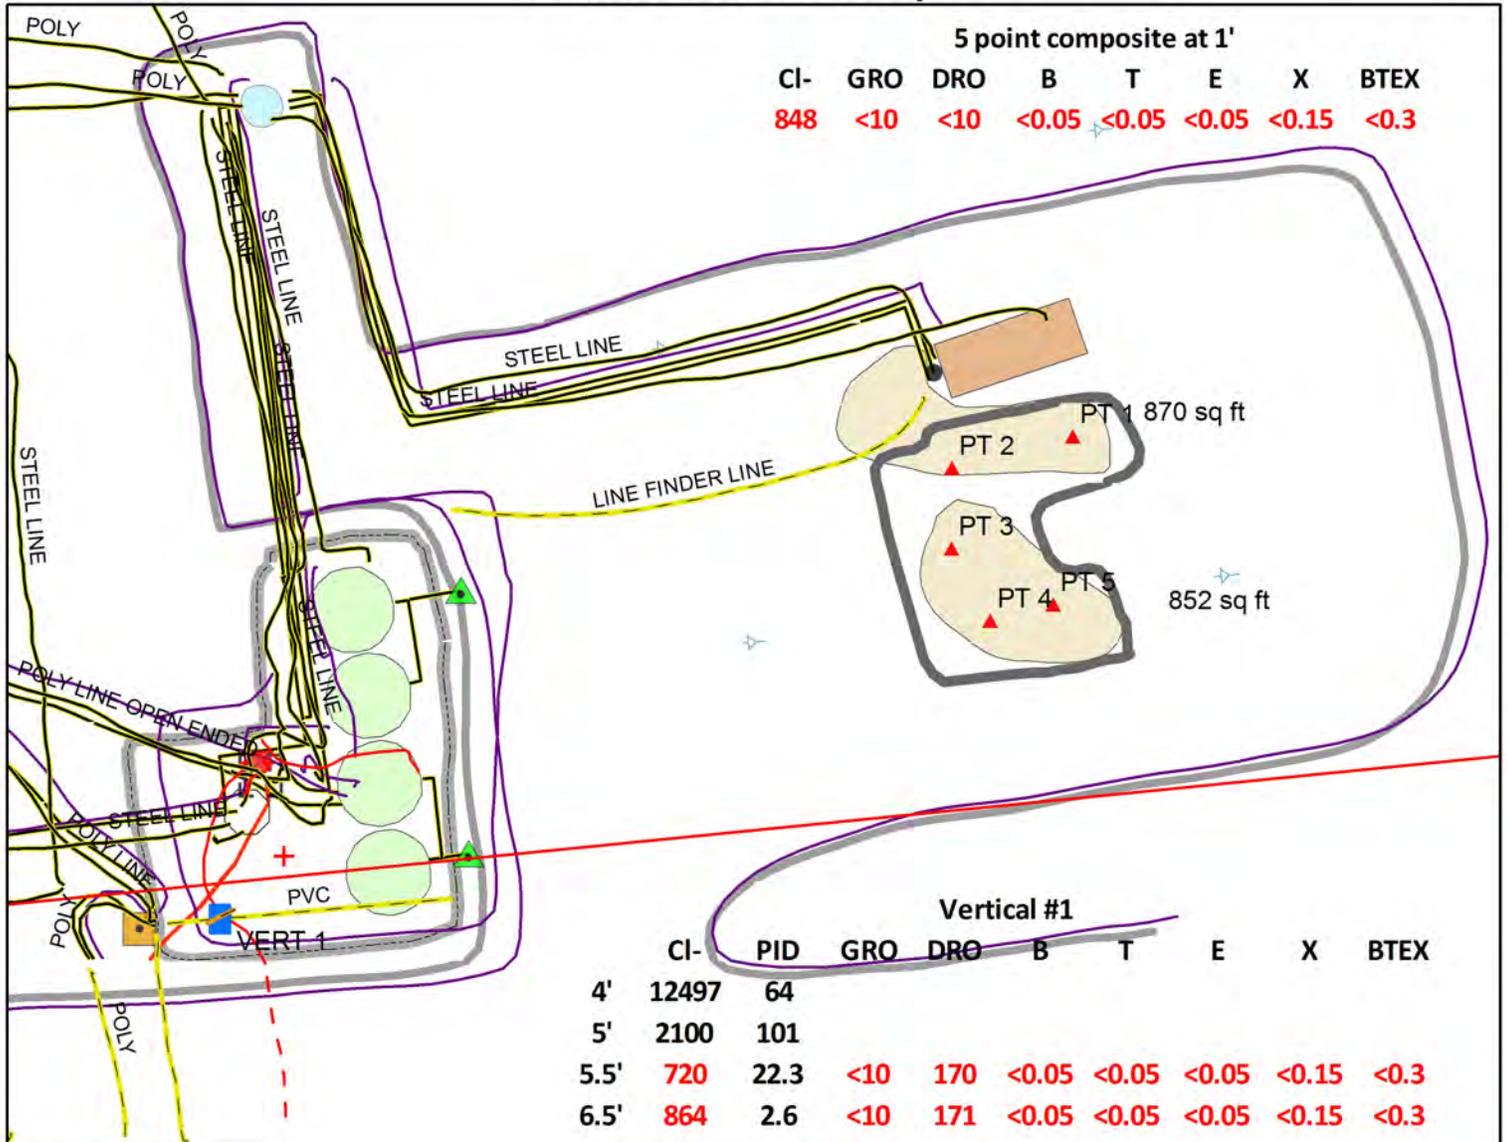
Figure 1

RECS personnel were on site beginning on September 6th, 2013 to assess the site. The stained area on the pad was scraped down to a depth of 1 foot and a 5 point composite of the bottom of the scrape was taken to a commercial laboratory for analysis (Figure 1 and Appendix C). The 5 point composite returned a laboratory chloride reading of 848 mg/kg and Gasoline Range Organics (GRO), Diesel Range Organics (DRO) and BTEX readings of non-detect. Vertical installation was attempted within the bermed battery area but had to be abandoned once an unmarked PVC pipe was discovered. Two samples were taken prior to the vertical being abandoned. The 4 ft sample returned a field chloride result of 12,497 mg/kg and the 5 ft sample returned a field chloride result of 2,100 mg/kg.

On December 26th, 2013, the previous vertical was extended to the north and with some effort, RECS was able to break through the rock and get samples at a depth of 5.5 ft and 6 ft (Figure 1). Both these samples were taken to a commercial laboratory and returned chloride values below 1,000 mg/kg (Appendix D). Another vertical was installed to the northeast and determined that rock was located there as well. This data was sent to BLM and NMOCD on January 15th, 2014. BLM replied to this data by requesting a site visit with RECS and NMOCD on January 22nd, 2014.

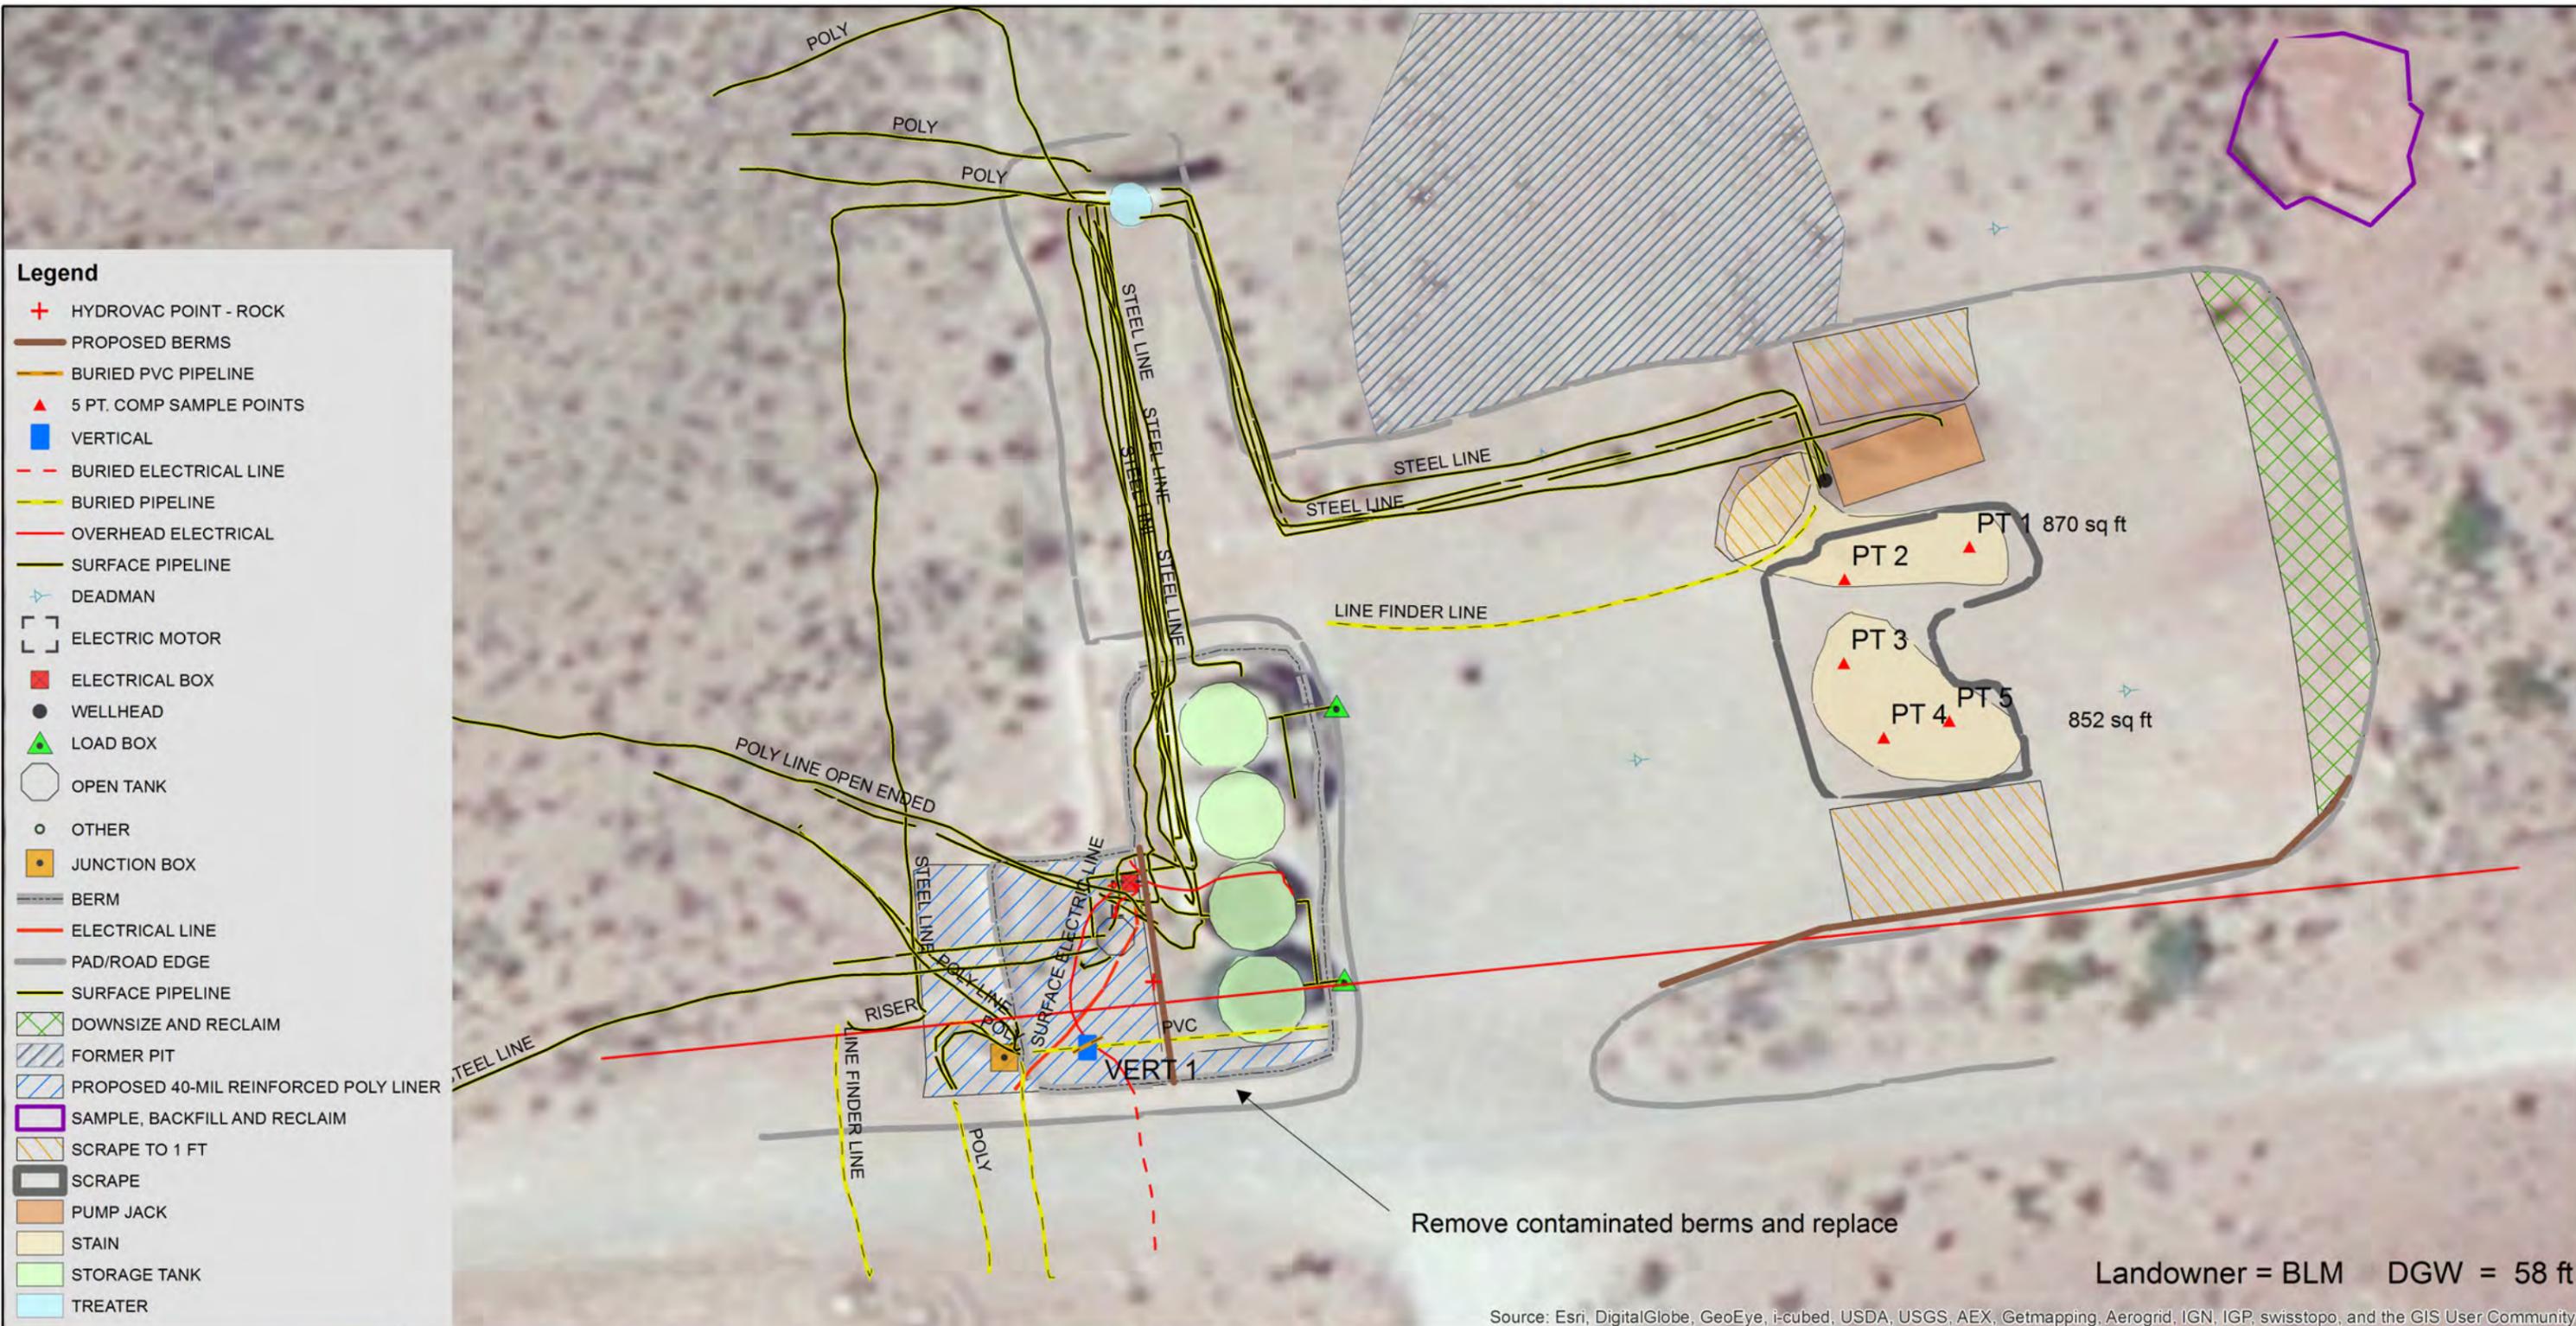
Figure 2

Based on the meeting with BLM and NMOCD on January 22nd, 2014, BLM and NMOCD requested that following items be addressed by GPII (Figure 2):

1. The pump jack is leaking and needs to be repaired.
2. The area around the pump jack needs to be scraped down to 1 ft bgs and replaced with clean, imported soil.

3. The scrape south of the pump jack needs to be extended south to the edge of the vegetation and erosion controls needs to be installed at the edge of the vegetation.

4. The east side of the pad needs to be reclaimed. The large rocks should be removed and the site seeded with a 3:4 mix.
5. There is a large hole to the northeast of the site. If the hole has been sampled, that data needs to go to BLM and NMOCD to prove the hole is clean. If not, the hole needs to be sampled and the laboratory data sent to BLM and NMOCD. The trash and debris need to be removed from the hole. If the hole is proved clean, the large rocks from the east side of the pad can be used to help backfill the hole. The hole needs to be backfilled then seeded with a 3:4 mix.

6. The old pit north of the site is beginning to be uncovered. Clean soil needs to be placed over the former pit so that the liner is not visible. A ravine needs to be cut into the imported soil to allow water to drain off the pit area and around the battery (not through the battery).

7. The short, tan tank seems to be leaking. BLM requests a tank integrity test and then the tank needs to be repaired or replaced. If it is replaced, the soil under the tank needs to be remediated per BLM/NMOCD guidelines.

8. The stock tank in the battery must be eliminated.
9. The area west and south of the tanks must be reclaimed.

- a. All leaking pipes and the pump must be repaired to eliminate the leaks. All unnecessary equipment needs to be removed.
 - b. The area west of the tanks will be excavated to the depth of the rock.
 - c. The excavated area will be padded with 6 inches of clean, imported soil to prevent liner punctures.
 - d. A 40-mil reinforced poly liner will be installed over the padding, under the new berms and south of the tanks.
 - e. The west excavation will be backfilled with caliche to 1 ft bgs, then 1 ft of topsoil over the caliche. The area south of the tanks needs to be backfilled with caliche to the surface.
 - f. The reclaimed areas need to be seeded with a 3:4 seed mix.
10. There is a wooden junction box on the southwest corner of the site that is leaking. If the box belongs to GP II, it needs to be fixed and soil around it remediated.
