**From:** Ashby, Treaver [mailto:tashby@blm.gov]  
**Sent:** Tuesday, June 14, 2016 4:18 PM  
**To:** White, Deborah A (Deb) (Contractor)  
**Cc:** WChildre@blm.gov; DHaywood@blm.gov; JNavarro@blm.gov; Dominick Chavez; David Jevons; Anthony Horn; Jennifer Montoya; David Wallace  
**Subject:** Re: EPNG Hydrostatic Test Failure Notificaiton

**Cc:** Greer, John; Thompson, Glen D; Verquer, Gary L (Gary L. Verquer); Castellano, Sheila Fennell  
(Contractor); White, Deborah A (Deb) (Contractor)  
**Subject:** EPNG Hydrostatic Test Failure Notification

## Summary Report

Project Name: 1103 Spike Test Water  
Project Number: 2016060204

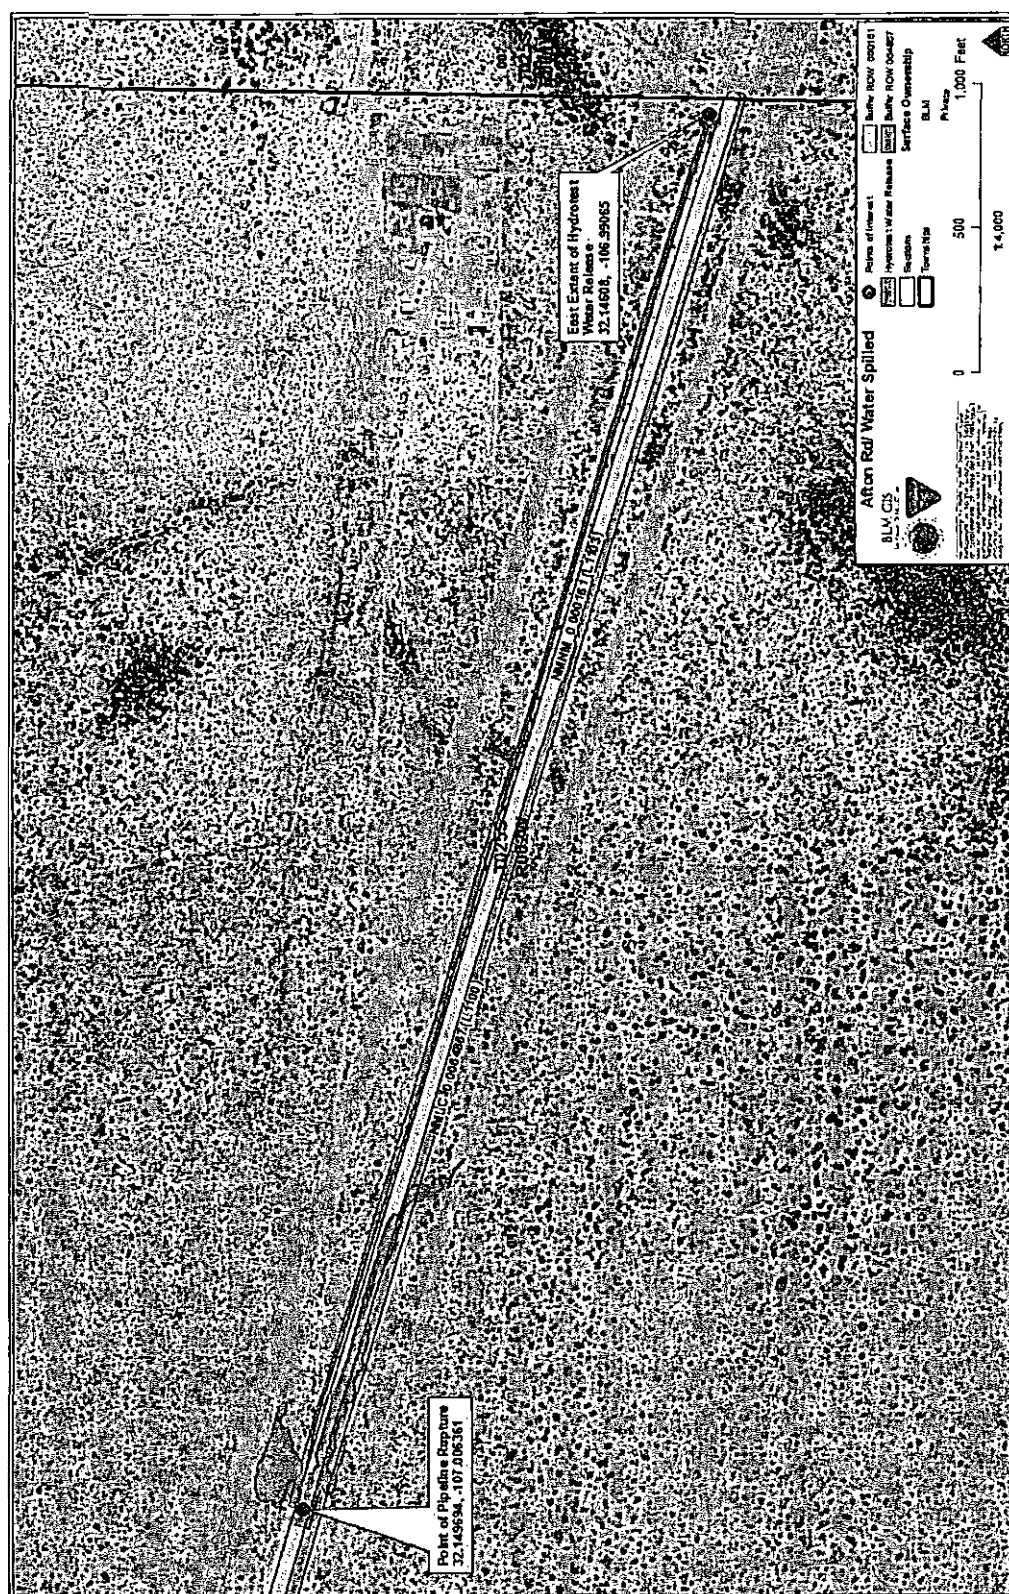
**ATTACHMENT B**

Apparently, when the EPNG pipeline ruptured during the hydrostatic pressure test conducted on Saturday, June 11, 2016, the pressurized test water sprayed north from the subject pipeline and then ran in an easterly direction down the pipeline rights-of-way and the adjacent roadway. Based on the inspection, the area covered by the release of the hydrostatic test water (shown as the green shaded area on the attached map) was roughly 4.5 acres (inside and outside the EPNG's rights-of-way).

BLM Las Cruces District Office Generated Map from 6/13/2016 Site Visit.

Over the next several days, the BLM-LCDO will be making a review of the unanticipated test water release and monitoring EPNG's investigation and potential cleanup activities. In the interim, EPNG must avoid any remediation/cleanup associated with the hydrostatic test water release. Any activities outside the limits of the EPNG's rights-of-way are prohibited.
