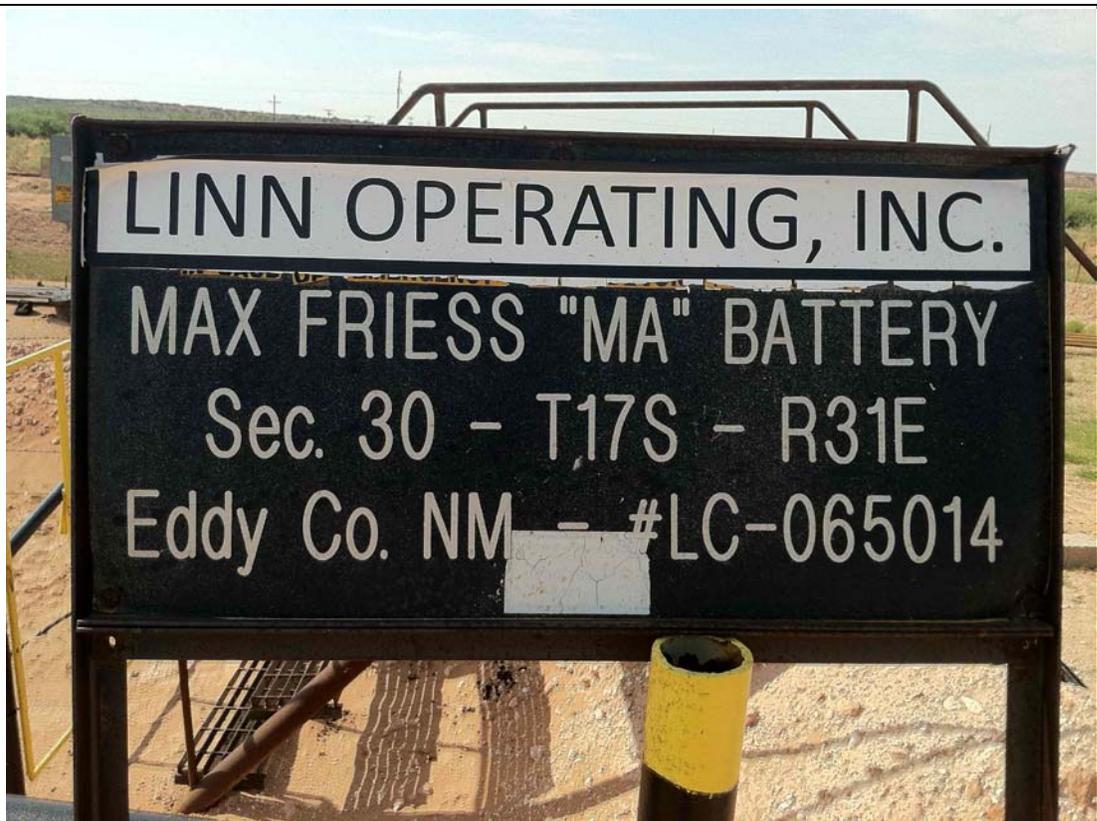
**Photo No:**  
1.

**Description:**  
Lease Sign

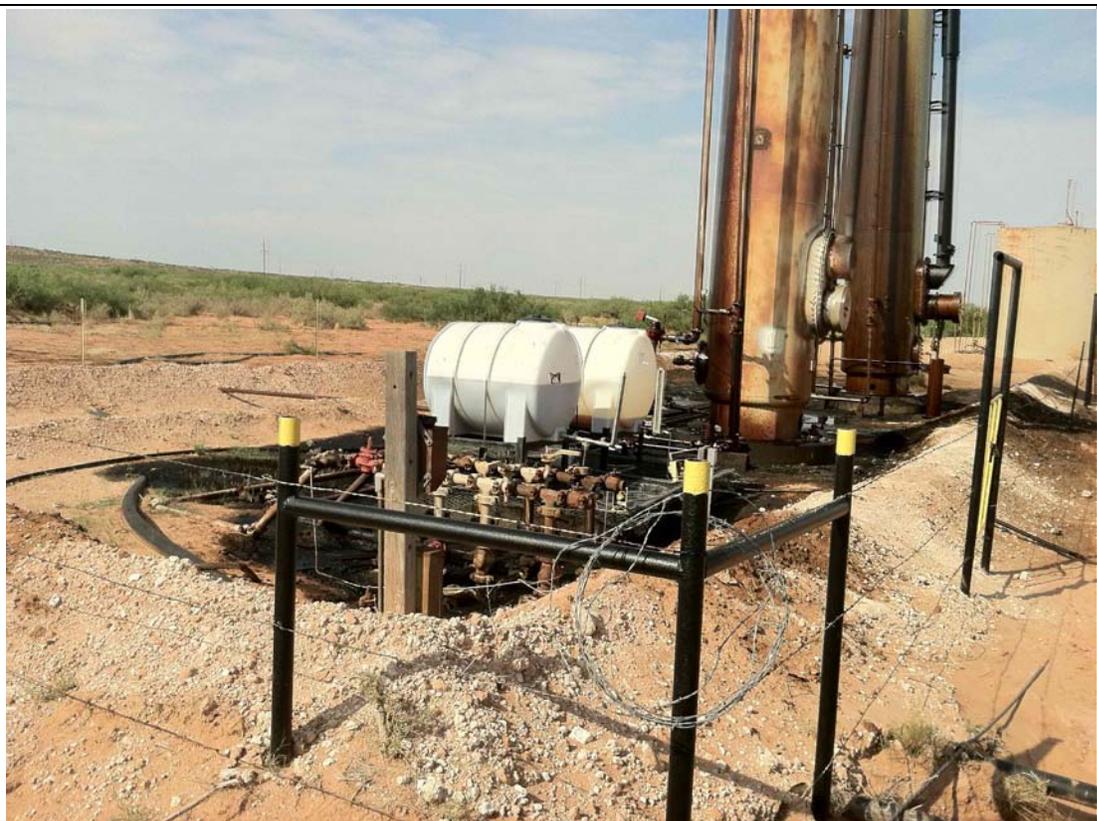
**Photo No:**  
2.

**Description:**  
View from NE corner of containment showing spill area confined inside of containment.

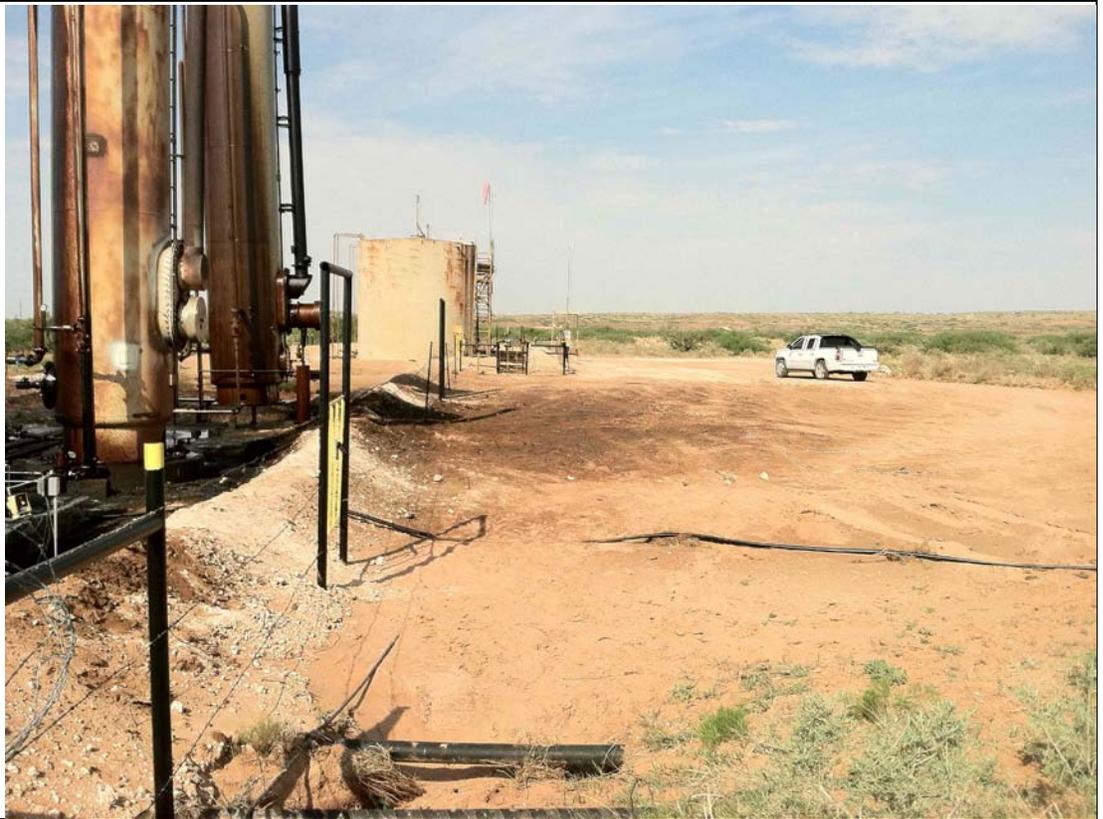
**Photo No:**  
3.

**Description:**  
View from NE corner showing overspray area located on pad area. Area is ~ 90' x 50'.

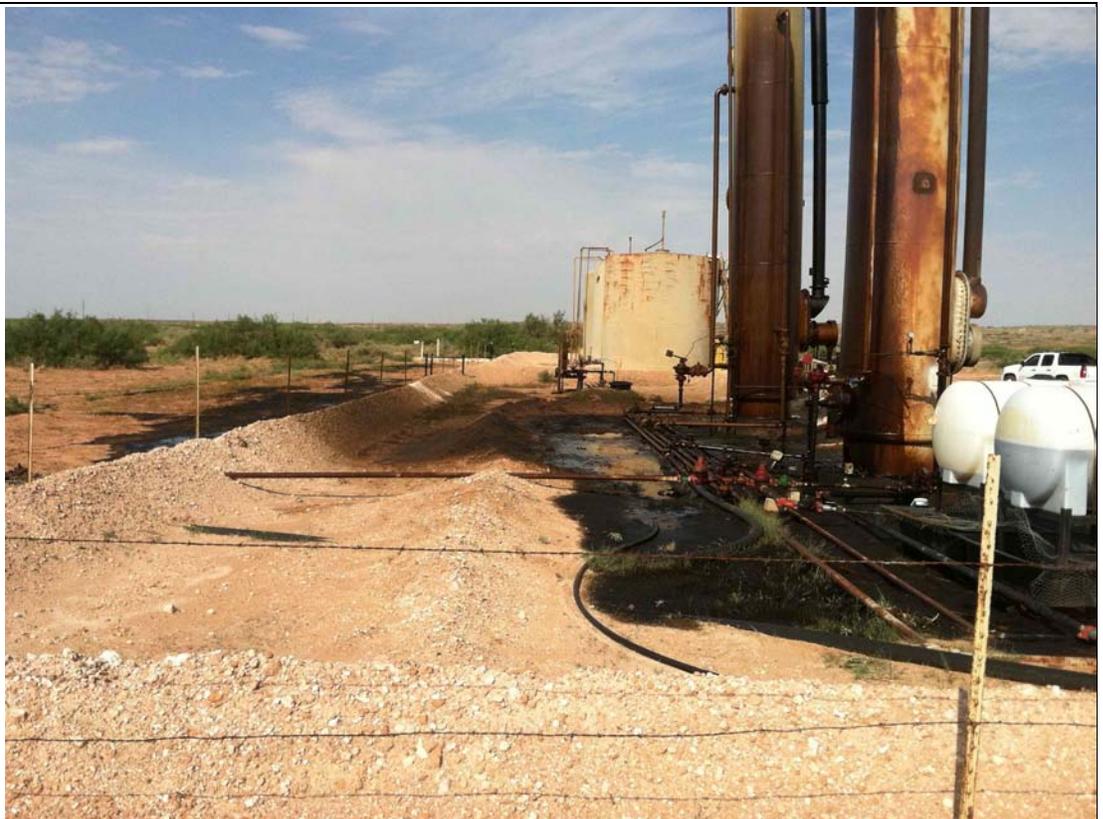
**Photo No:**  
4.

**Description:**  
View from east side of containment showing where spill sprayed over containment and area where pressure relief valve discharged product onto the pasture area outside of the containment.

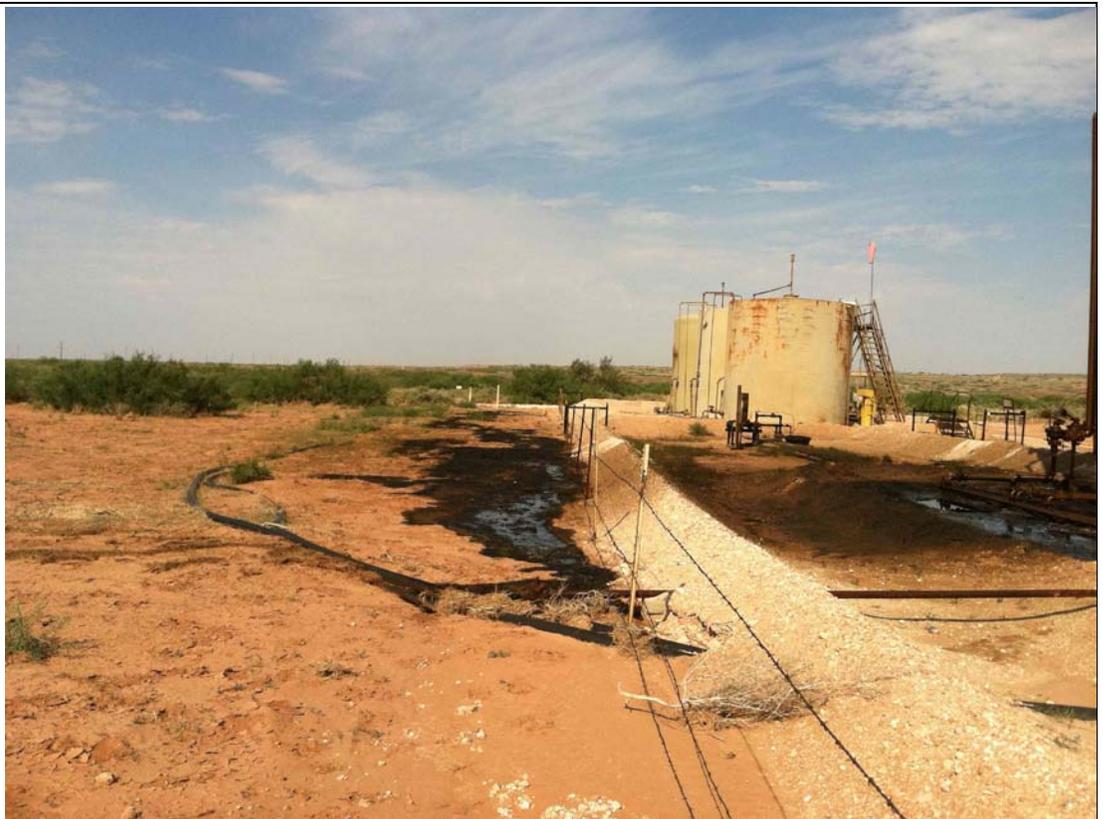
**Photo No:**  
5.

**Description:**  
View from the SE corner of the containment showing the spill area outside of the south side of the containment. Staining is largely due to the pressure relief valve located outside of the containment opening and product being discharged onto the ground. Impacted are is ~ 180' x 10'.

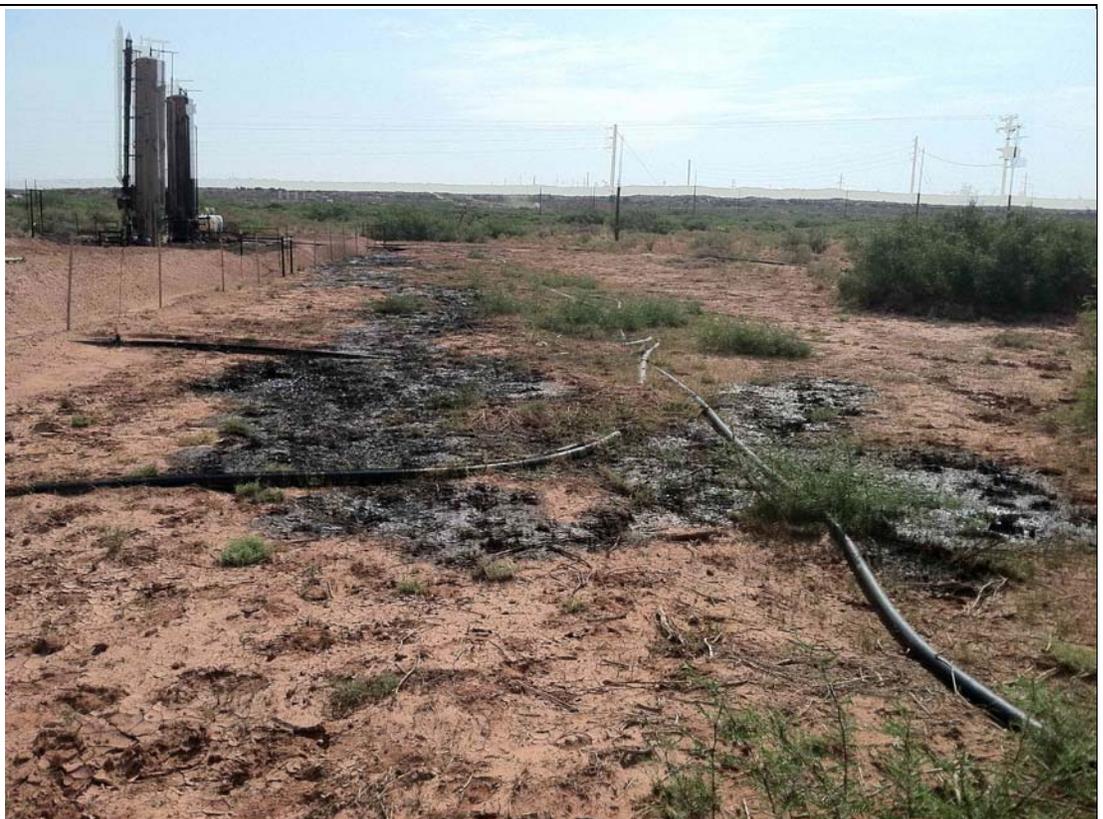
**Photo No:**  
6.

**Description:**  
View from the end of the release looking east back towards the release point.
