Release Notification and Corrective Action

Name of Company Cimarex Energy 102683	Contact Christine Alderman
Address 600 N Marienfeld Ste 600 Midland TX	Telephone No. 432-853-7059
Facility Name Oracle 21 Fed #4	Facility Type Production

2RP-4183

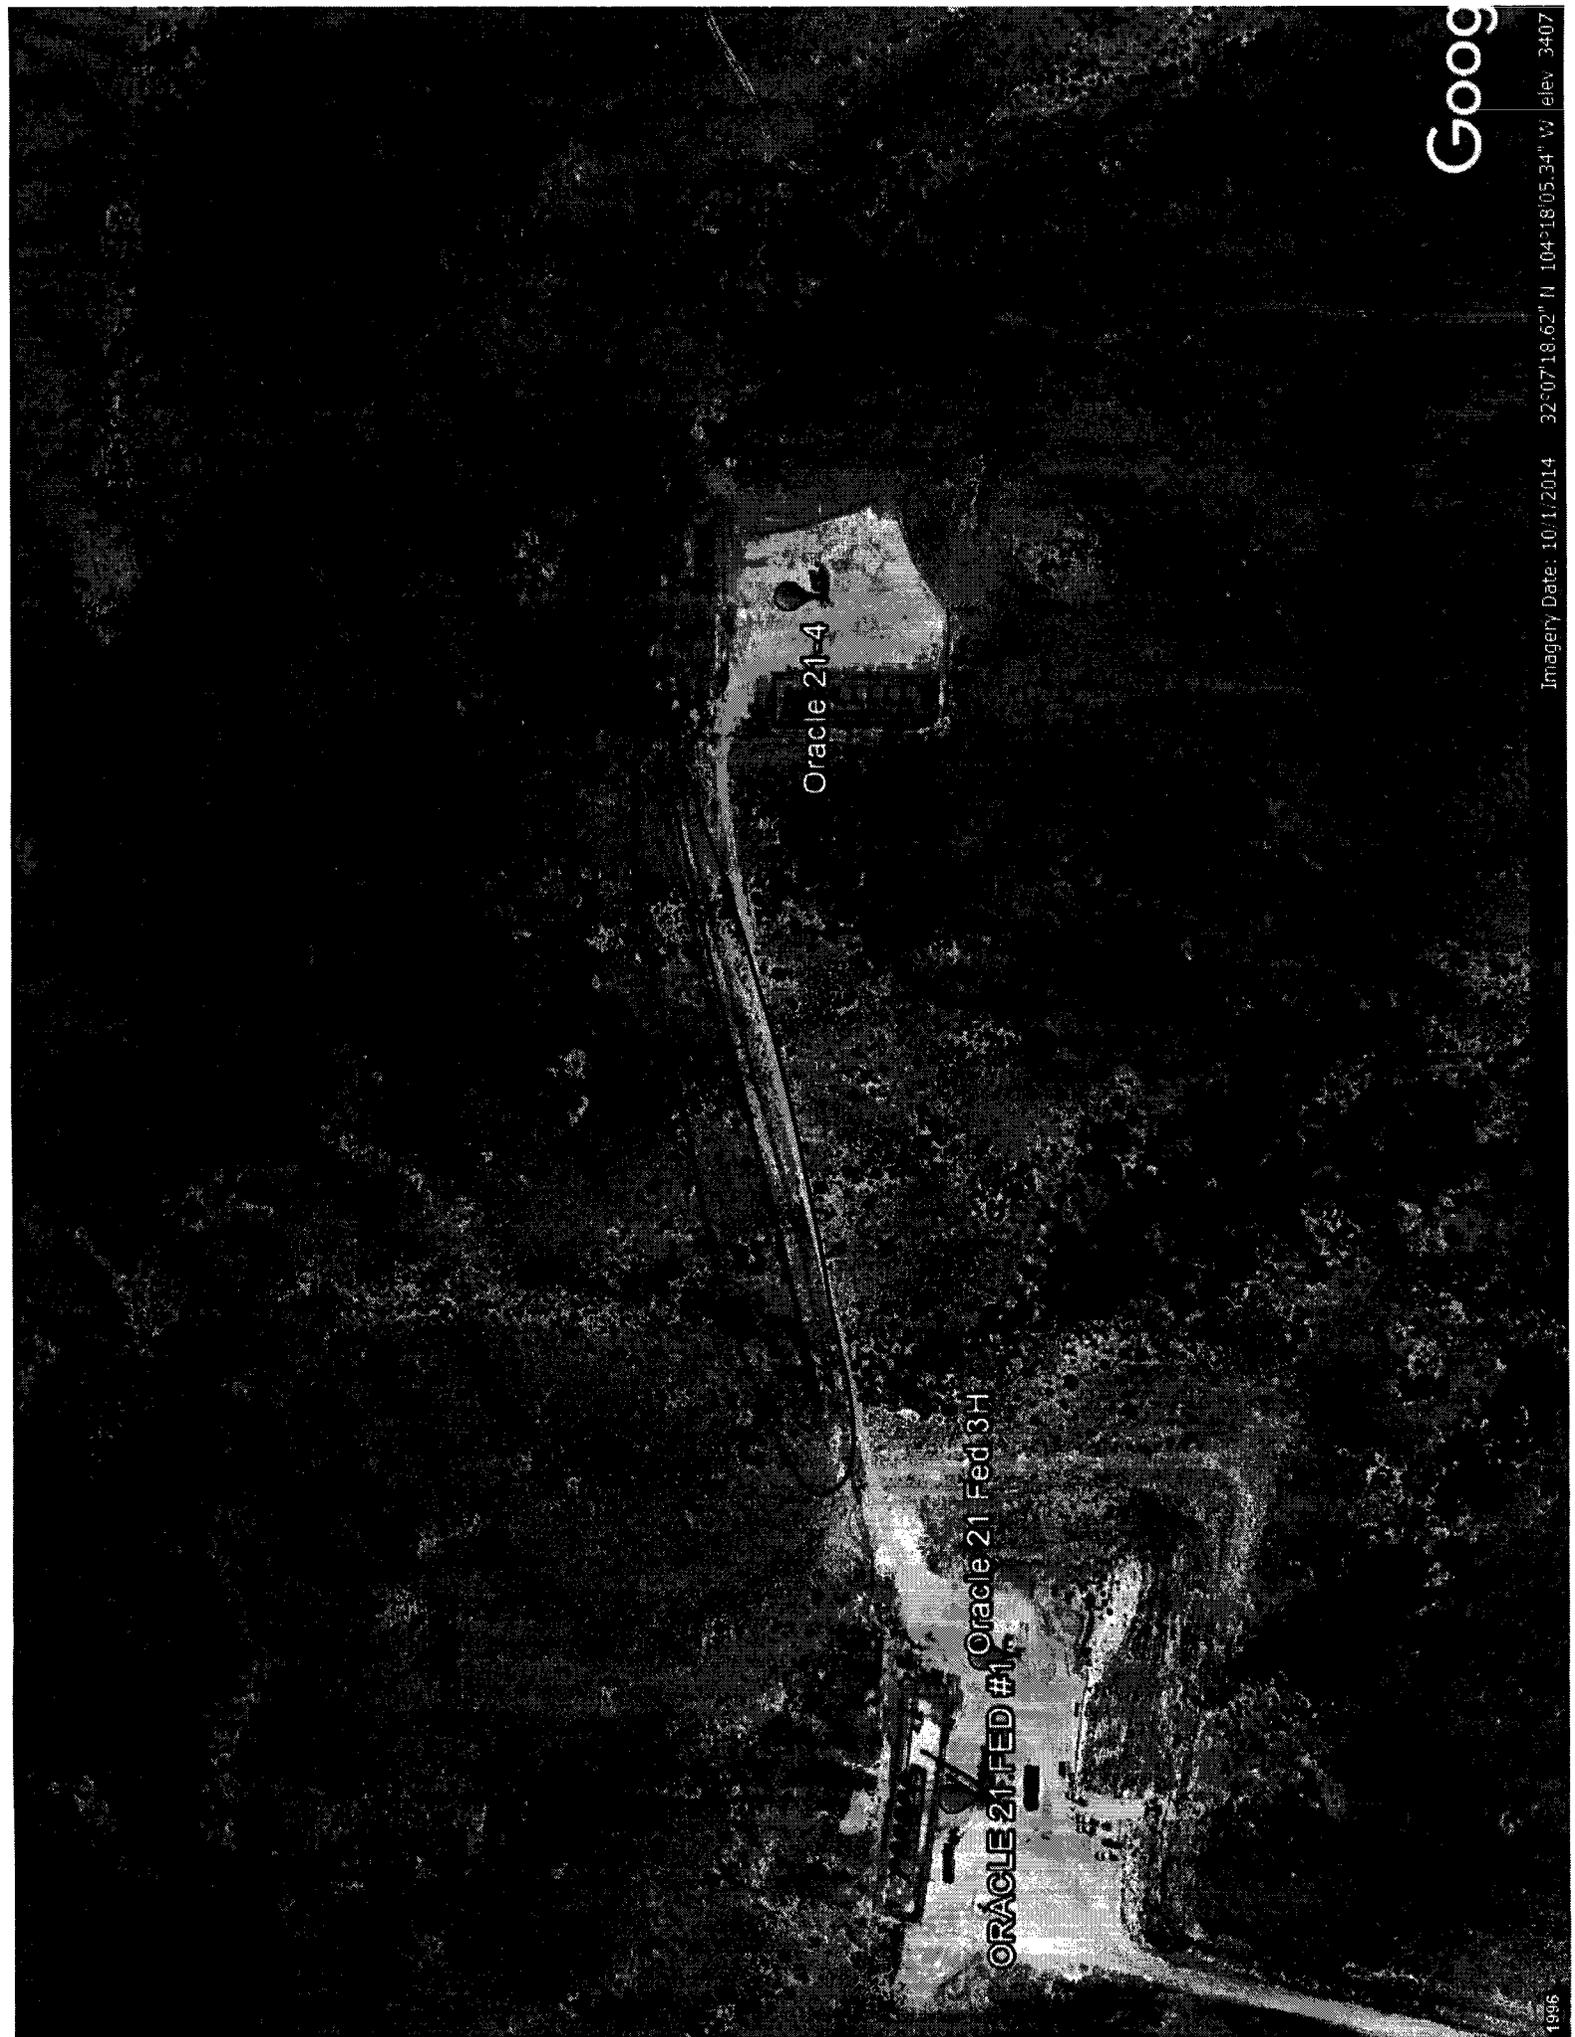
Type of Release produced water	Volume of Release 20 bbls	Volume Recovered 0 bbls
Source of Release Poly flowline	Date and Hour of Occurrence 4/11/2017	Date and Hour of Discovery 4/20/2017
Was Immediate Notice Given? <input type="checkbox"/> Yes <input checked="" type="checkbox"/> No <input type="checkbox"/> Not Required	If YES, To Whom?	
By Whom? Christine Alderman	Date and Hour 4/21/2017	<i>e-mail 12:56pm</i>
Was a Watercourse Reached? <input type="checkbox"/> Yes <input checked="" type="checkbox"/> No	If YES, Volume Impacting the Watercourse.

Describe Cause of Problem and Remedial Action Taken.*
It appears that BLM did a controlled burn on 4/11/2017 and approximately 600' of 4" poly pipe was impacted by the fire. It was noticed on 4/20/2017 when the pumper turned on the transfer pump and he saw water shoot up in the pasture north of the location. He immediately turned the pump off and went to investigate and discover the burnt piping.

Sorry about that! I meant to send the map with it. The red line indicates the damaged line location.

Describe Area Affected and Cleanup Action Taken.*
The pasture area north of the facility. An environmental consultant will be contacted and a work plan will be developed.
