Site Assessment/Characterization/Closure

3Bear Cottonwood Water Treatment and Impound

3Bear Field Services, LLC

June 2019

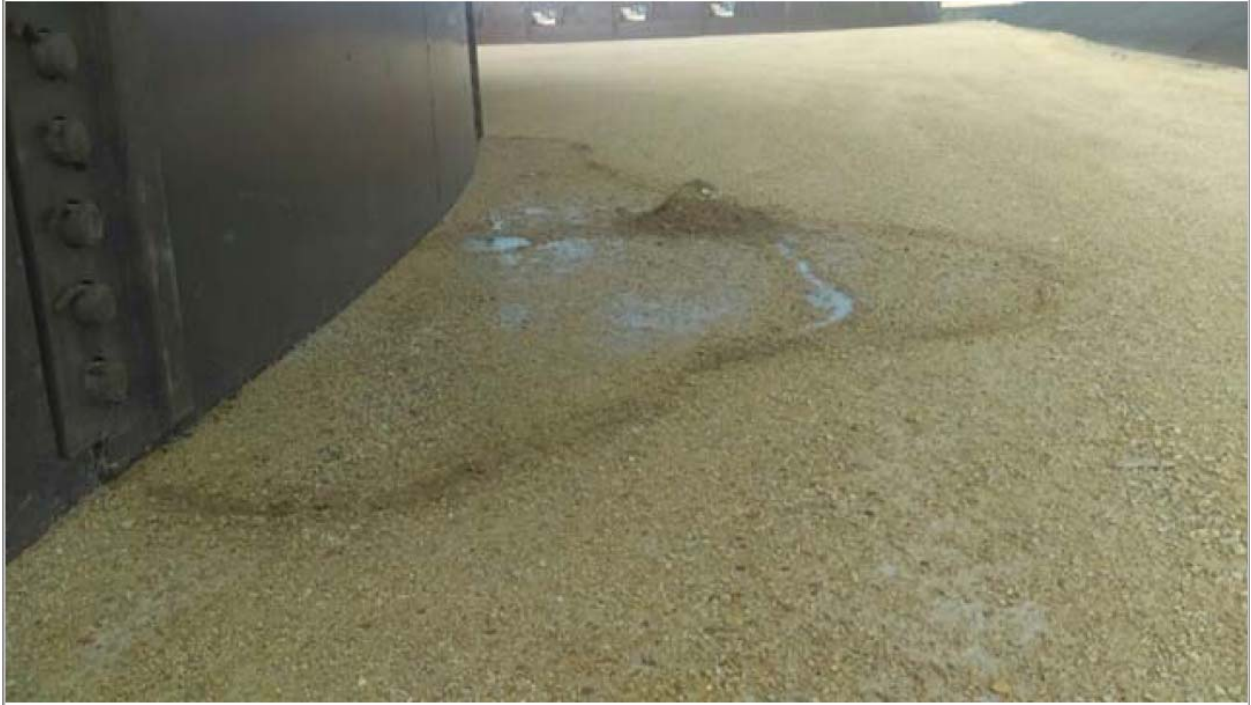
Figure 5

On March 26, 2019 a leak was detected on tank TK-454 on the Southwest corner of Cottonwood Water Terminal and Impound. TK-454 was removed from service and drained to determine the cause of the leak. After inspecting the tank it was determined that there was a tear in the liner of the tank allowing a small amount of produced water with hydrocarbons to release into the surrounding soil contained within lined storage tank berm; calculated estimate was 11 bbl of produced water was released. To remediate the contaminated liquids, 3Bear excavated the saturated soil until the soil was dry. A total of two cubic yards of contaminated soil was removed from the spill site, concluding that 3Bear's original estimation of the amount of liquids released was a conservative estimation. The tank liner has been repaired and the tank remains out of service until further notice.

Figures 5-7 are photographs of the spill. There are no photographs of the remediated site prior to backfill.
