Souder, Miller & Associates ♦ 201 S. Halagueno St. ♦ Carlsbad, NM 88220
(575) 689-7040

SMA #5E28395, BG6

**RE: LINER INSPECTION REPORT
CHISO 14 STATE 8711 #3H TANK BATTERY (1RP-5460)**

BTA Oil Producers, LLC
Chiso 14 State 8711 #3H Tank Battery (1RP-5460)

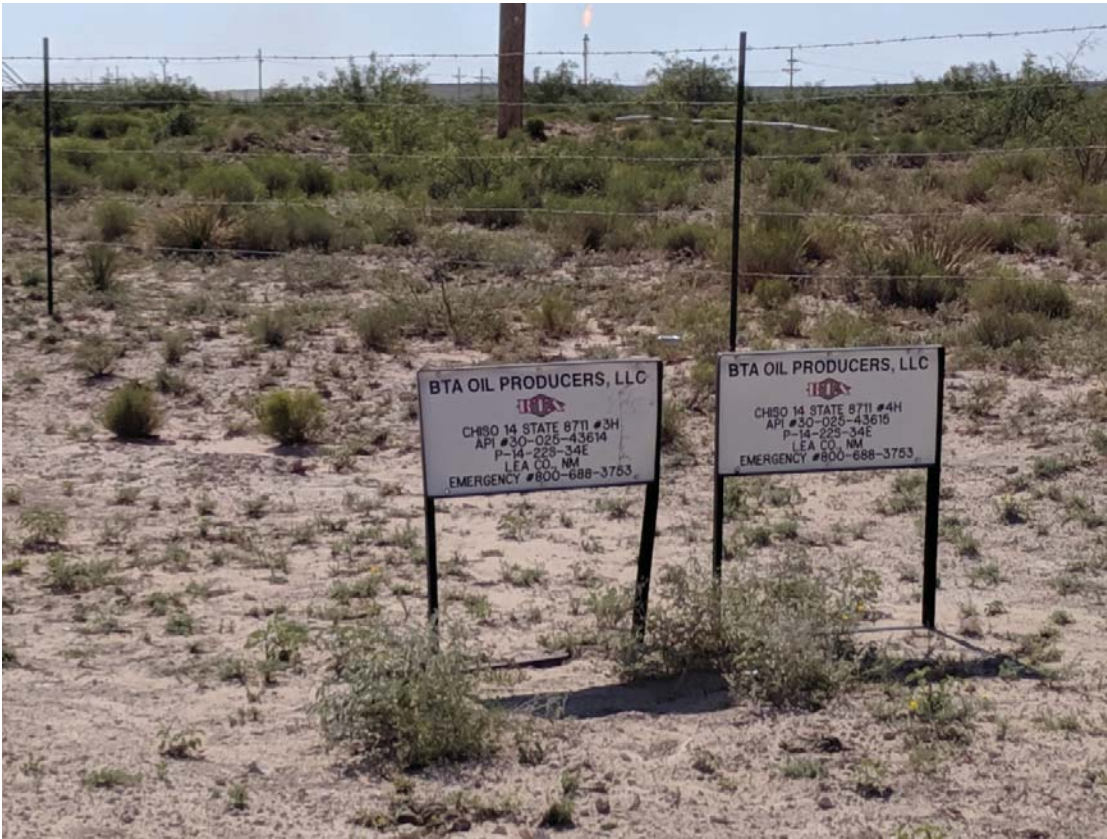
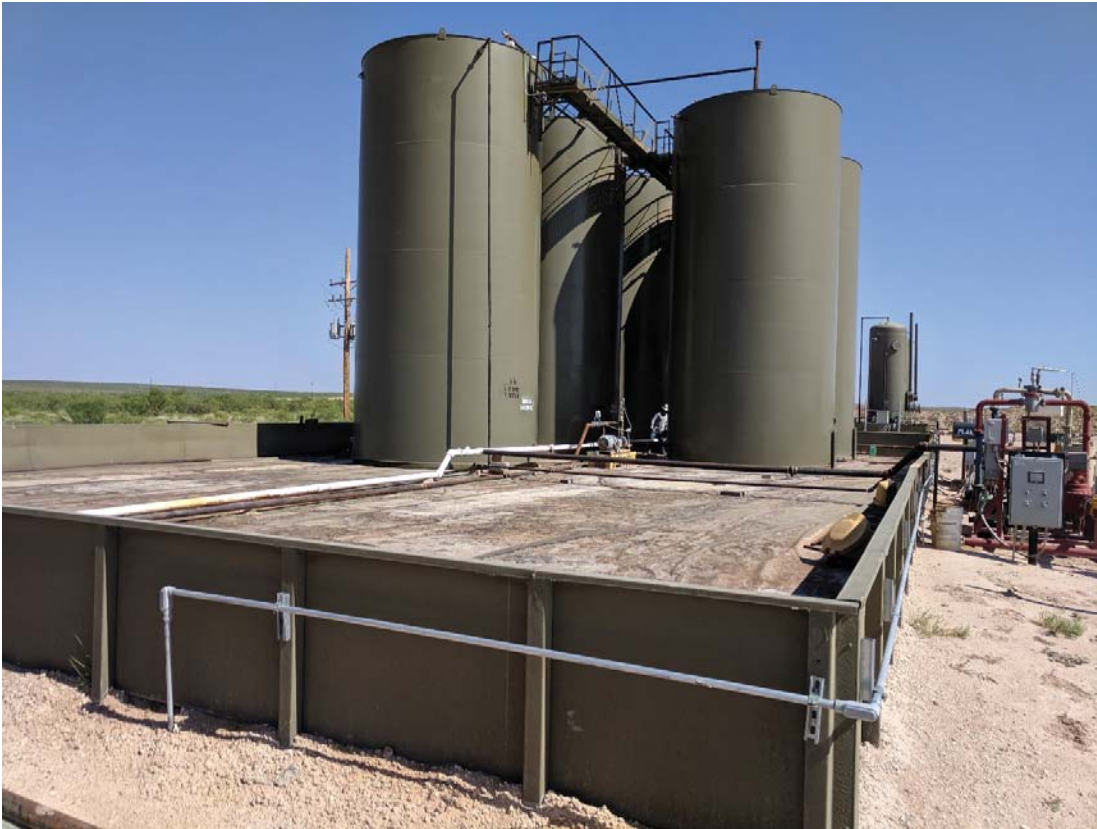
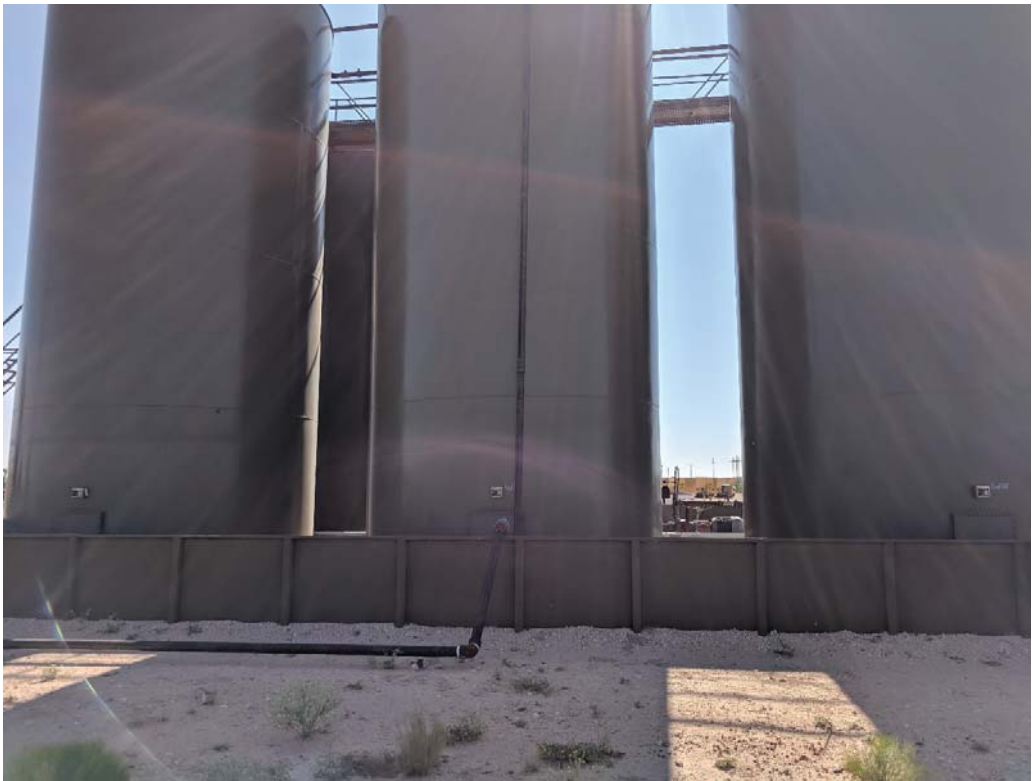
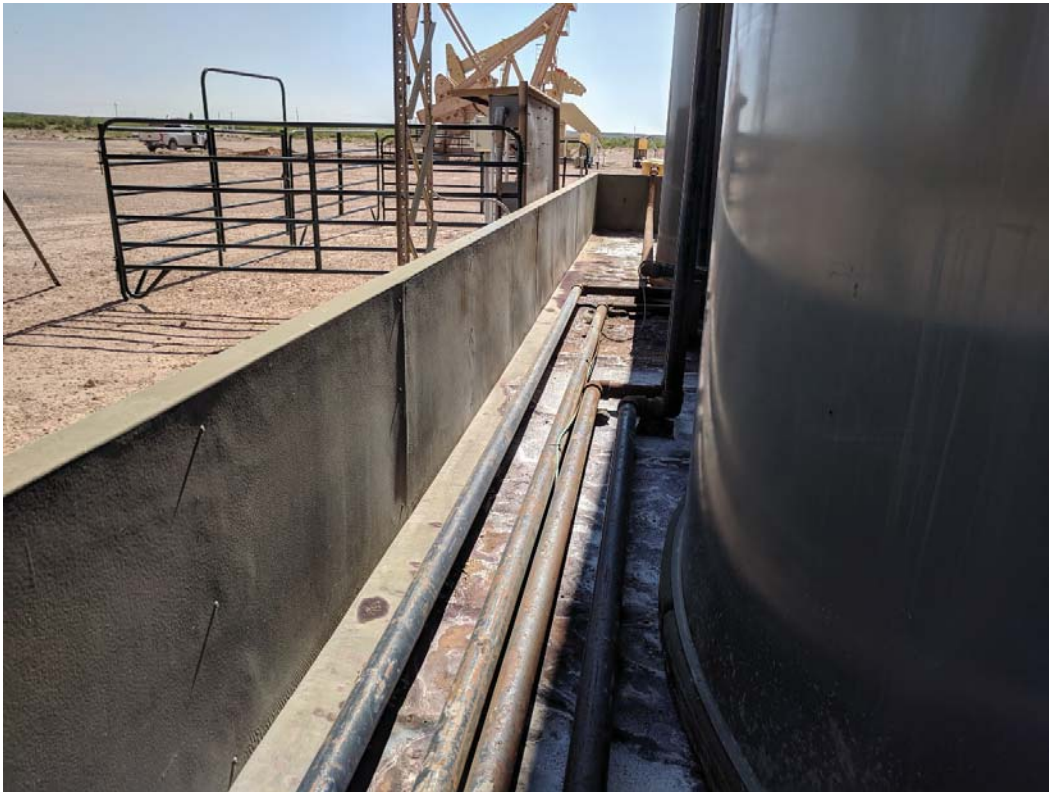
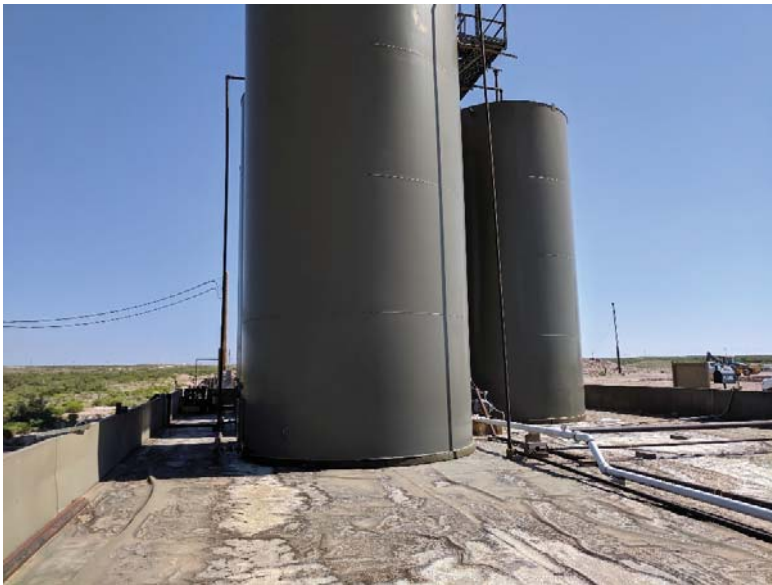
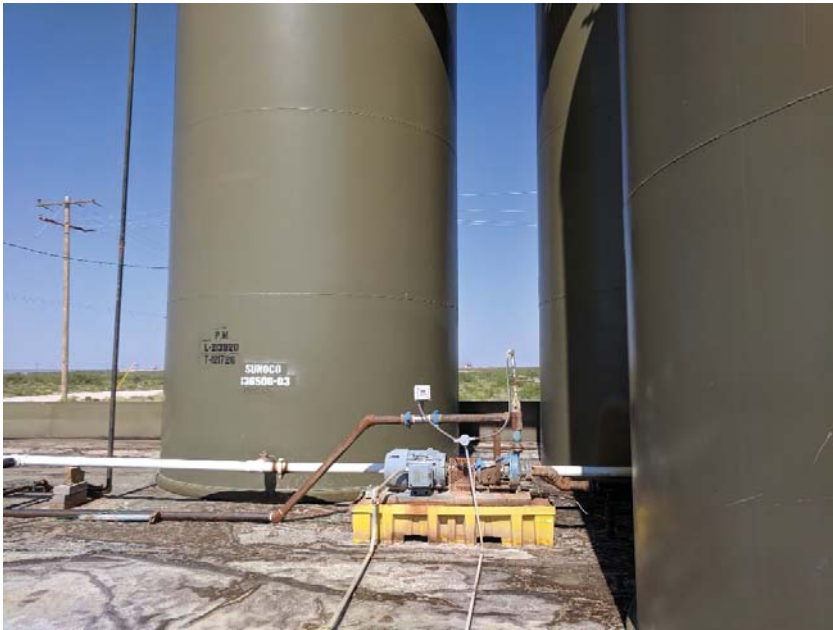
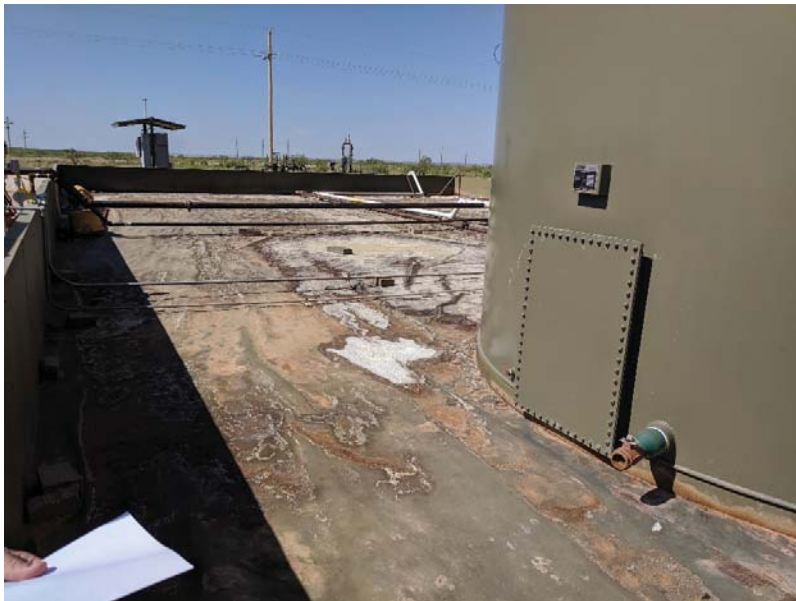
Appendix A
PHOTO LOG & FIELD NOTES

At the request of BTA, SMA conducted a liner integrity inspection per the requirements of 19.15.29.11.A(5)(a) NMAC. NMOCD was notified on July 8, 2019 that the liner inspection was to occur, and SMA conducted the liner inspection on July 11, 2019. After a thorough visual inspection of the liner within the tank battery containment, the liner appeared to be intact and had the ability to contain the leak in question. The tank from which the release occurred was identified, and SMA verified that the release did not occur outside of the lined containment. A photo log and field notes of the inspection is included in Appendix A.

SMA recommends no further action for this release.
