M-E-M-O-R-A-N-D-U-M (3-02-04)

To: Joanna Prukop, Acting Director
From: Frank T. Chavez, District III Supervisor
Subject: Report on Chi Operating Incorporated Well Incident in Carlsbad
Date: May 7, 2004

Oil Conservation Division Investigation of the Chi Operating Inc. Gas Well Incident in Carlsbad

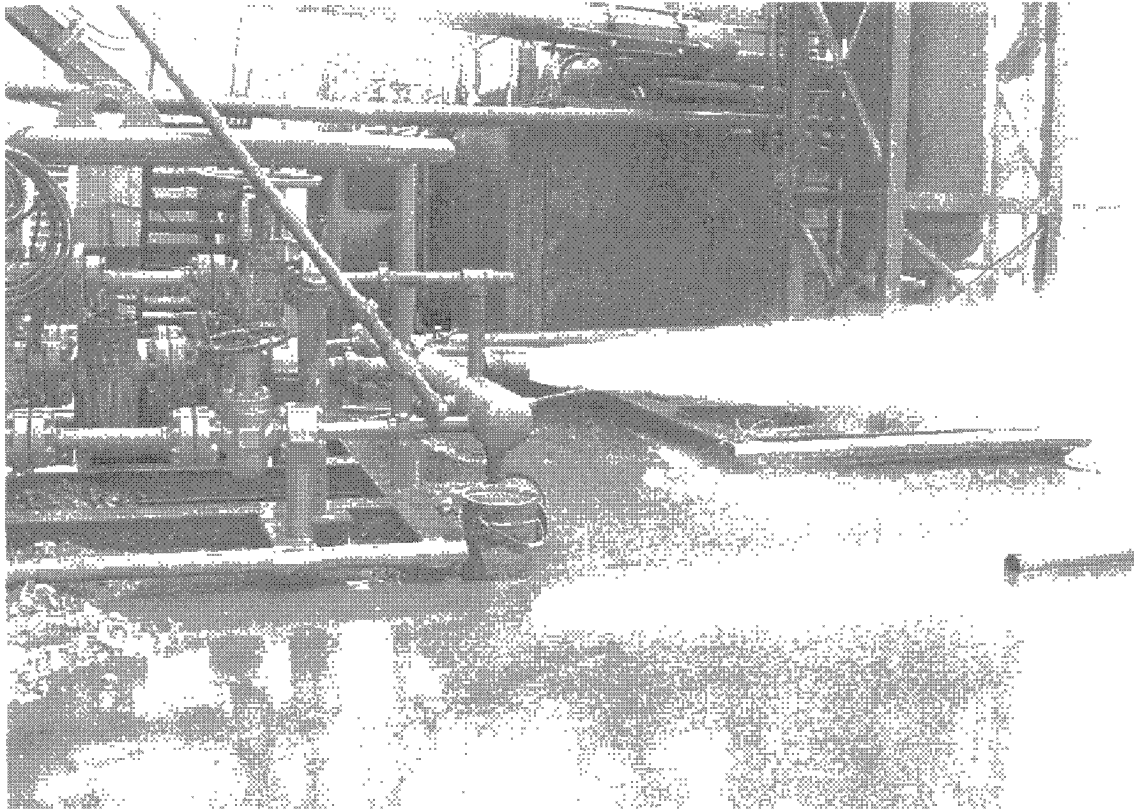
15. The safety pipe separated from the manifold to which it was connected and the force of the drilling fluid pushed the pipe aside. Very shortly most of the drilling fluid was emptied from the hole and only gas was blowing out. The pusher discussed the problem with the Chi engineer in Midland and was instructed to allow the gas to flow through the existing separated connection and begin the necessary emergency notification and safety procedures. The pusher alerted the Carlsbad Fire Department and others. Chi then passed the handling of this incident at the rig to Cudd Pressure Control, Inc., a company specializing in well emergencies. (The technical handling of the release does not pose an issue to be included in this report.)

gas that was flowing from the deeper formation until some kind of equilibrium was established that caused the pressures to rise in the hole. If a thin layer of fine material from the drilling fluid effectively sealed those shallower formations, then the high pressures from the deeper formation would have been exerted immediately against the base of the shallower casing and the casing itself. Chi stated that they were concerned that during the drilling of the hole, the drill pipe rubbed against the casing and very likely created some thinning of the pipe. This thinning could have lowered the pressure capacity of the casing. If the pressure from the deeper formations ruptured this thinned pipe, gas may have uncontrollably escaped to even shallower formations or into the water table, and erupted through the ground around the rig. Quite often these eruptions ignite around the rig causing a very dangerous and difficult situation to control. Igniting the gas at the broken connection would have created a large fire at a point close enough to likely cause loss of control of the well by damaging the well control equipment or causing the substructure of the rig to collapse and destroy the BOP thus causing complete loss of control. Attachment C is a photo showing the gas flowing from the connection.

19. OCD Rule 109.B. requires a blowout preventer (BOP) to be installed and maintained "in good working order" on all rigs operating within the corporate limits of any city. On most wells the BOP includes attached equipment such as remotely controlled valves, manifolds, chokes, and safety lines to be effective. A schematic of the actual BOP installation used on this well is shown on Attachment D. The pipe that came loose from the connection and made it

impossible to flare the gas was an important part of the BOP on this well and was necessary for the entire system to be used as intended. Had that line not come loose, the impact of the sudden gas flow would have been minimal because the gas could have been safely burned at the pit. There is a possibility that the force from the drilling fluid moving at high speed through the pipe caused the connection to fail, however, that is what the pipe is supposed to be able to handle. This line was not assembled tightly enough to be usable due to the two leaks that developed the first time that the pusher diverted the flow through it. This also reveals the likelihood that the line was not tested when it was installed. If the line that separated from the manifold had been tested when it was installed, the problem could have been discovered and repaired. The crewmember who tightened the connections on the line told us that one of the leaking connections was adjacent to the threaded connection that actually came apart. The direction of turn to tighten a connection that was leaking was the same direction that would have loosened an upstream threaded connection. He told us he was very aware of this and as he tightened the loose connections he observed that the other upstream connection did not move. As a secondary note, this pipe was not secured to keep it from moving if a large volume of gas had actually been sent through it. Because of the leaks on this line and the inability of the pipe to stay together during a process it was intended to handle, the BOP equipment was not in good working order. Thus Chi was in violation of Rule 109.B.

This photo shows the gas flowing from the blowout preventer equipment at the point where the safety pipe came loose. The safety pipe is in the lower right of the photo. Note the drilling fluid covering the area.
