Merrion Oil & Gas Corporation

Casing Repair Procedure

N. Lindrith A No. 1

Repair casing leak, put back on production.

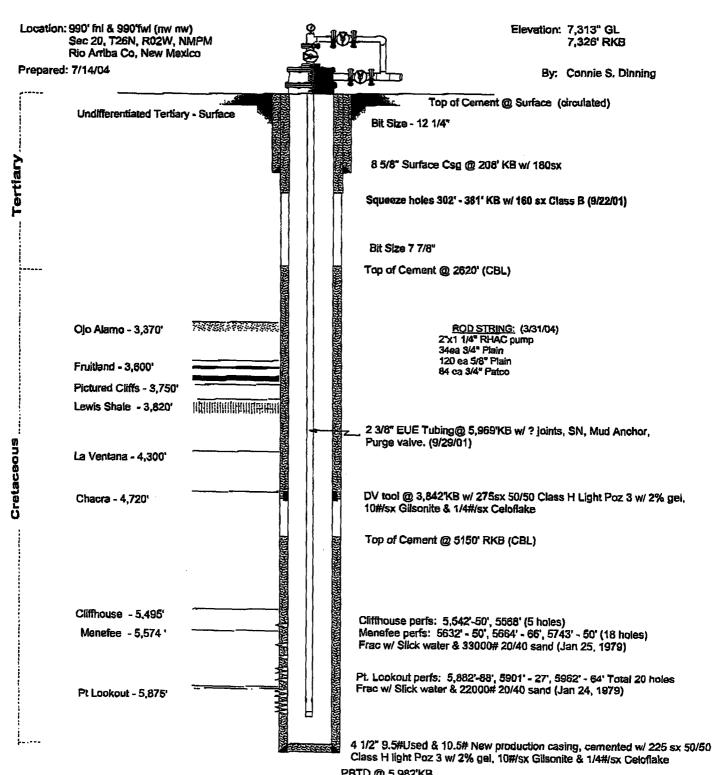
Merrion Oil & Gas Corporation Wellbore Schematic

Current Wellbora Configuration

CAPACITIES
4 1/2* 10.5# Casing 0.0150 bbl/ft.
2 3/8* 4.7# Tubing 0.00987 bbl/ft.
4 1/2* X 2 3/8* Annulus; 0.0105 bbl/ft.

PBTD @ 5,982'KB TD @ 6,045'KB
