BP - San Juan Wellwork Procedure

GCU 307 SWD
30-045-24286

Gallegos Canyon Unit 307

API # 30-045-24248

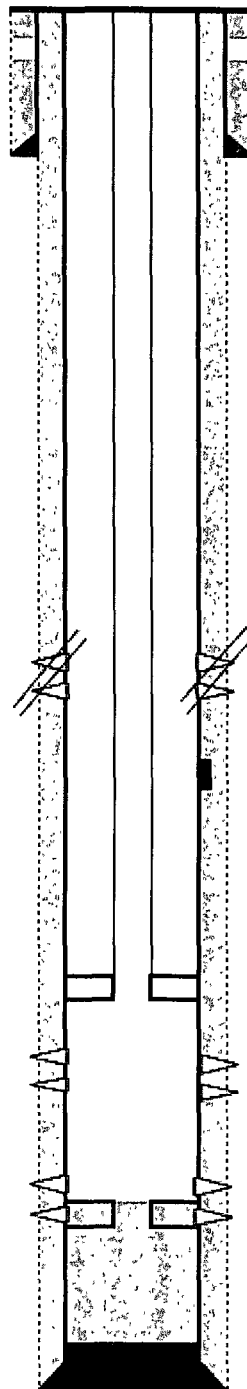
Current Wellbore Diagram

April 1980: Drilled well as a dual completion.

9/15/81: Pulled dual strings. Set Model D pkr w/ flapper

5/2/2000: Inj. Pressure went from 1000 psi to 0 psi @

5/16/00: POOH w/ 2 1/16" short string. Jt. #36 had rodwear

5/24/2000: CO to 2677' w/ air. Pull 2 3/8" string. Jt. #39 had hole.

11/15/02: Pull tubing and inspect. Replace 1jt. Damaged tbg.

10/24/06: Flowed well to tank. TOH w/ rods.

Pulled tubing. Tagged 125' fill above packer. Cleaned out

and pulled packer and tubing. Pumped 25 bbls Class G

to shut off PC Perfs. Drilled out cmt. Cleaned out to

2928' (hard scale). Drilled on an old Model D pkr and tried to

push to bottom. Pushed to 3000'. Pumped Xylene and

1. MIRU service unit
2. Test tubing for holes. (Do not broach tubing because it is internally plastic coated and potential damage to coating may occur).
 - a. If test indicates a hole in tubing, change out tubing string. Ensure tubing string that is run is internally plastic coated.
3. Pull tubing string and packer, lay down any bad joints. If many joints are bad, replace entire string
4. Inspect packer for damage, if any damage is seen, replace packer
5. Test casing integrity.
 - a. If casing test fails determine location of leak and injection rate.
 - b. Repair casing as required
6. Perform a scraper run to clear walls of casing to ensure packer will set
7. Install tubing string with new packer, if required. Ensure tubing string that is run is internally plastic coated.
8. Reland tubing on packer @ +/- 2675'
9. RD/MO service unit
