Incident ID	NVF1830934126
District RP	
Facility ID	
Application ID

Release Notification

Site Name La Plata 33 1	Site Type Gas Well
Date Release Discovered 10/16/2018 @ 9:30am	API# 30-045-29272

Photographs – 11/13/18 Liner Integrity Inspection

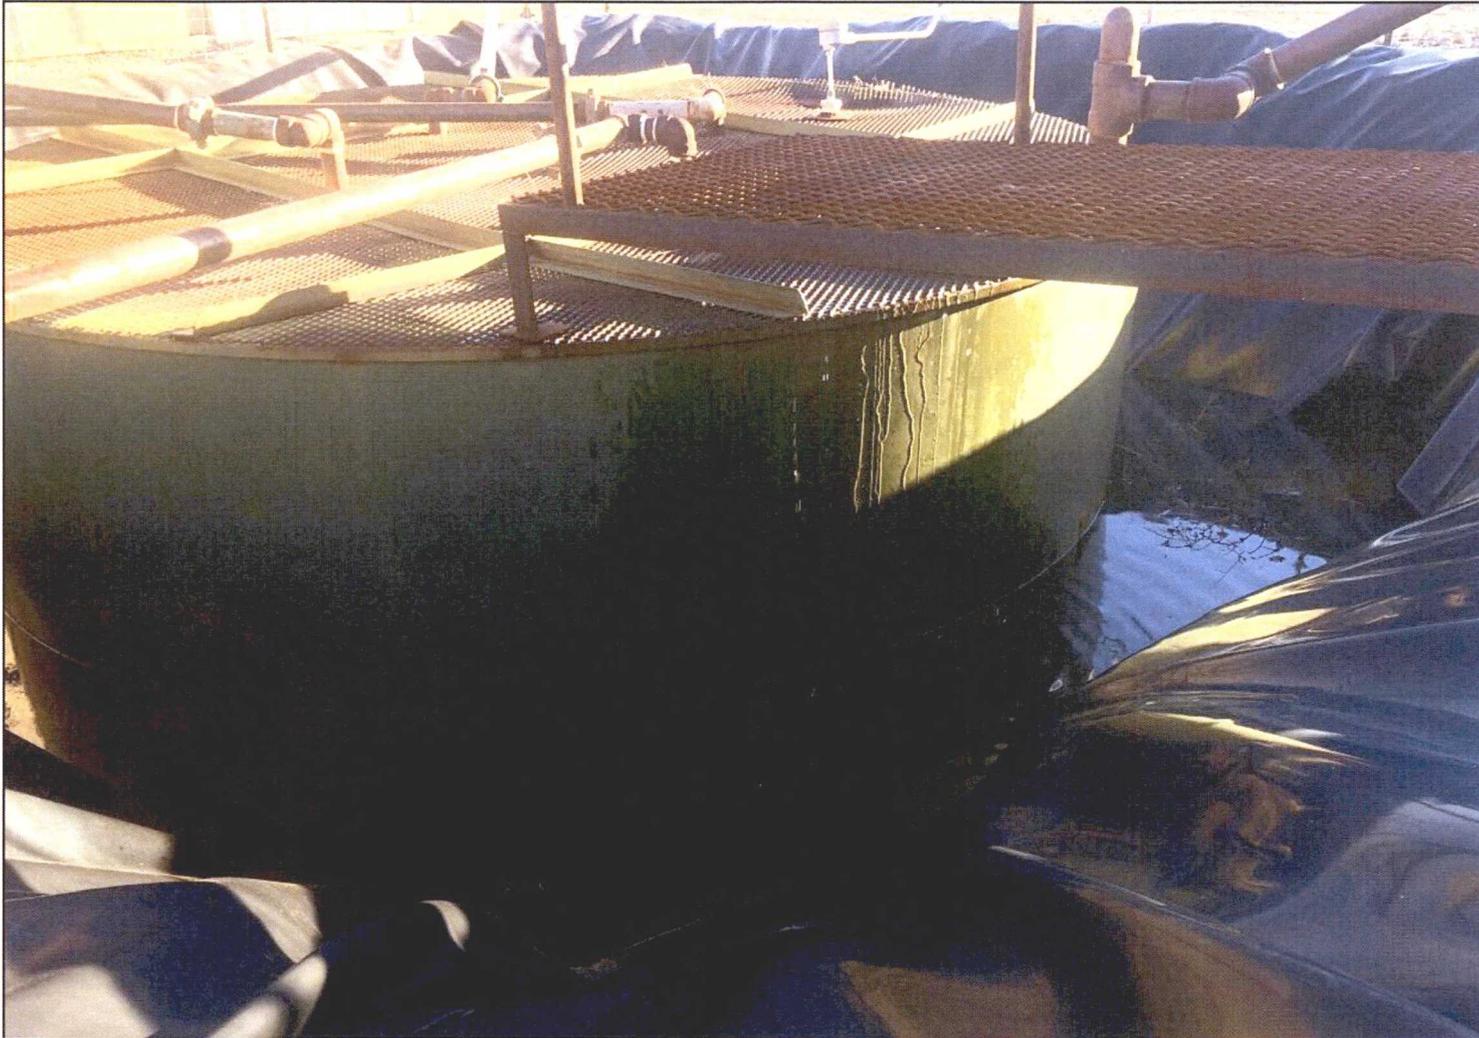
Photographs – Impacted area (10/16/2018)

An over the top release of 15 bbls of produced water was discovered by the water truck driver. Hilcorp was notified and the operator went to location. A request was created Friday, 10/12/18 to have the pit pulled but wasn't submitted until 10/14 and pit tank was running over on 10/16/18. The high kill switch did not work because the float was damaged and not functional. 15 bbls was recovered from inside the lined berm area. No soil was impacted from this spill.

- Hilcorp Energy Company used a vac truck to recover 15 bbls of Produced water. The water stayed with in the berm area which is lined. The liner was steam cleaned.
- Liner integrity inspection notification was sent on 11/9 and was conducted on 11/13/18 at 10:00am.
