30-045-22933 PIT REMEDIATION AND CLOSURE REPORT

Operator: Hallador Petroleum, LLP	erator: Hallador Petroleum, LLP Telephone: 1-800-839-5506				
Address: 1660 Lincoln Street, Denver, CO	80264				
Facility Or: Horton 5 Well Name	THE STATE OF THE S	2375			
Location: Unit G Sec 7, T 32N, R 11W, C	County San Juan, NM	2003			
Pit Type: Separator X Dehydrator	County San Juan, NM Other Other	W. W.			
Land Type: BLM <u>X</u> , State	_, Fee Other	M. A. M. M. C. B. C.			
Pit Location: Pit dimensions: length	, width <u>20'</u> , depth <u>2</u>	5'			
Direction from reference: 15					
Depth To Ground Water (Vertical distance from contaminants to seasonal high water elevation of ground water.)	Less than 50 feet No 50 feet to 99 feet Greater than 100 feet	(20 points) (10 points) (0 points) 			
Wellhead Protection Area: (Less than 200 feet from a private domestic water source, or; less than 1000 feet from all other water sources.)	No	(20 points) (0 points) 			
Distance To Surface Water: (Horizontal distance to perennial lakes, ponds, rivers, streams, creeks, irrigation canals and ditches.)	Less than 200 feet 200 feet to 1000 feet Yes Greater than 1000 feet	(20 points) (10 points) (0 points)

RATIO

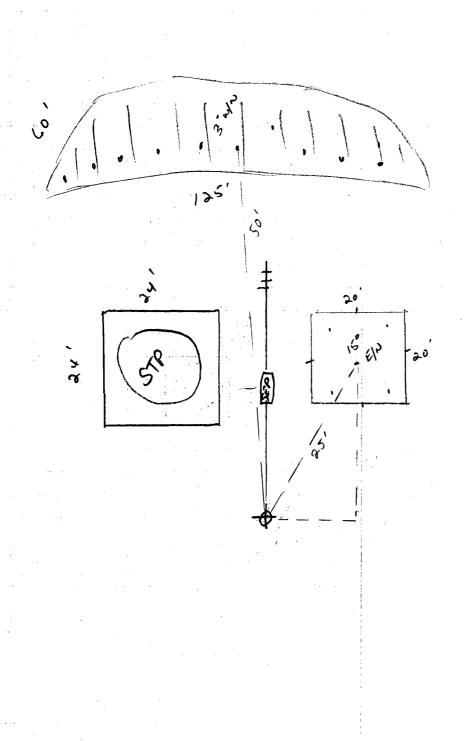
SUBJECT HOLTON 5

Owner/Operator: Hallador Petroleum, LLP Telephone:1-800-839-5506
Address: 1660 Lincoln Street Denver, CO 80264
Facility or Well Name: Horton 5
Location: Unit G, Section: 7 T32N R11W County: San Juan
Land Type BLM X, State, Fee, Other Landfarm location Length: 125' Width: 60' Reference: Wellhead: X Other: Footage from reference: 50' Direction from reference: 43° West of North Refer to attached map for land farm location
GENERAL DISCRIPTION of LANDFARM ACTIVITIES: Contaminated soils were excavated from the pit area to bedrock of shale at approx. 22'. Recovered soil was distributed on location and plowed/tilled, numerous times over a twenty four month period. Following clearance sampling and land farm remediation, treated soils will be backfilled in original pit area.
SAMPLING INFORMATION
Type of sample: Grab: Composite: <u>10 points</u> Sample Depth : <u>0-12"</u>
Sample Date: 6/9/03 Sample Time: 1130 Laboratory Analysis: BTEX NA (ppm) TPH ND mg/Kg(ppm) OVM/PID 0.0 units Refer to attached map for sample location. Laboratory results attached
