Release Notification and Corrective Action

Name of Company	Williams Production	Contact	Michael K. Lane
Address	999 Goddard Ave, Ignacio, CO 81137	Telephone No.	970/563-3319
Facility Name	Rosa 361	Facility Type	Well Site

Location: ROSA 361

RE: Summary for Sampling  
Rosa 361 (3/1/05 Produced Water Spill)

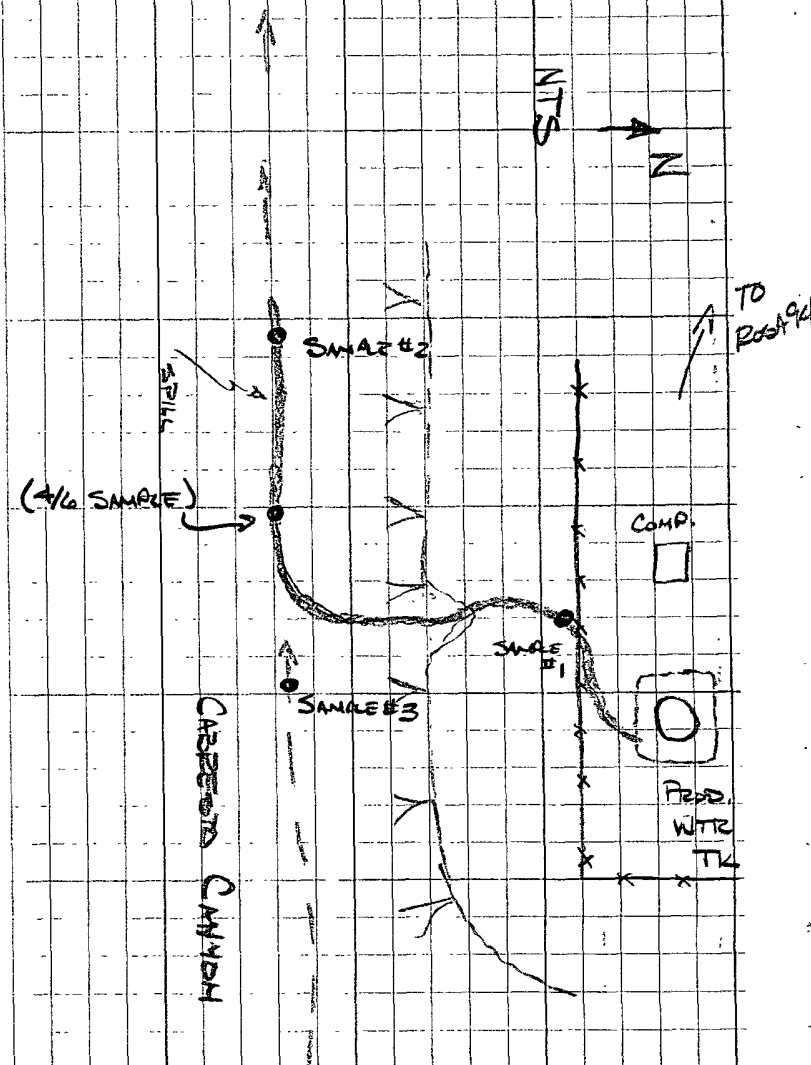
Site Diagram.

Sample ID	Description	Field Reading
1	@ FIVE	NA - SILTY SAND
2	IN WASH	NA - SATURATED SAND FINE
3	UPSTREAM	NA - SATURATED SAND FINE
4		
5 #1	IN WASH	NA - WET SAND FINE
6		
7		
8

Comments: POURING WATER IN WASH (3/4/05)
