Api # 30.039.23231

From: Martin, William
Sent: Monday, October 27, 2003 7:49 AM
To: Foust, Denny; Perrin, Charlie
Subject: Re: NM&O Operating Rucker Lake SWD #2

Incident# ADGF 0332157807

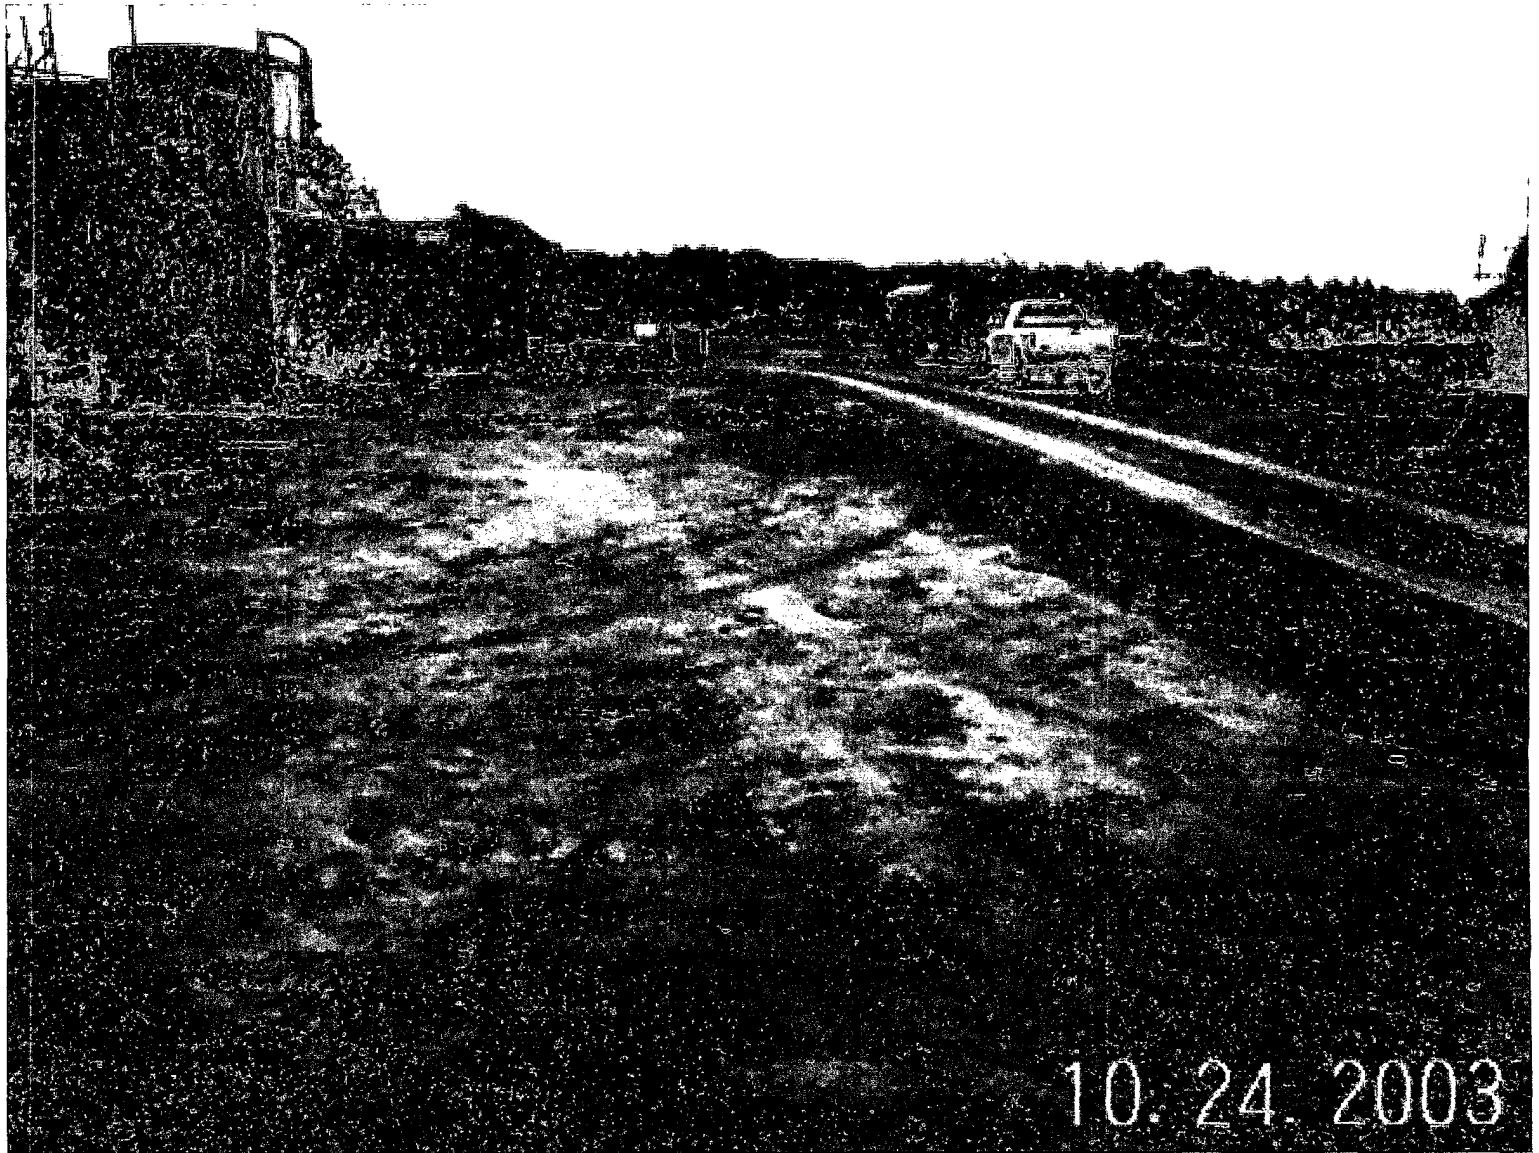
30 039 23231

On 10/24/03, I inspected the above referenced facility in response to a landowners complaint about oil spills. I could find no evidence to support his claims. I talked with Mr. Caleb Post who previously operated this facility and he stated that there had been some tank runovers in the past due to equipment problems, but they had cleaned up the spills as evidenced by my inspection.
