Release Notification and Corrective Action

Name of Company Patina San Juan, Inc.	Contact John Nussbaumer
Address 5802 U.S. Hwy. 64, Farmington, N.M. 87401	Telephone No. 303.263.4608
Facility Name Champlin #1	Facility Type Tank Battery

**Champlin #1**  
**Rio Arriba County, NM**  
**SW/SW, Sec. 35, T27N,**  
**R4W**  
**San Juan Basin**  
**Patina Oil & Gas Corp.**

RE: Champlin # 1 Spill (4/21/04)

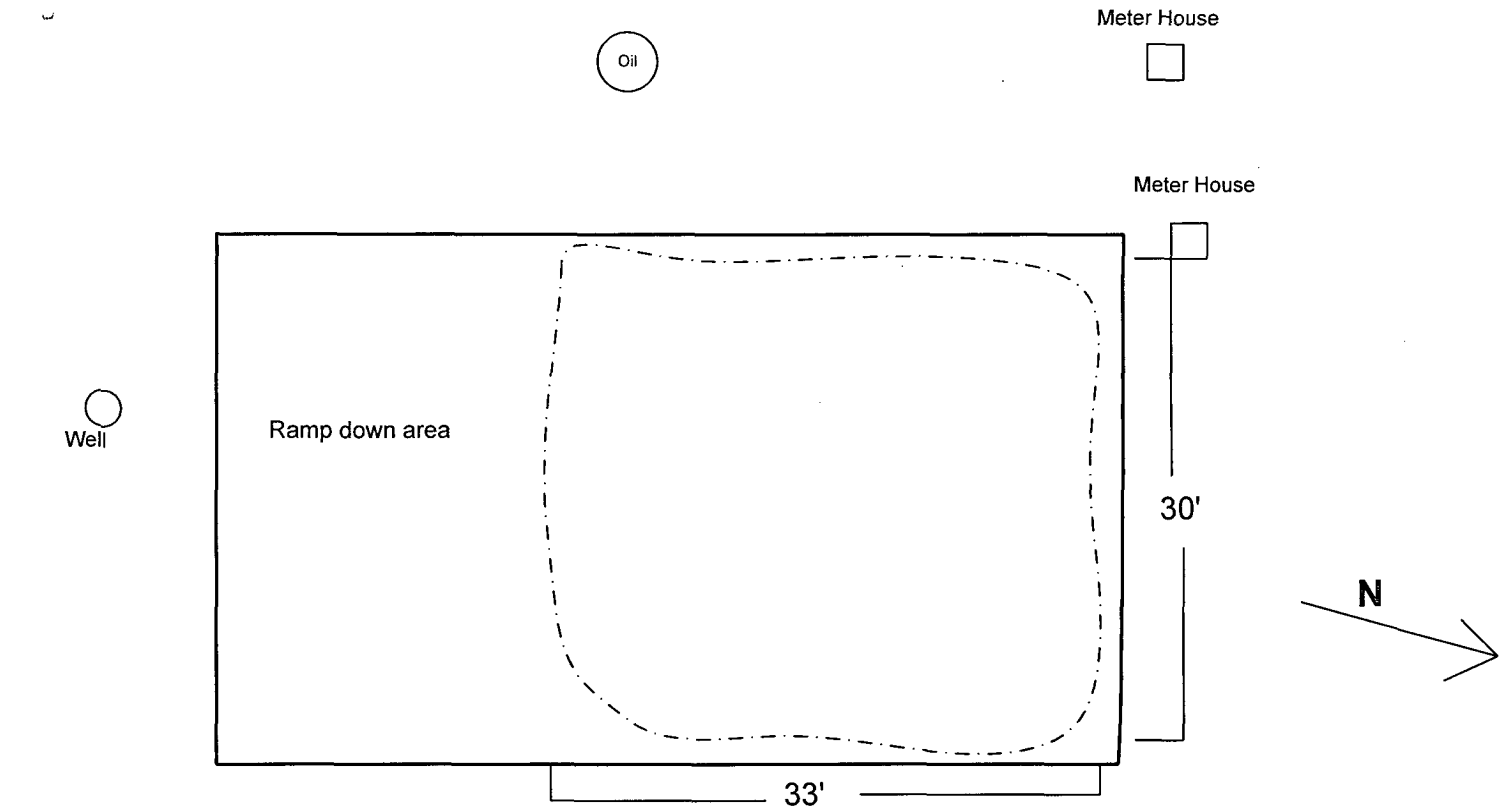
Area of excavation  
Area of impacted soil excavated

North Wall Composite = 1.9ppm  
South Wall Composite = 8.3ppm  
West Wall Composite = 12.1ppm  
East Wall Composite = 4.9ppm  
Bottom Hole Composite = 0.8ppm

North Wall Composite = 3.7ppm  
South Wall Composite = 16ppm  
West Wall Composite = 14ppm  
East Wall Composite = 6.5ppm  
Bottom Hole Composite = ND

Depth to Ground Water = 750'

Wellhead Protection Area = There are no private domestic fresh water wells or springs within 1000'

Distance to Surface Water Body = There are no surface water bodies within 1000'
