Release Notification and Corrective Action 912

APT# 30-045-31857						OPERATOR Initial Report X Final Report				
Name of Company: Energen Resources Corporation						Contact: Larry M. Brooks				
Address: 2198 Bloomfield Hwy, Farmington, NM 87401						Telephone No.: 505-325-6800				
Facility Name: Santa Rosa 17 #4						Facility Type: Producing Natural Gas Well Site				
Surface Owner: Mineral Owner					Owner				Lease N	No.:
Federal									NMSF	076337
				LOC	ATIO	N OF REI	LEASE			
Unit Letter	Section	Township	Range	Feet from the	North	South Line	Feet from the	East/V	Vest Line	County
I 17 29N 9W 1925 SOUT					ГН	715	EAST		SAN JUAN	
				NA	TURE	OF RELI	EASE			
		nsate Storage		κ			Release: 79 BBL			Recovered : All
Source of Re	lease: 210 F	BBI site stora	ge tank	(Date and Hour of Occurrence: Between 11/30/2005 and 12/2/2005 10:00 AM			· ·	
Was Immedia	ate Notice (Given?				If YES, To	Whom?			
		<u>X</u>	Yes 🔲 N	o 🔲 Not Re	quired	D. Foust				
By Whom?							Hour — 12/2/2005			,

ENI	ERGE	.N	RES	soui	RCES
SAN	AT	RO:	SA	17-	-#4-1
	_		Clea		"
San	Juan	Cou	ınty,	New	Mexico

FIGURE NO. 2

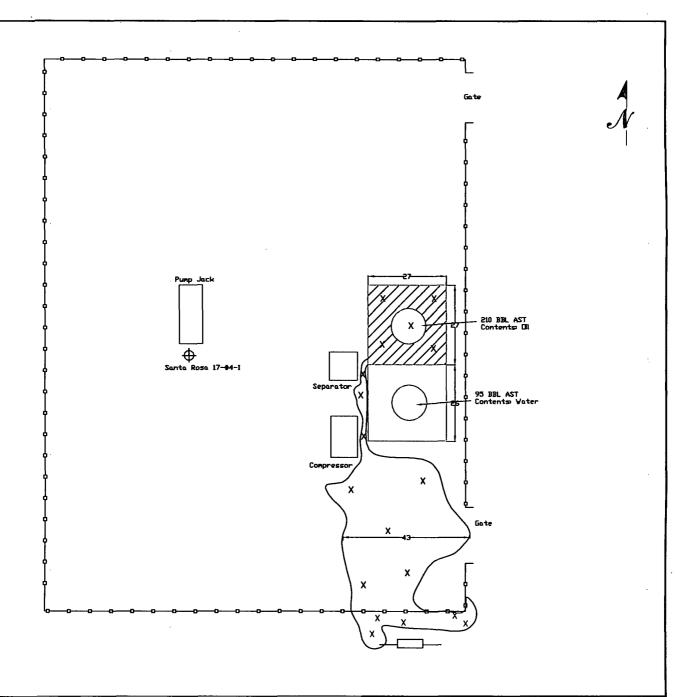
Sample #	OVM (ppm)	TPH (ppm)	Comments
1	334	8,628	Discrete sample from beneath tank
2	10	12	Discrete sample from excavated area 3' beneath 210 bbl tank
3	21	58	5-point composite from excavated area 3' beneath 210 bbl tank
4	29	44	5-point composite from excavated area outside fenced area
5	59	336	5-point composite from excavated area inside fenced area
6	95	292	Composite sample from area excavated by hand

Envirotech has completed monitoring and confirmation sampling at the Santa Rosa 17-#4-I well site located in San Juan County, New Mexico. All impacted areas were cleaned and restored to pre-incident conditions. The clean-up was completed to less than the clean up standards for this site determined by the NMOCD guidelines. Envirotech recommends no further action be taken in this matter.
