Sundry Notices and Reports on Wells

2. Name of Operator
**BURLINGTON
RESOURCES**

WORKOVER PROCEDURE
Tubing Repair / Cleanout / Plunger Installation

Mangum #5
Chacra / Gallup Commingled Well
1721' FSL, 1919' FWL
Sec. 10, T28N, R11W, San Juan County
Lat: 36°40.44" Long: 107°59.58"

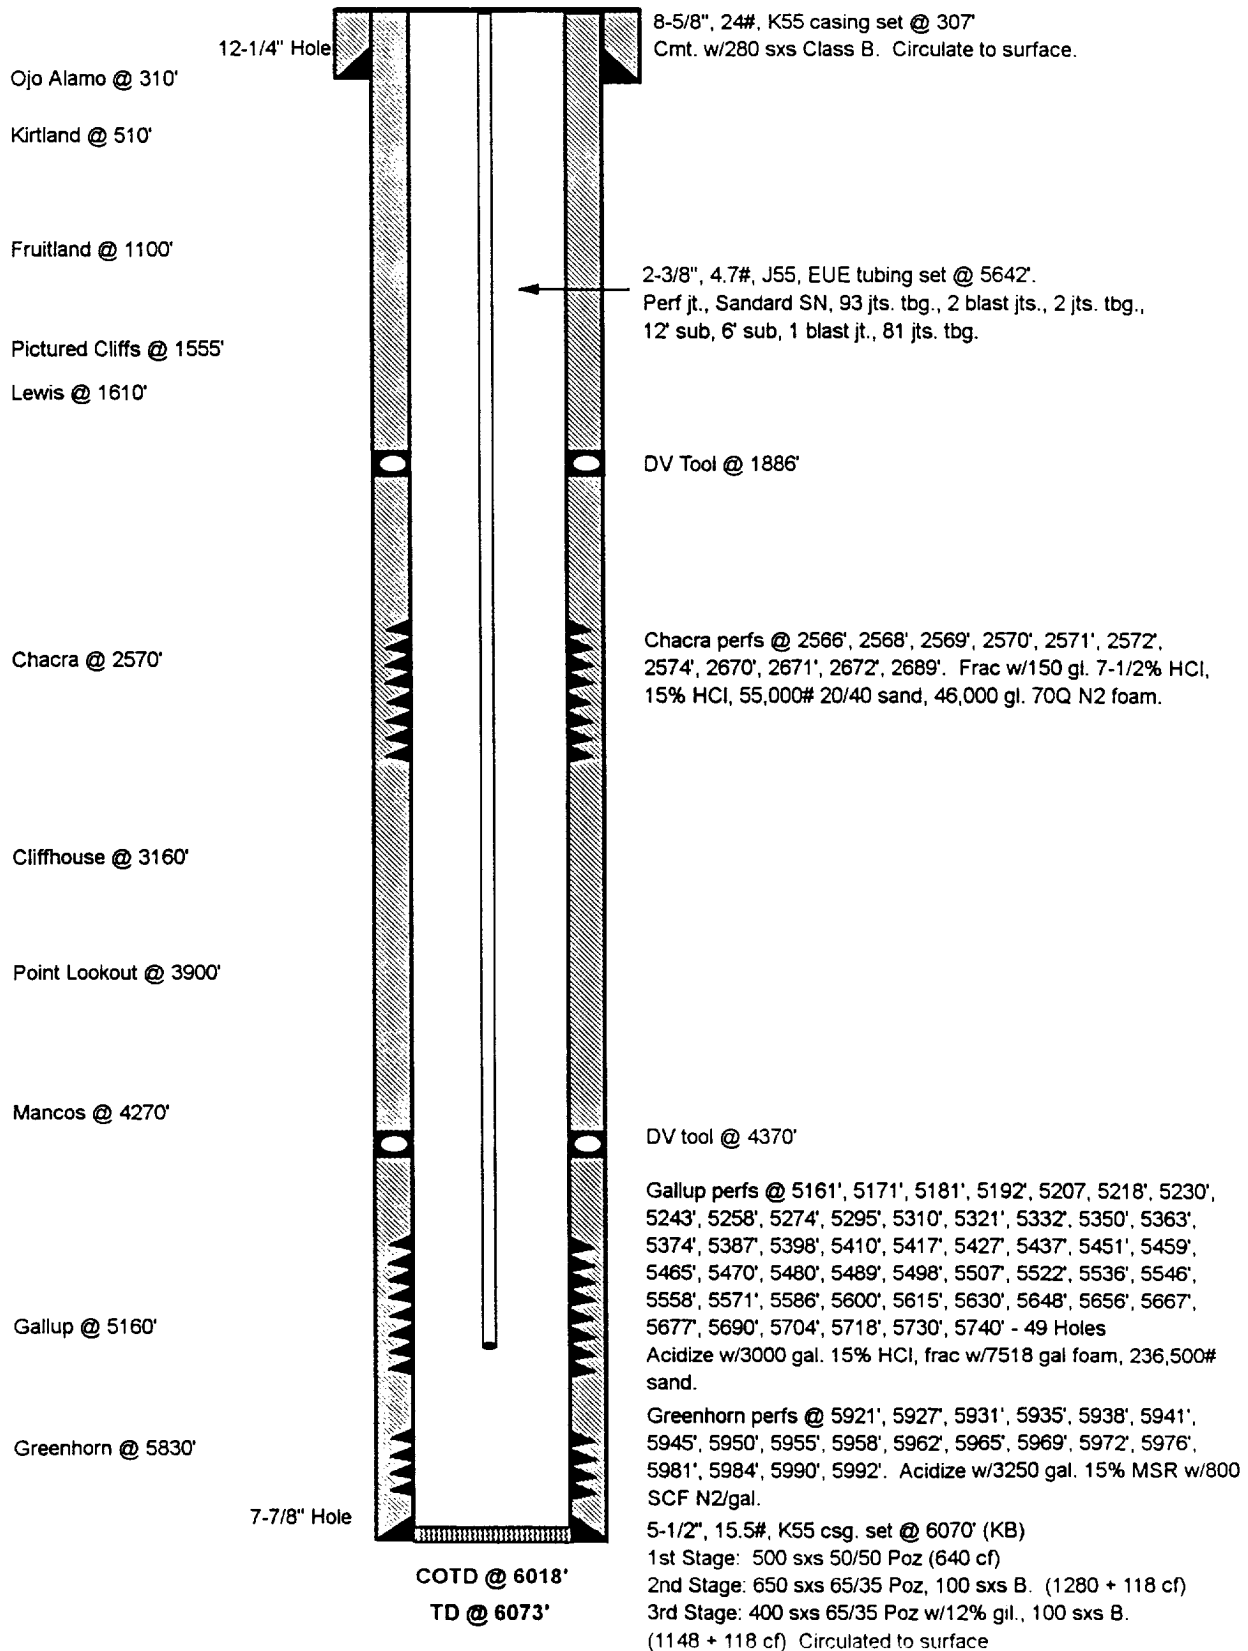
Mangum #5

Current -- 1/7/97

Spud: 6/20/83
Completed: 7/23/83
Elevation: 5502' GL
5516' KB
Workovers: 7/89: Ran plunger, later pulled.
08/87: Recomplete Chacra, commingle with Gallup
12/83: Ran pump & rods, later pulled.

DPNO: 32496A/B
Commingled Gallup / Chacra
1721' FSL, 1919' FWL
Sec. 10, T28N, R11W, San Juan County, NM
Lat/Long: 36°40.45", 107°59.58"
