Sundry Notices and Reports on Wells

2. Name of Operator
MERIDIAN OIL

WORKOVER PROCEDURE -- TUBING REPAIR

Marcotte #1
DPNO 48821A
Blanco Mesaverde
Sec. 8, T31N, R10W
San Juan County, New Mexico

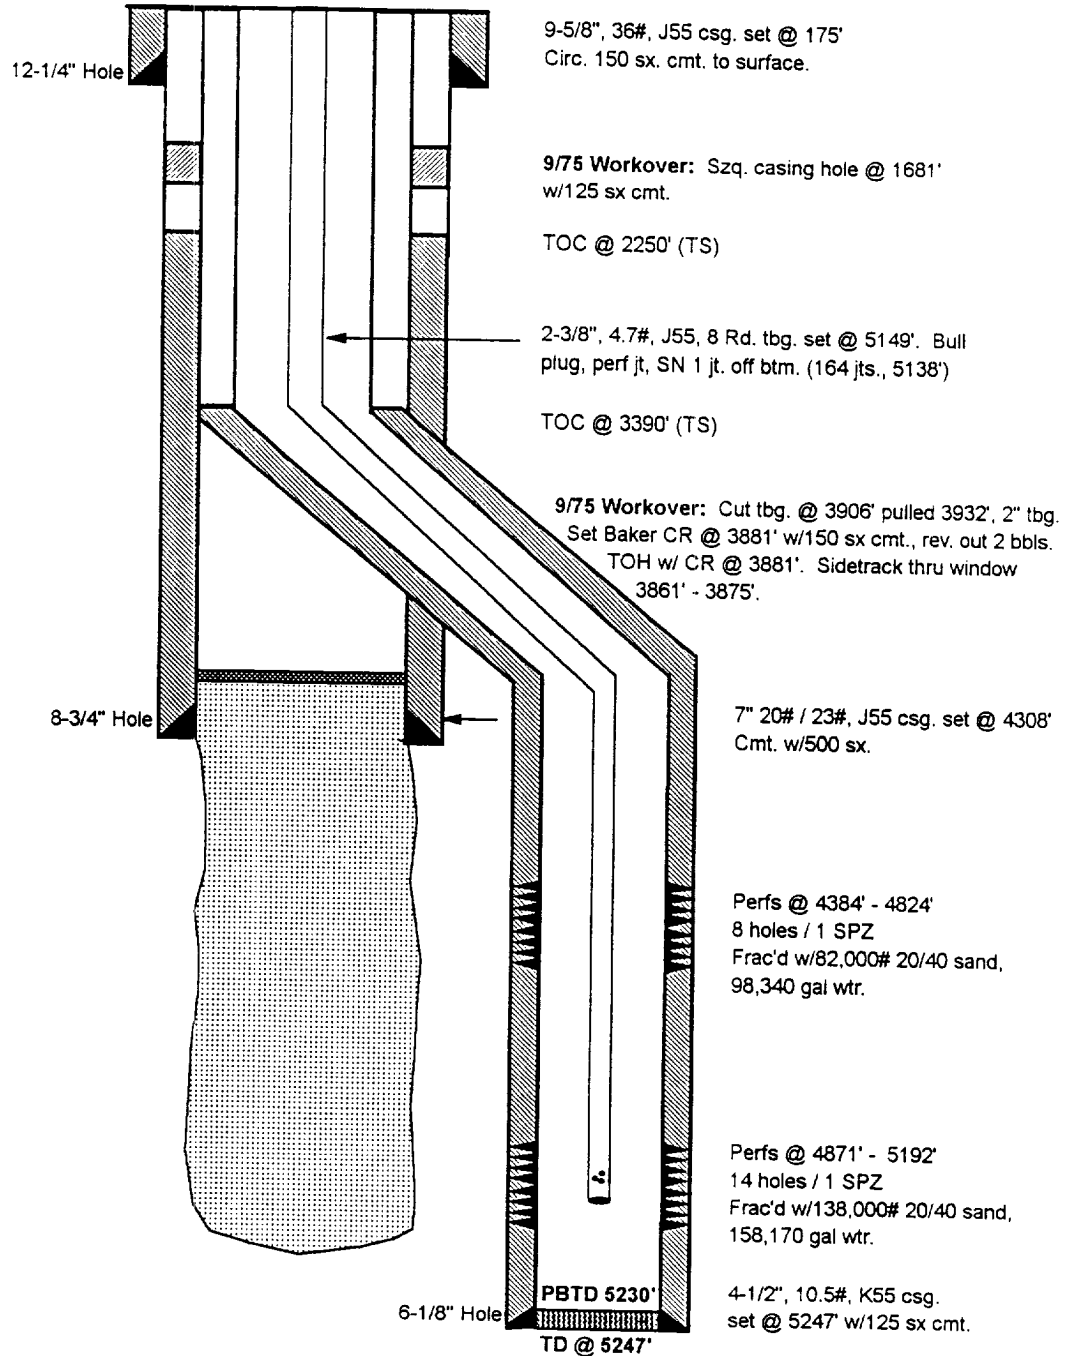
Marcotte #1

Current -- 11-15-95

Ojo Alamo @ 1566'

Pictured Cliffs @ 2441'
Lewis @ 2505'

Mesaverde @ 4325'
Menefee @ 4483'

Point Lookout @ 4835'

It is intended to repair the tubing in the subject well according to the attached procedure and wellbore diagram.
