Oil Conservation	on Division	ℓ
	Sundry Notices and F	Reports on Well	s
			# (assigned by OCD) 30-045-23368
1. Type of Well GAS		5.	Lease Number
		6.	State Oil&Gas Lease # K-5737
2. Name of Operator SOUTHLAND ROYALTY COMPANY		7.	Lease Name/Unit Name Rattlesnake Canyon
3. Address & Phone No. of Operato		8.	Well No. 1A
PO Box 4289, Farmington, NM		9.	
4. Location of Well, Footage, Sec. 1045'FSL, 1175'FEL, Sec.32, T-		=	Elevation:
Type of Submission	Type of Act		
X Notice of Intent	Abandonment Recompletion	Change of Pl New Construc	ans tion
Subsequent Report	Casing Repair	Non-Routine Water Shut o	ff
Final Abandonment	Altering Casing _X_ Other -	Conversion t	o Injection
13. Describe Proposed or Comple	eted Operations		
It is intended to workover wellbore diagram.	the subject well accord	rding to the at	tached procedure and
		DE	<i>aemieo</i>

WORKOVER PROCEDURE - PACKER REPAIR

RATTLESNAKE CANYON # 1A
Pictured Cliffs/Mesaverde Duel
SE/4 Sec. 32, T32N, R8W
San Juan Co., New Mexico

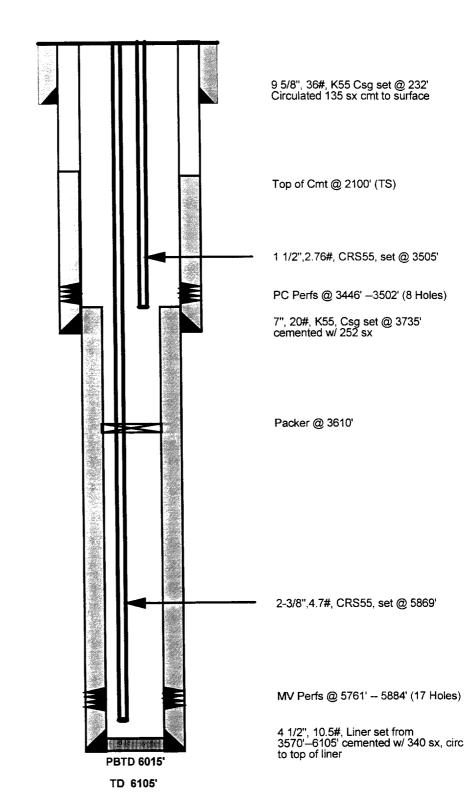
Rattlesnake Canyon #1A

CURRENT - 11-29-94

MV - PC Commingle
