ENVIRONMENTAL PLUS, INC.
CONSULTING AND REMEDIAL CONSTRUCTION

Re: Initial C-141
Duke Energy C-23-10 Line – Leak #1 – Reference #130044
UL-A, Section 13, Township 20 South, Range 35 East
Latitude N 32° 34' 46.65" and Longitude W 103° 24' 14.66"

Release Notification and Corrective Action

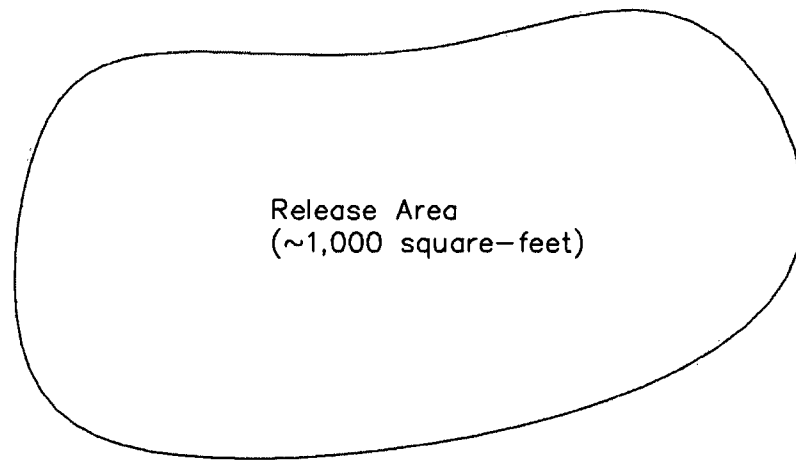
Figure 3
Site Map
Duke Energy
C-23-10 Line - Leak #1

Release Area
(~1,000 square-feet)

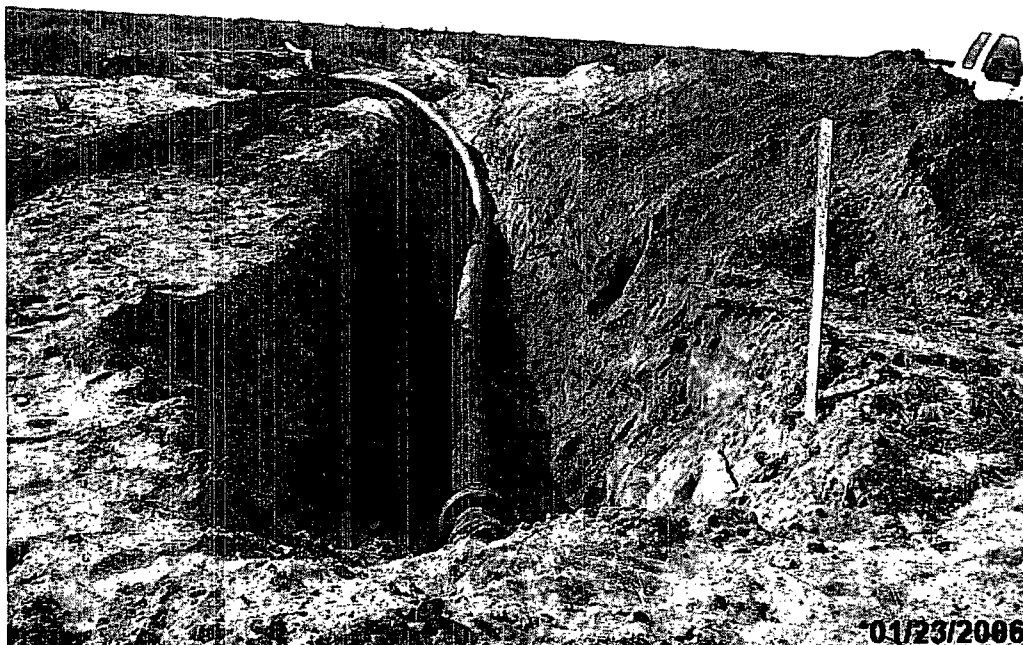
Photograph #1-Looking west at the release area.

Describe Cause of Problem and Remedial Action Taken.* An unknown amount of natural gas was released as the result of the structural integrity of the natural gas line failing when the pressure was increased on the line, with no amount recovered from the site. The line was shut in and is scheduled to be replaced.

Describe Area Affected and Cleanup Action Taken.* Approximately 1,000 square-feet of surface area was impacted by the release. Remediation of the site will be in accordance with NMOCD guidelines.
