Penroc Oil Corporation  
Langlie Jal Unit #032  
Producing Well - Flowline Failure

**Submission of Delineation/Remediation Workplan  
Remediation Case Number: 1R-4617**

Section 06, T25S, R37E  
Detailed coordinates in report.

Date of Incident  
02/15/2017

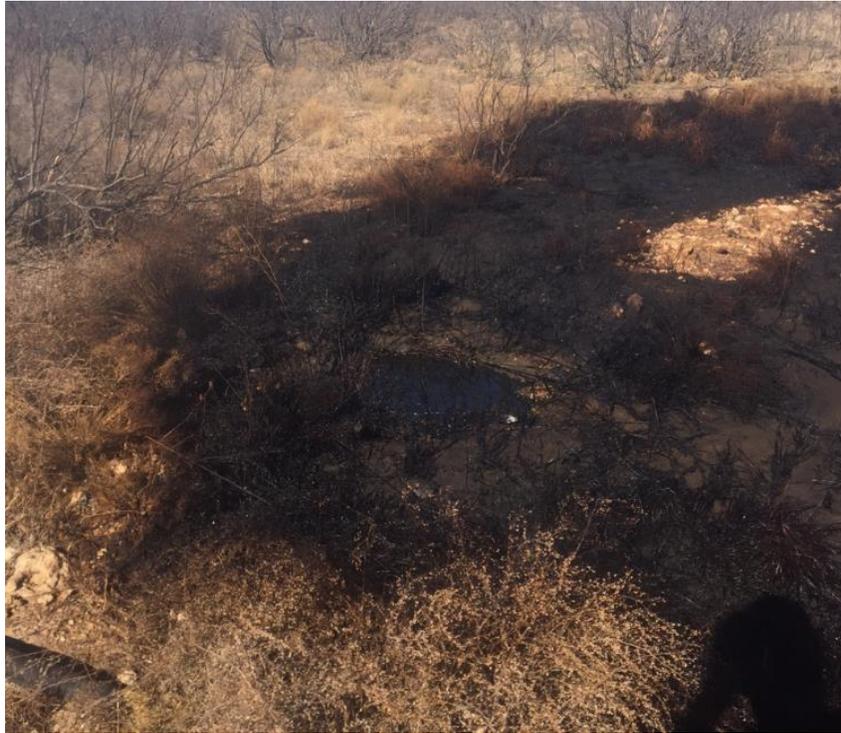
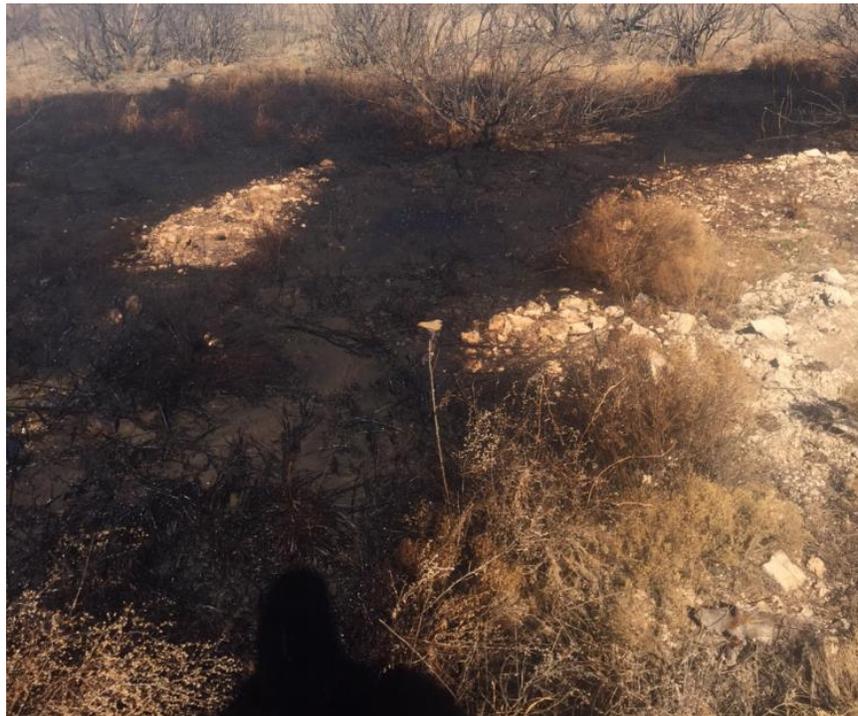
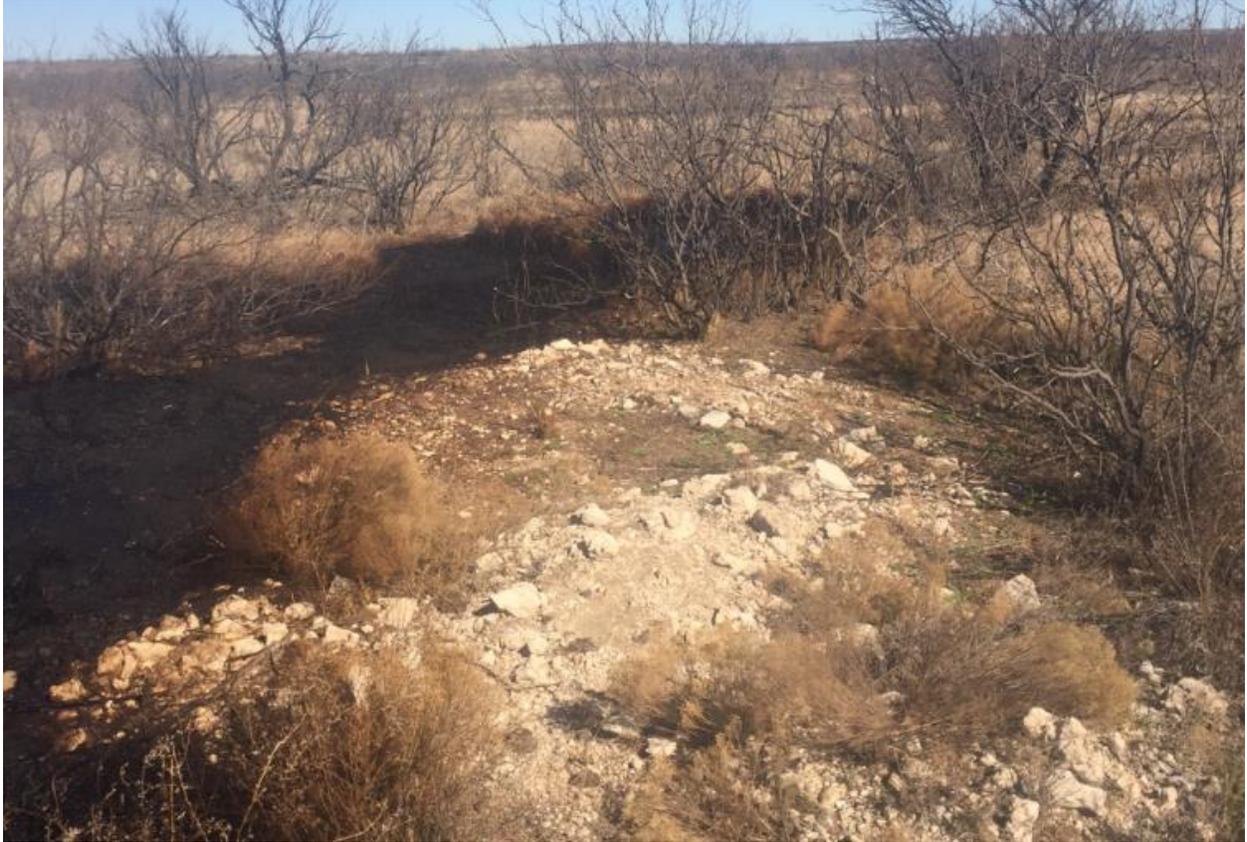
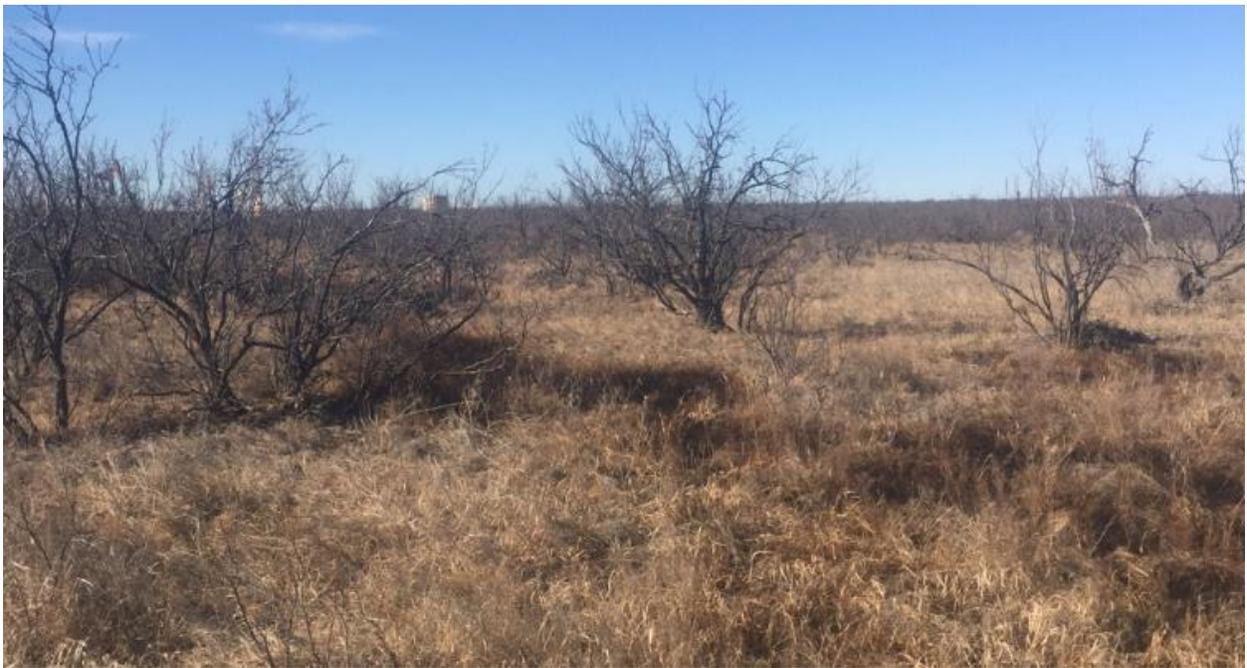
Per the C-141, the failure of the well’s buried flowline caused an unauthorized release of oil, produced water, and gas. This caused the liquids to surface and created a pool of fluid near the failure point, with runoff in an eastern direction. Ranch Supervisor for Woolworth Trust, Bob Haddox, discovered the release and contacted the proper field personnel. Field personnel responded immediately by shutting in all five wells that have flowlines in that portion of the field. This stopped the release and it was discovered that the Langlie Jal #032 flowline was the issue. The area impacted was approximately 2,050 square feet. The NMOCD was notified on 2/15/2017 and the C-141 was filed 2/16/2017. NMOCD filed remediation case number 1R-4617 to this event. NMOCD correspondence up to this point have been with Ms. Olivia Yu in Hobbs, New Mexico.

The following are photos taken immediately after the unauthorized release occurred and the wells in the area were shut in to prevent any further release of oil, produced water, or gas.
