Subject: RE: 088210-38 - Presidente BPD State Com #1H (1RP-2822) ~COR-088210-38~

**Subject:** 088210-38 - Presidente BPD State Com #1H (1RP-2822) ~COR-088210-38~

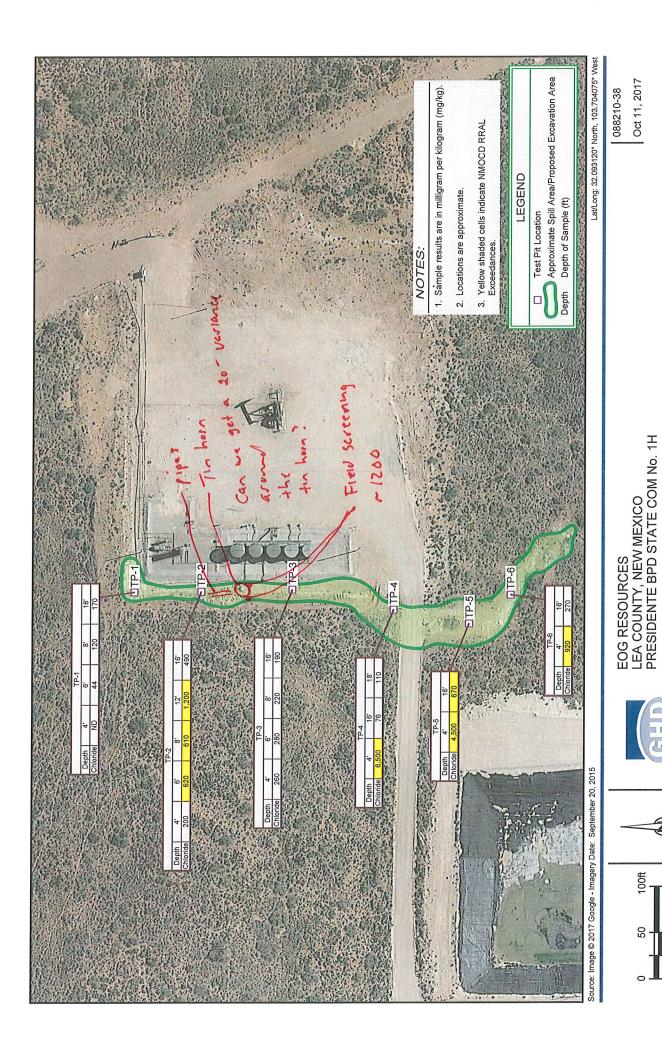
FIGURE 2

We are excavating the chloride impacted soil to the north of the access road and field screening is indicating concentrations of chloride close to the tin horn. I have attached a drawing showing the tin horn. We are excavating as close as safely possible and I wanted to request an approximate 15-20 foot variance around the tin horn. There are also two pipelines that run to the north from the tin horn. We will excavate as much of the impacted soil as possible to the north of the tin horn and around the pipes. Can you provide a variance for the area around the tin horn and the pipelines?

NMOCD will not grant the variance for not completing the proposed remediation around the tin horn for 1RP-2822. Unless the pipelines are high pressure, deferral of remediation around the pipelines connecting to the tin horn is also not accepted.

In the remediation report, please demarcated on a scaled map, if necessary: 1) the area(s) with a 20 mil liner at 4 ft. bgs; 2) the differing depths of excavation; and 3) locations of confirmation samples.
