**1RP-4229  
DELINEATION PLAN  
W.A. Simpson Tank Battery  
Produced Water Spill  
Lea County, New Mexico**

LAI Project No. 17-0175-21

February 15, 2018

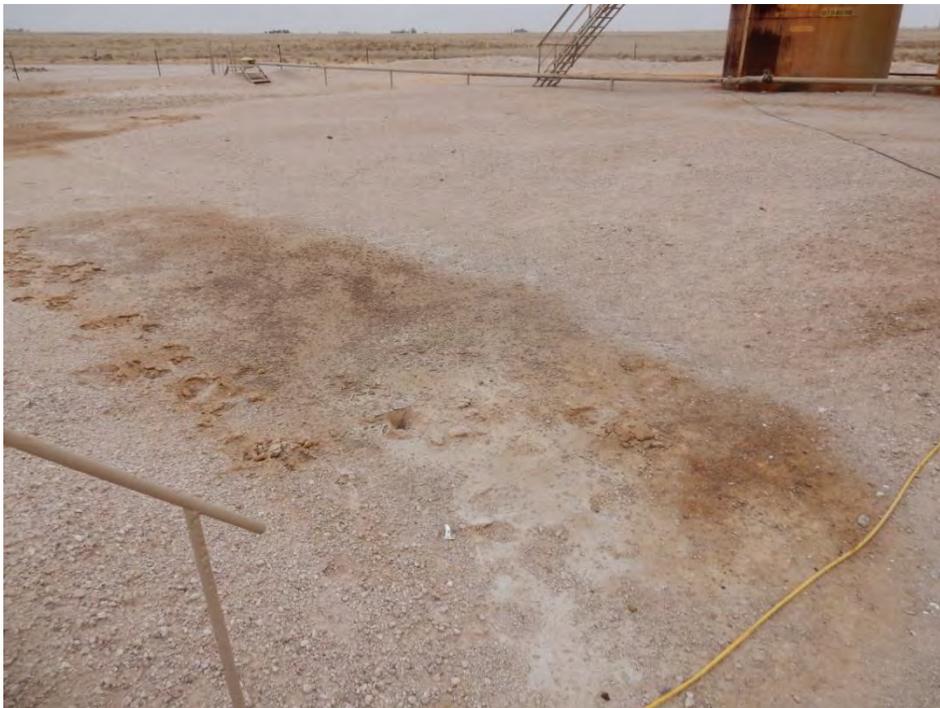
Site Prior to Remediation Viewing North, February 6, 2018

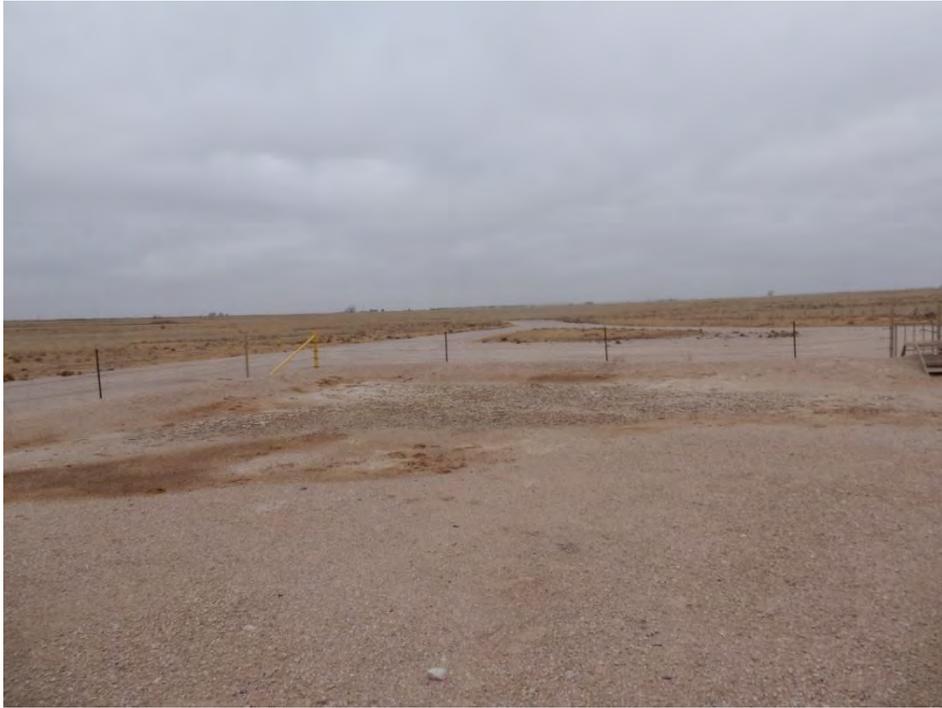
Site Prior to Remediation Viewing Southwest, February 6, 2018

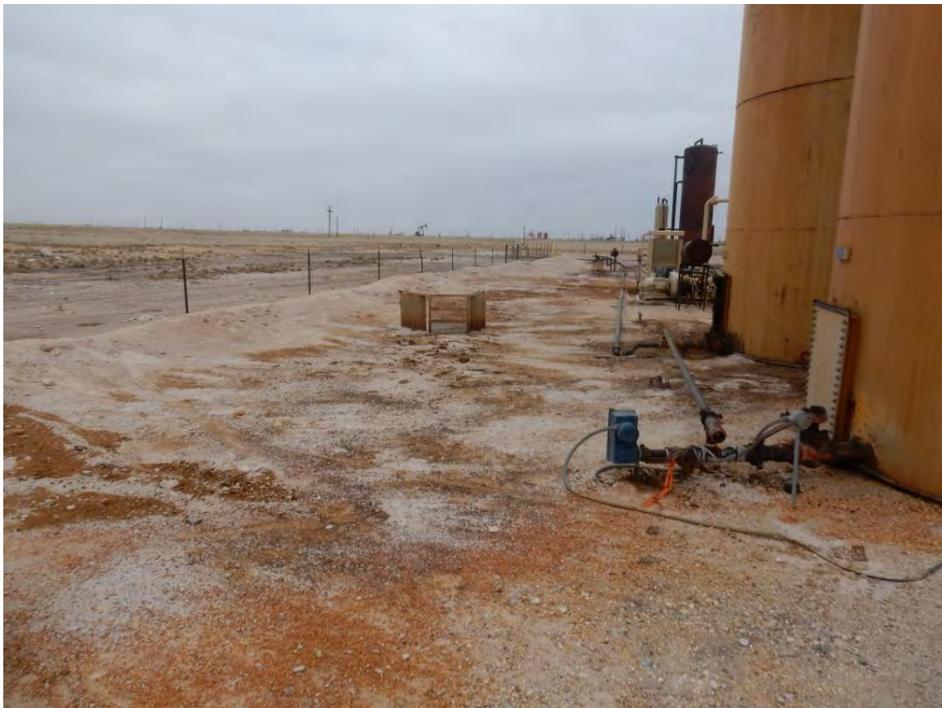
Site Prior to Remediation Viewing East, February 6, 2018

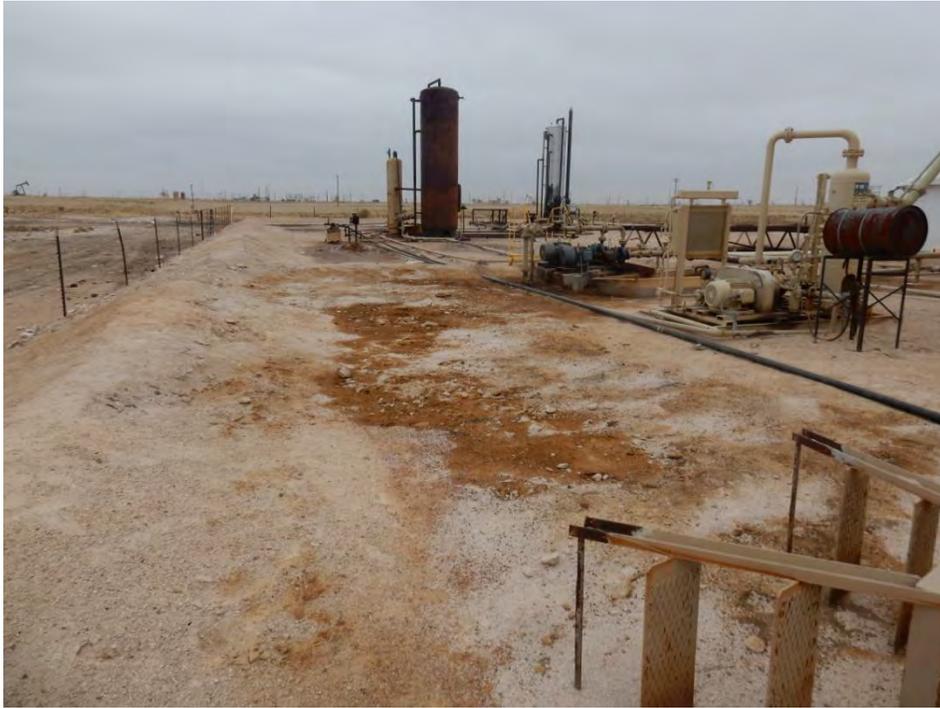
Site Prior to Remediation Viewing East, February 6, 2018

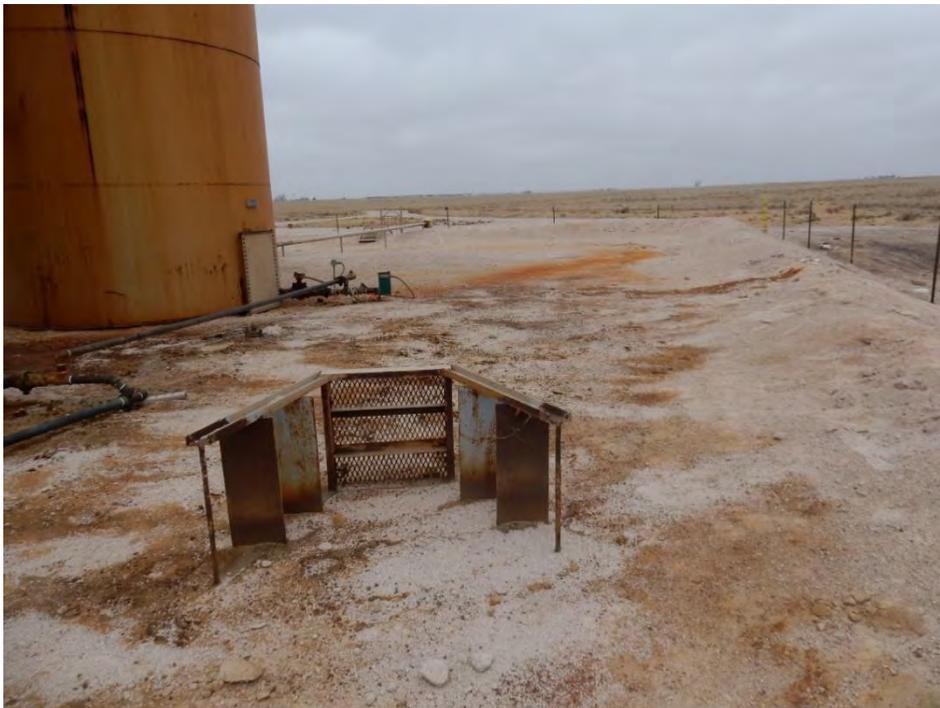
Site Prior to Remediation Viewing West, February 6, 2018

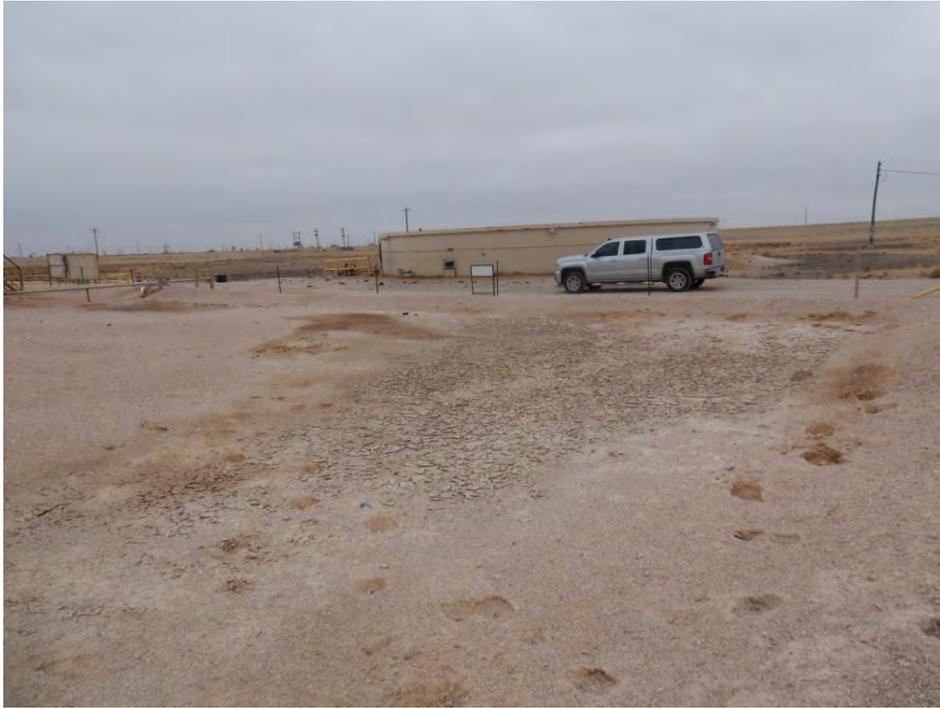
Site Prior to Remediation Viewing South, February 6, 2018

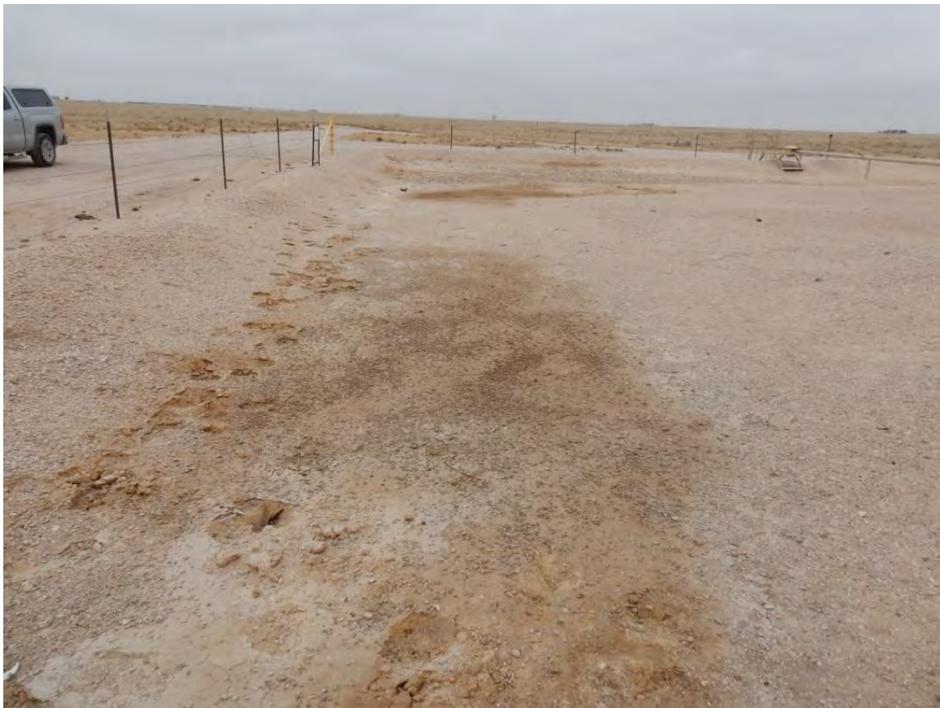
Site Prior to Remediation Viewing West, February 6, 2018
