# 1RP-3299 DELINEATION PLAN Panther Federal #003 Crude Oil Spill Lea County, New Mexico

LAI Project No. 17-0175-08

February 20, 2018

Prepared for: Legacy Reserves Operating, LP 303 West Wall Street, Suite 1300 Midland, Texas 79701

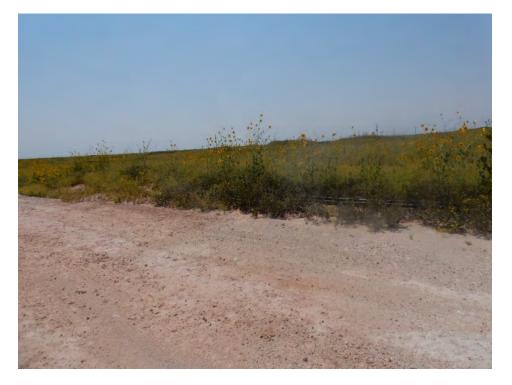
Site Prior to Remediation Viewing East, September 11, 2017

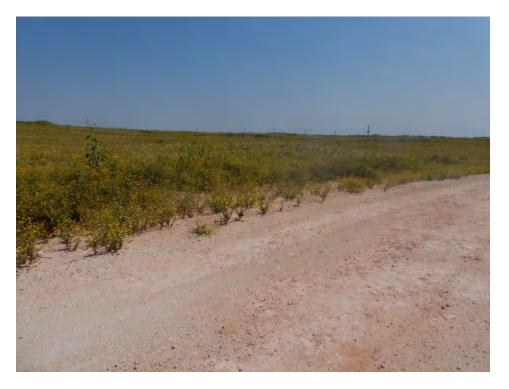
Site Prior to Remediation Viewing South, September 11, 2017

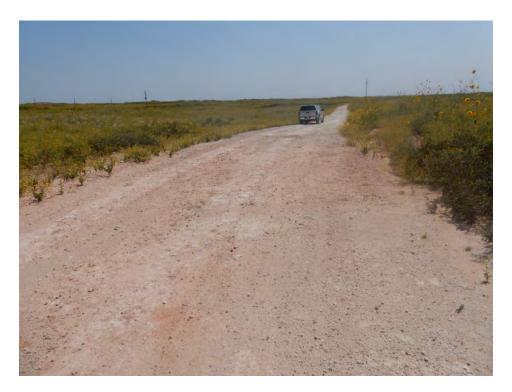
Site Prior to Remediation Viewing West, September 11, 2017
