**2RF-106 - Tiger
Recycling Facility ID
[fAB1619053403]
C-147/Closure**

Vertex Project #: 22E-02197

Reclamation Report: Tiger Recycling Facility/Containment (Section 14, Township 24 South, Range 28 East)
County: Eddy

2022 Spill Assessment and Closure
October 2022

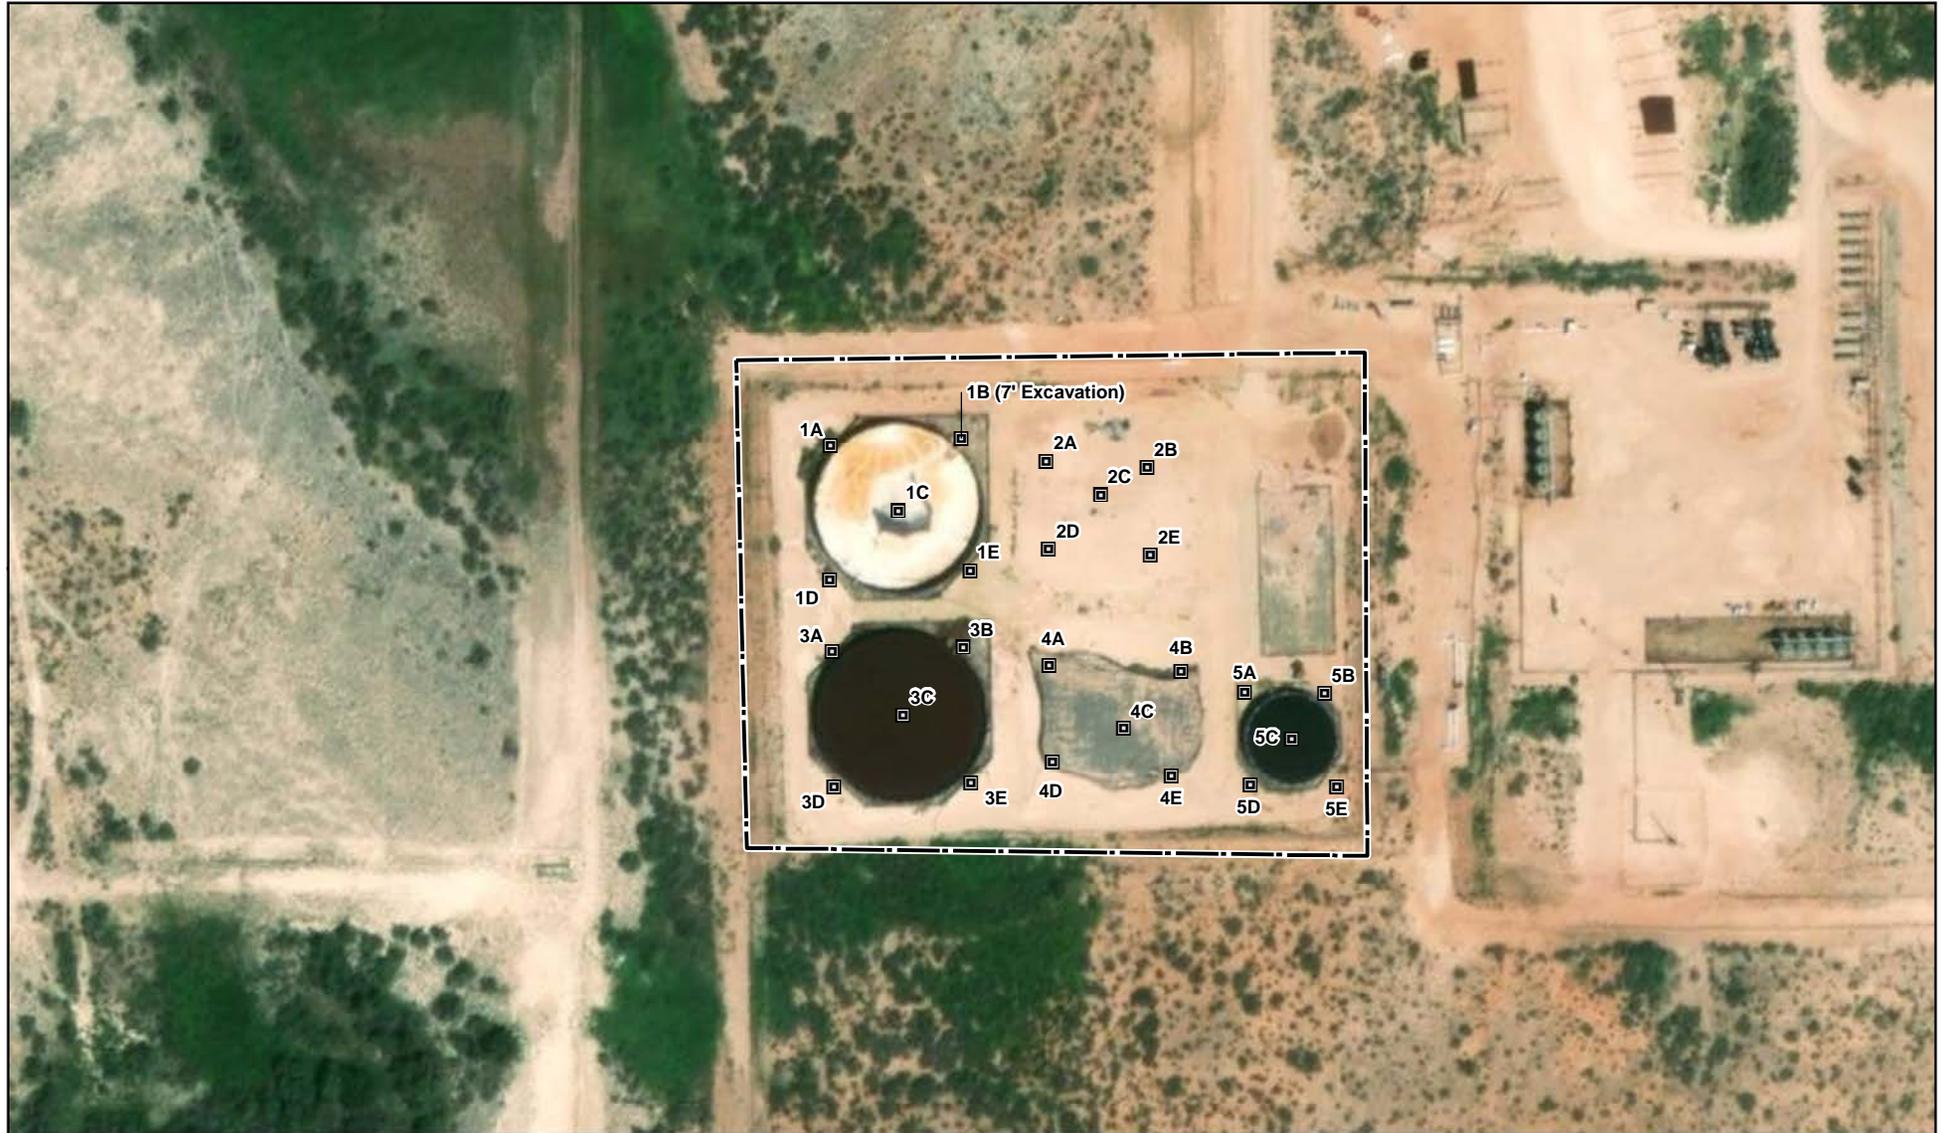
FIGURE:

Sampling Locations Tiger Recycling Facility

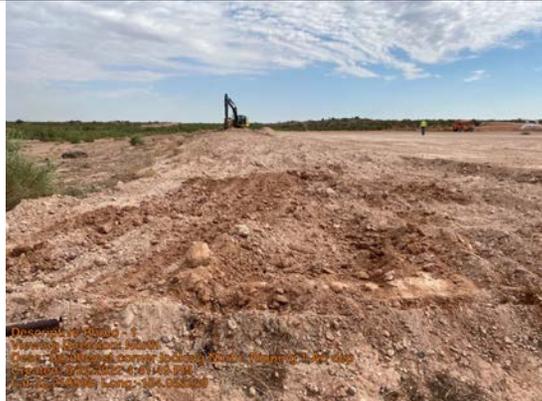
Image Date: 10/28/2022
Viewing Direction: North
Caption: Southwest corner looking North. Ripping 1' depth
Created: 10/28/2022 4:01:44 PM
Lat: 32.819985, Long: -104.853389

Southwest corner looking North. Ripping 1' depth

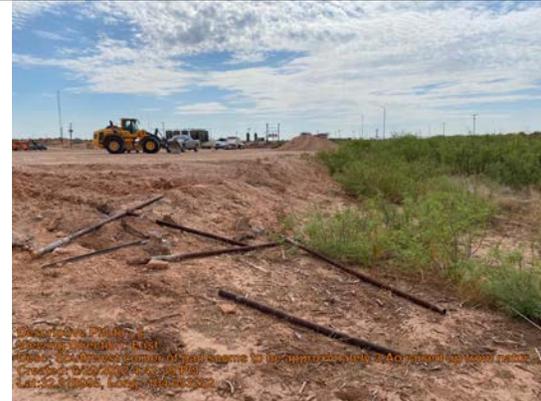
Image Date: 10/28/2022
Viewing Direction: East
Caption: Southwest corner of pad seems to be approximately 3' raised up from natural
Created: 10/28/2022 4:02:26 PM
Lat: 32.819985, Long: -104.853389

Southwest corner of pad seems to be approximately 3' raised up from natural topography.

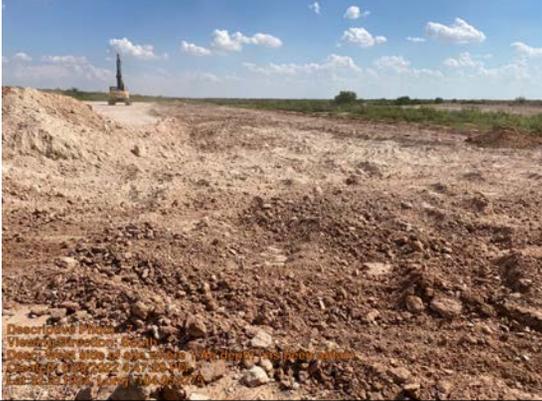
<p><small>Description: Photo View: Direction: South Date: 10/28/2022 9:34:16 AM Camera: 1080x720 2772x1728 File: 20221028_093416.jpg</small></p>
West side of site where 1' depth has been obtained

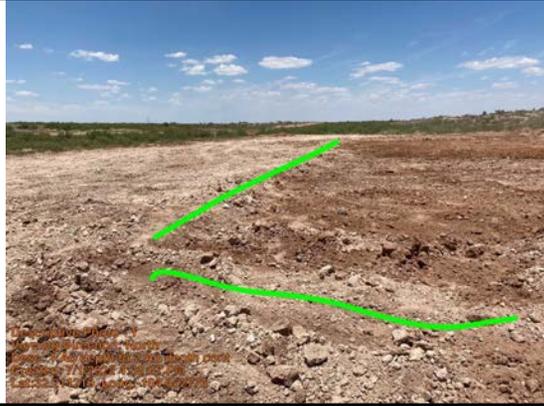
1' depth to 2' depth contour

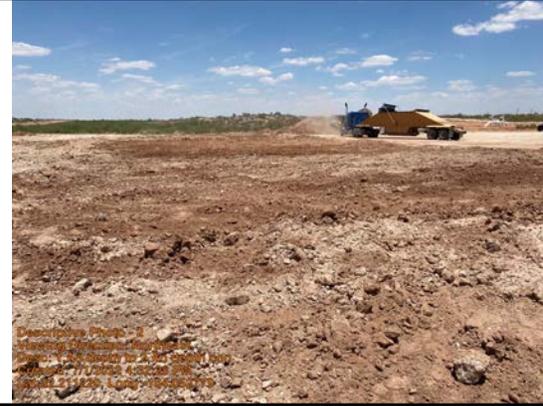
1' depth to 2' depth contour

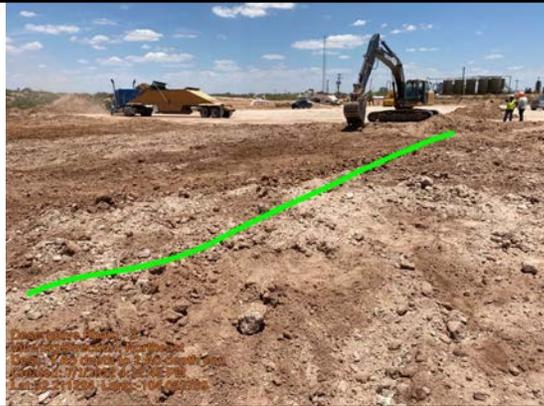
1' depth to 2' depth contour

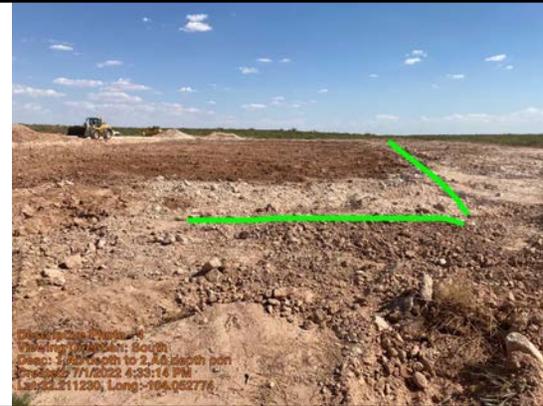
1' depth to 2' depth contour

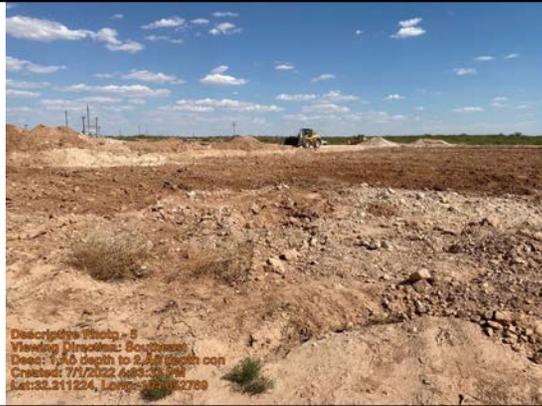
Descriptive Photo - 5
Viewing Direction: Southeast
Depth: 1' to 2' depth to 2' depth con
Created: 7/1/2022 4:43:33 PM
Lat:32.211224, Long:-104.052789

1' depth to 2' depth contour

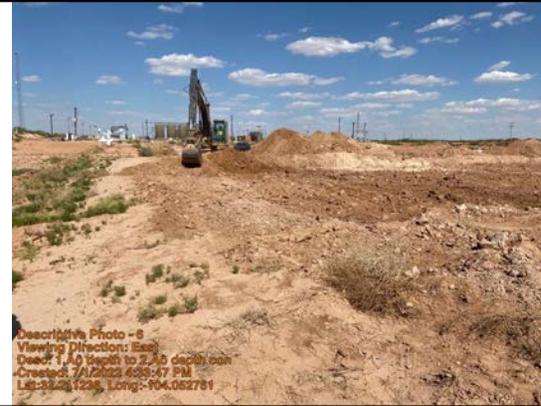
Descriptive Photo - 6
Viewing Direction: East
Depth: 1' to 2' depth to 2' depth con
Created: 7/1/2022 4:39:47 PM
Lat:32.211224, Long:-104.052781

1' depth to 2' depth contour

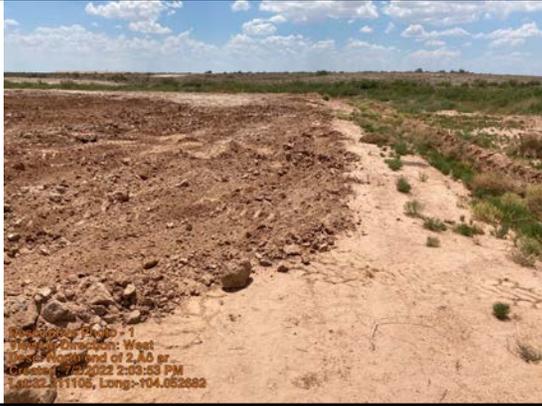
Descriptive Photo - 1
Viewing Direction: West
Dist: North end of 2' AO sr
Created: 7/2/2022 2:03:33 PM
Lat:32.211100, Long:-104.062692

North end of 2' area

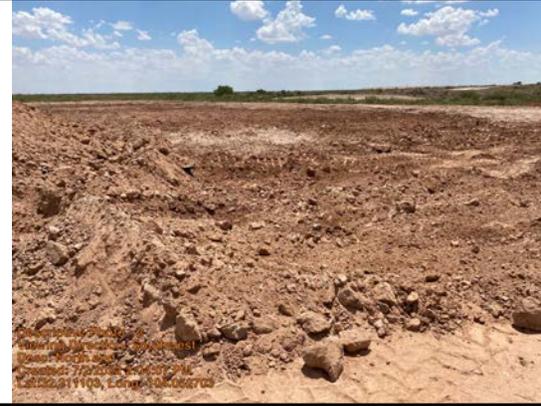
Descriptive Photo - 2
Viewing Direction: Southwest
Dist: North end
Created: 7/2/2022 2:04:07 PM
Lat:32.211100, Long:-104.062703

North end

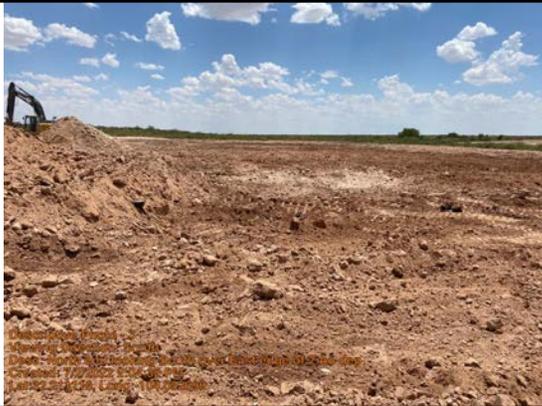
Descriptive Photo - 3
Viewing Direction: South
Dist: North end
Created: 7/2/2022 2:04:36 PM
Lat:32.211100, Long:-104.062698

North end looking South over East edge of 2' depth

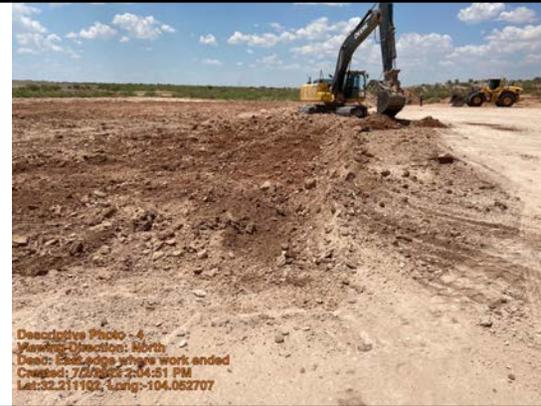
Descriptive Photo - 4
Viewing Direction: North
Dist: East edge where work ended
Created: 7/2/2022 2:04:51 PM
Lat:32.211100, Long:-104.062707

East edge where work ended

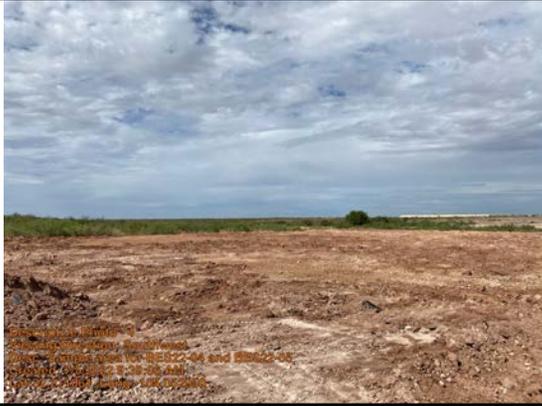
Sample area for BES22-04 and BES22-05

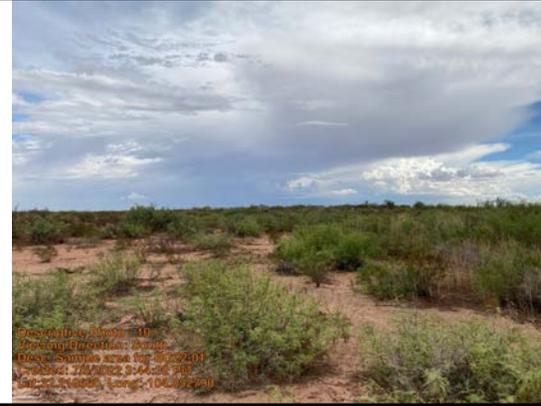
Sample area for BG22-01

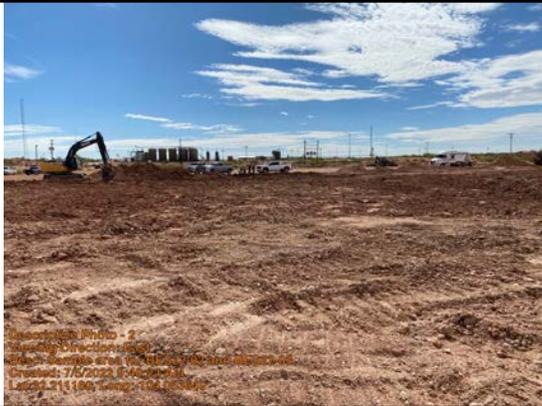
Sample area for BES22-02 and BES22-03

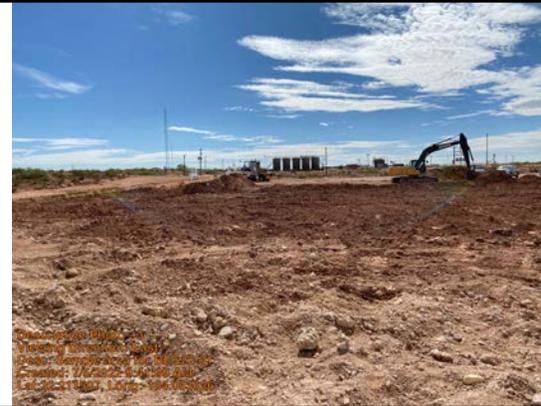
Sample area for BES22-01

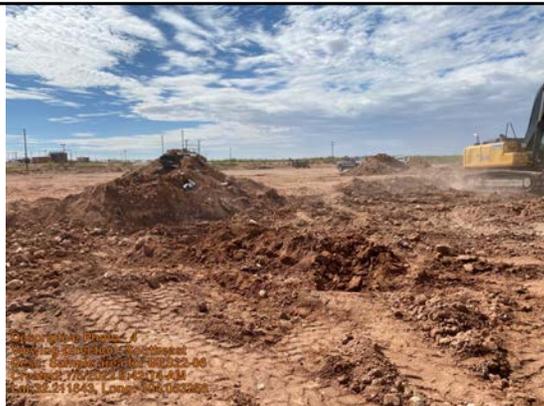
Descriptive Photo - 6
Viewing Direction: Southeast
Date: Sample area for BES22-06
Created: 7/5/2022 8:43:14 AM
Labels: 211843, Long-10482369

Sample area for BES22-06

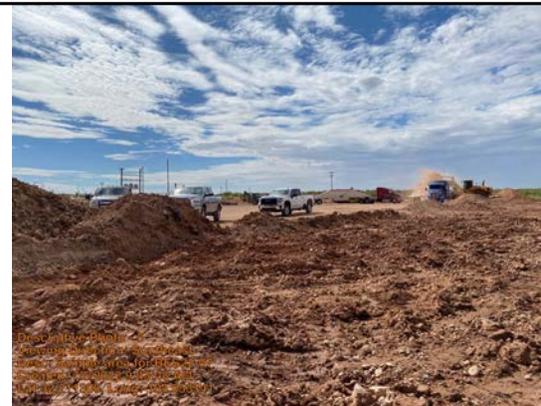
Descriptive Photo - 6
Viewing Direction: Southeast
Date: Sample area for BES22-07
Created: 7/5/2022 8:43:14 AM
Labels: 211843, Long-10482369

Sample area for BES22-07

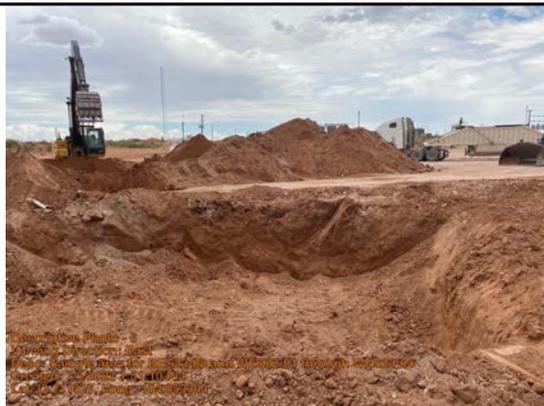
Descriptive Photo - 8
Viewing Direction: East
Date: Sample area for BES22-08 and WES22-01 through WES22-04
Created: 7/5/2022 8:40:36
Labels: 211843, Long-10482369

Sample area for BES22-08 and WES22-01 through WES22-04

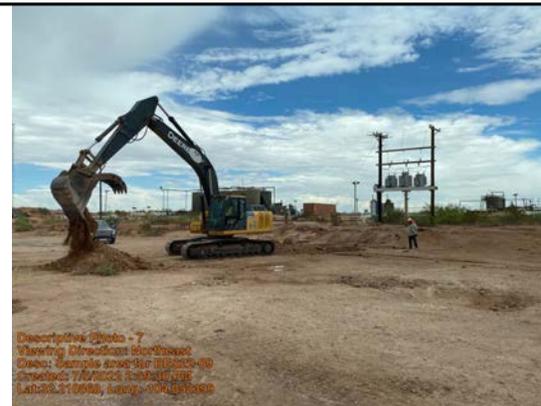
Descriptive Photo - 7
Viewing Direction: Northeast
Date: Sample area for BES22-09
Created: 7/5/2022 8:38:07 AM
Labels: 211843, Long-10482369

Sample area for BES22-09

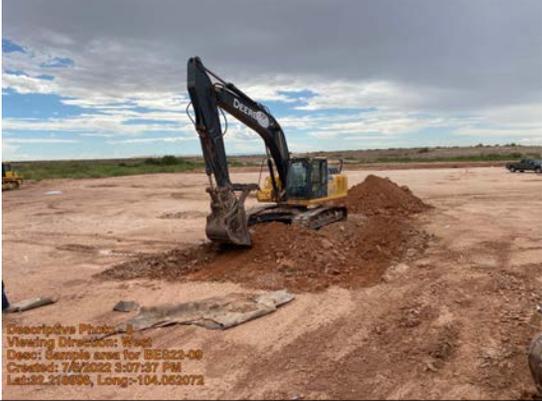
Descriptive Photo:
Viewing Direction: West
Desc: Sample area for BES22-09
Created: 7/5/2022 3:07:37 PM
Lat:32.218996, Long:-104.062072

Sample area for BES22-09

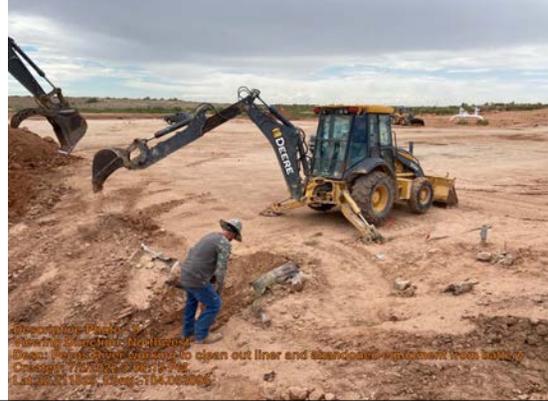
Descriptive Photo:
Viewing Direction: Northwest
Desc: Pecos River working to clean out liner and abandoned equipment from battery
Created: 7/5/2022 3:08:15 PM
Lat:32.218996, Long:-104.062072

Pecos River working to clean out liner and abandoned equipment from battery

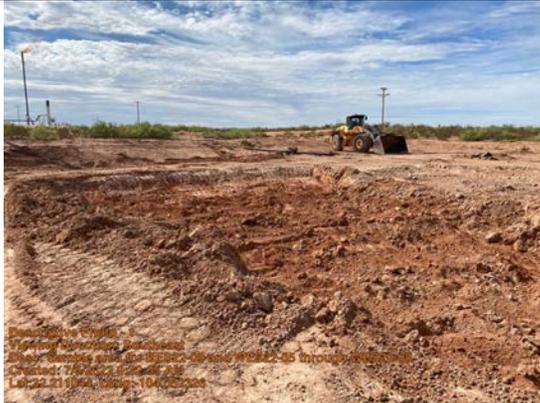
Descriptive Photo - 1
Viewing Direction: Southeast
Desc: Sample area for BES22-09 and WES22-05 through WES22-08
Created: 7/6/2022 9:33:45 AM
Lat:32.211994, Long:-104.029906

Sample area for BES22-09 and WES22-05 through WES22-08

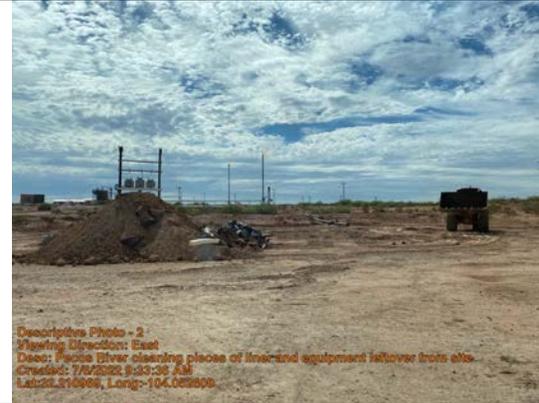
Descriptive Photo - 2
Viewing Direction: East
Desc: Pecos River cleaning pieces of liner and equipment leftover from site
Created: 7/6/2022 9:33:35 AM
Lat:32.210988, Long:-104.029906

Pecos River cleaning pieces of liner and equipment leftover from site

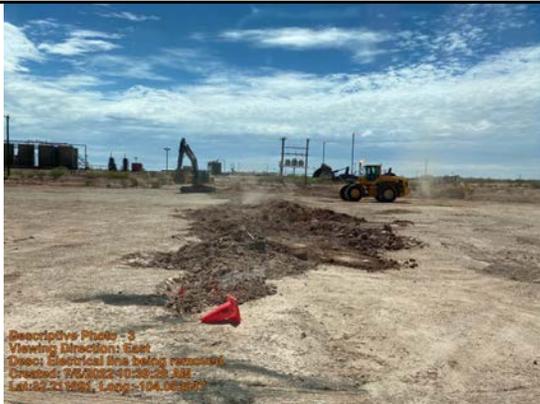
Descriptive Photo - 3
Viewing Direction: East
Desc: Electrical line being removed
Created: 7/6/2022 9:33:29 AM
Lat:32.211994, Long:-104.029906

Electrical line being removed.

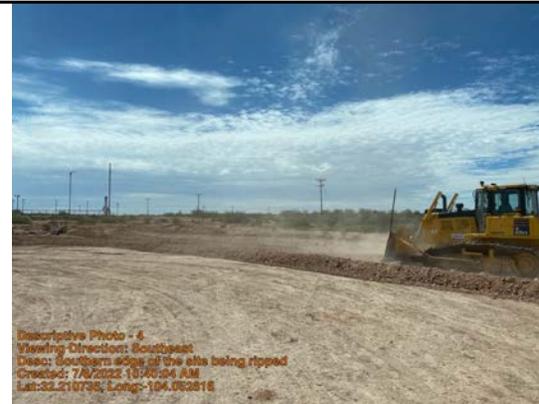
Descriptive Photo - 4
Viewing Direction: Southeast
Desc: Southern edge of the site being ripped
Created: 7/6/2022 10:40:04 AM
Lat:32.210735, Long:-104.030815

Southern edge of the site being ripped

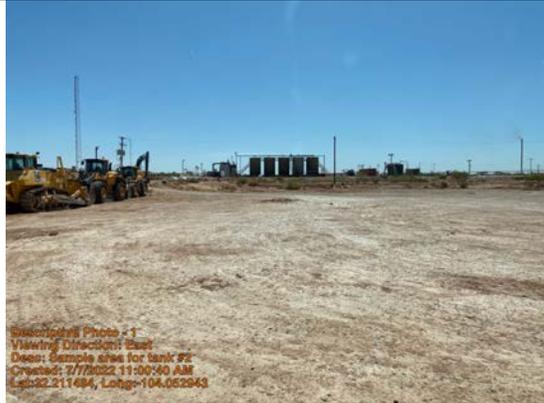
Descriptive Photo - 1
Viewing Direction: East
Desc: Sample area for tank #2
Created: 7/7/2022 11:00:40 AM
Lat:32.211494, Long:-104.052943

Sample area for tank #2

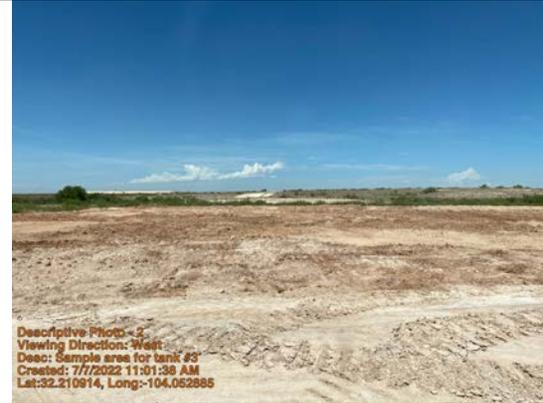
Descriptive Photo - 2
Viewing Direction: West
Desc: Sample area for tank #3
Created: 7/7/2022 11:01:38 AM
Lat:32.210914, Long:-104.052885

Sample area for tank #3

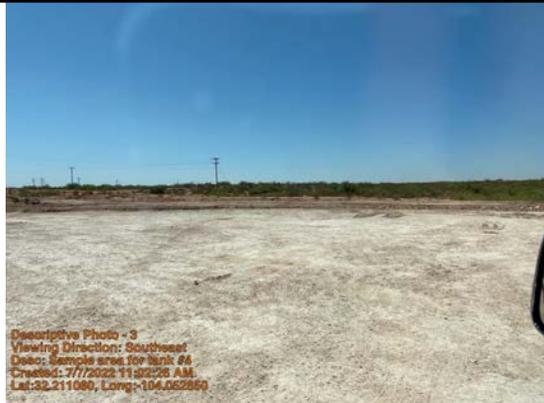
Descriptive Photo - 3
Viewing Direction: Southeast
Desc: Sample area for tank #4
Created: 7/7/2022 11:02:26 AM
Lat:32.211080, Long:-104.052850

Sample area for tank #4

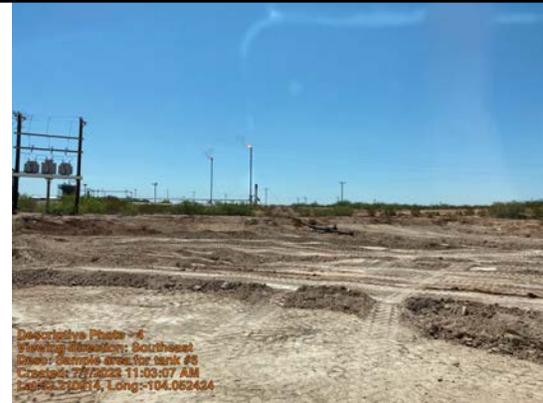
Descriptive Photo - 4
Viewing Direction: Southeast
Desc: Sample area for tank #5
Created: 7/7/2022 11:03:07 AM
Lat:32.210914, Long:-104.052424

Sample area for tank #5
