Form C-147  
Revised October 11, 2022

## Recycling Facility and/or Recycling Containment

**Type of Facility:** ☐ Recycling Facility ☐ Recycling Containment\*  
**Type of action:** ☐ Permit ☐ Registration  
☐ Modification ☒ Extension  
☐ Closure ☒ Other (explain) Cessation of Operations Request from 03-31-2025 - 09-30-2025

The Oil Conservation Division has reviewed the cessation of operations extension request for 1RF-463 - JAVELINA FACILITY [fVV2108855989], received from [308339] OWL SWD OPERATING, LLC on 04/16/2024, Application ID 452865. The request for an extension of the cessation of operations is approved with the following conditions for approval:

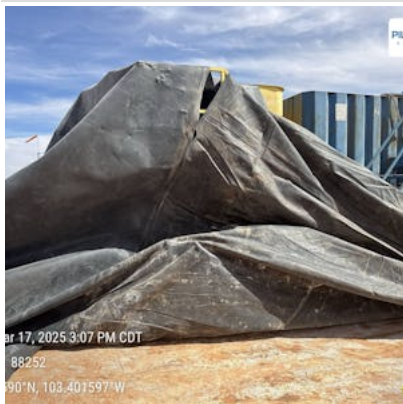
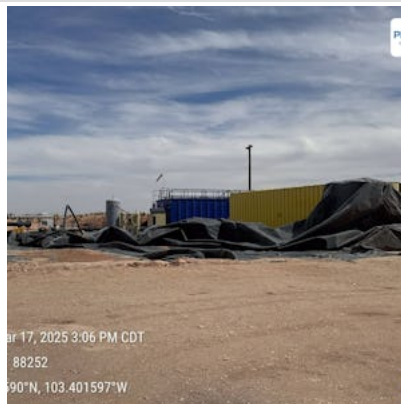
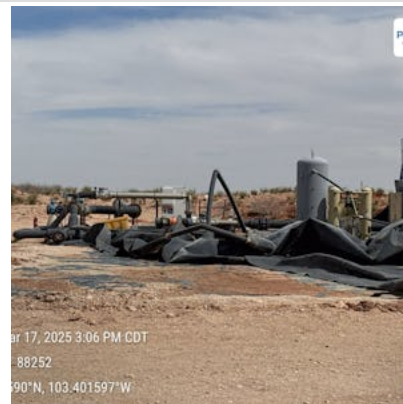
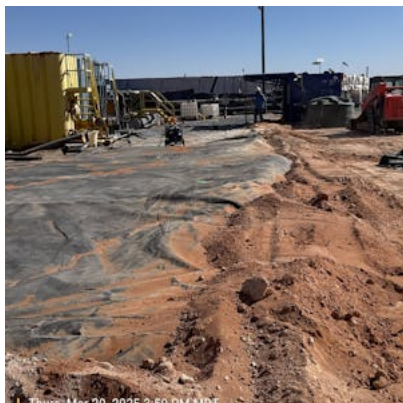
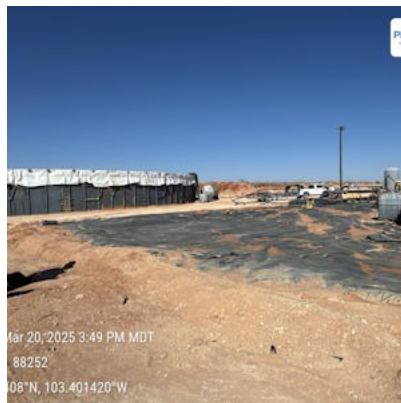
Is fencing and cattleguard in good condition?	Yes
Is there any evidence of spills or soil staining that have not been cleaned up?	No
Any migratory birds or wildlife discovered in the facility?	No
Are there any holes found in the containment liner?	Yes

Any evidence of erosion on the outside slope of the facility?	No
Comments	Liner sustained some wind damage and we've completed repairs

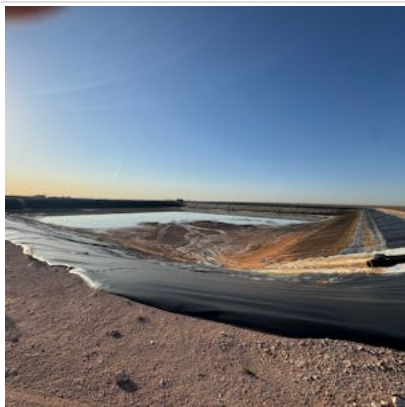
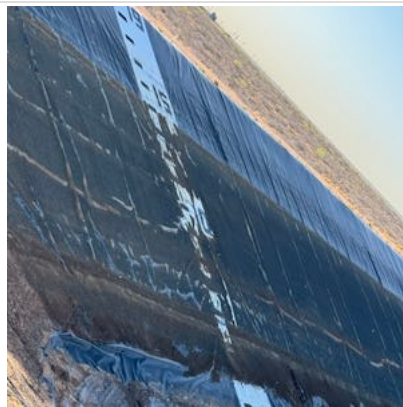
## SOUTH POND

Is there fluid in the leak detection system?	Yes
Has the fluid been pumped out or is it scheduled?	N/A
Are pond level markers visible?	Yes
Is pond level sensor working?	N/A
Is there any visible damage to the pond liner?	No
Any migratory birds or wildlife discovered in the pond?	No
Is bird deterrent working?	Yes
Is there any evidence of cracking or subsidence around the pond berm?	No
Is there any erosion on the outside of the berm?	No
Is life vest and related pond safety equipment in working condition?	No
Is pond aeration system functional?	Yes

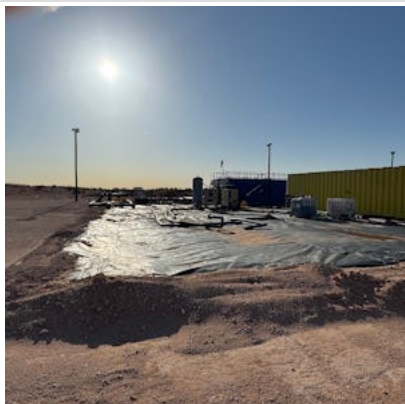
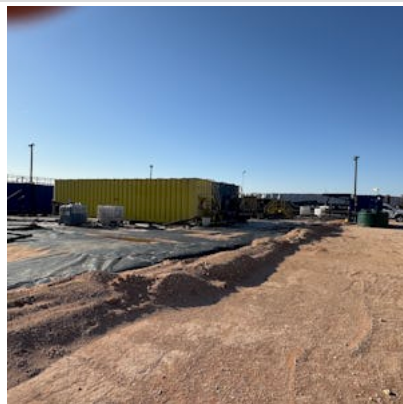
## TREATMENT FACILITY

Is fencing and cattleguard in good condition?	Yes
Is there any evidence of spills or soil staining that have not been cleaned up?	Yes
Any migratory birds or wildlife discovered in the facility?	No
Are there any holes found in the containment liner?	No

Any evidence of erosion on the outside slope of the facility?	N/A
Comments	We are working on getting quotes to fix berm around facility

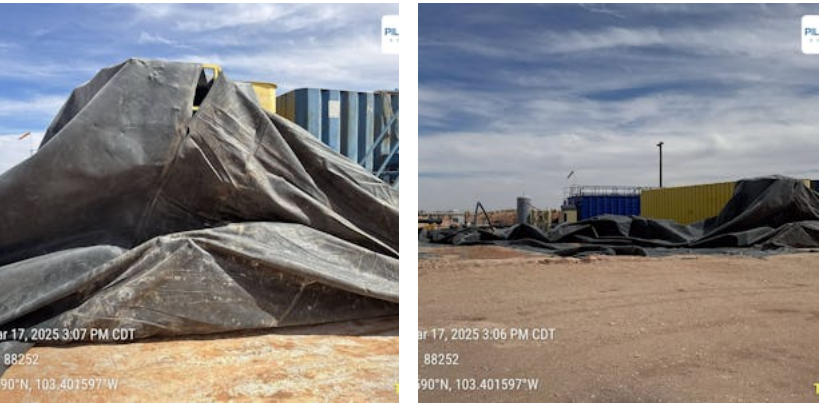
WEEKLY INSPECTION	
Read and record the fluid height of staff gauges	6'
Does the pond surface show visible oil?	No
Visually inspect containments liner	Wind damage on some of the liners, will schedule liner crew to fix

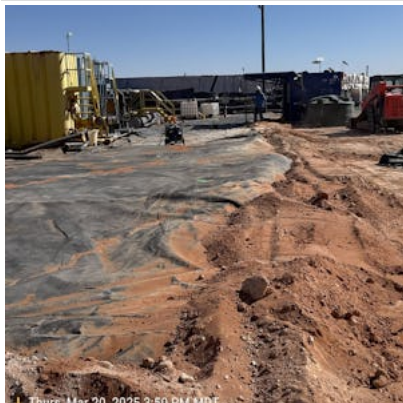
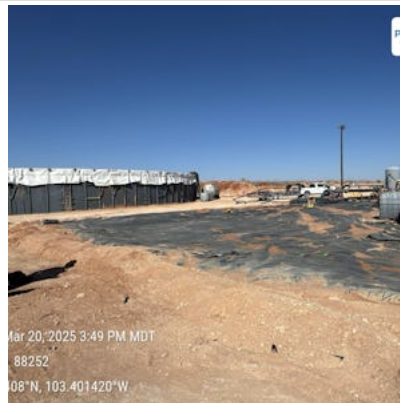
Visually inspect containments liner all containments/liners fixed

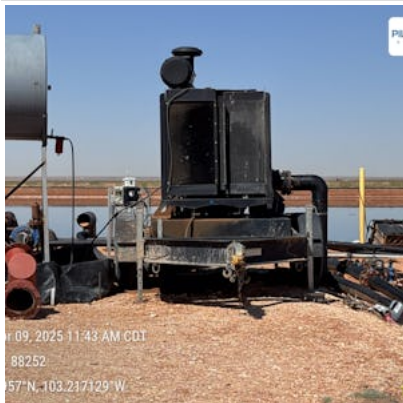
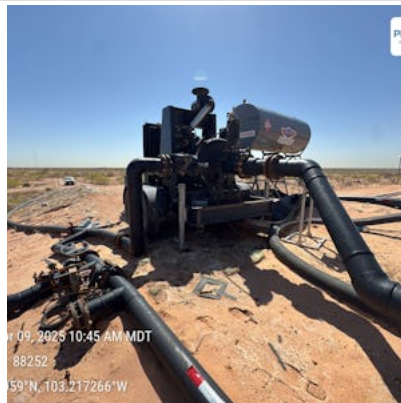
Visually inspect containments liner Pump on site doesn't have containment, ground and fire extinguisher
