Incident ID	NAPP2206028617
District RP	
Facility ID	
Application ID

Release Notification

Location: LOE East pad, Zia Fed Com 706H

Incident: Diesel hose overfilled dryer shaker bin resulting in an estimated 24 bbl diesel spill.

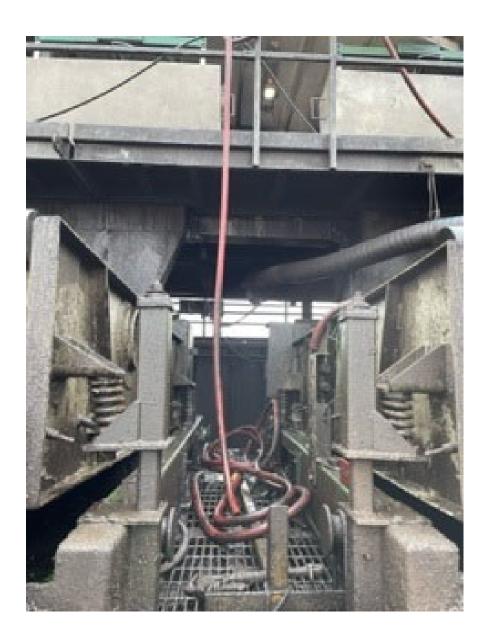
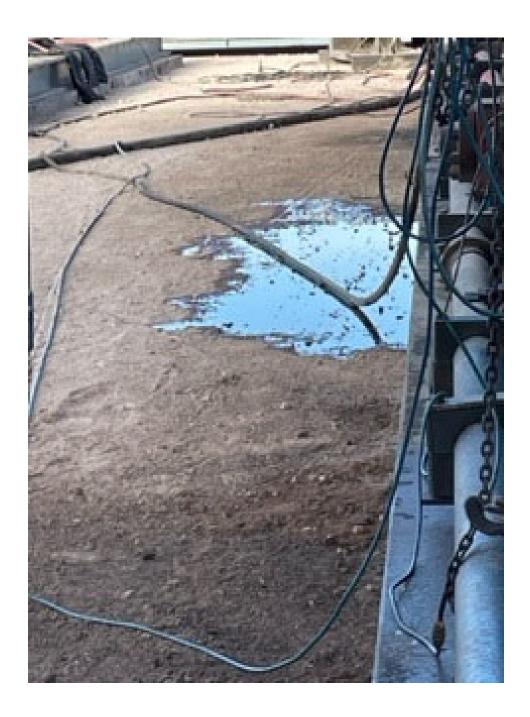
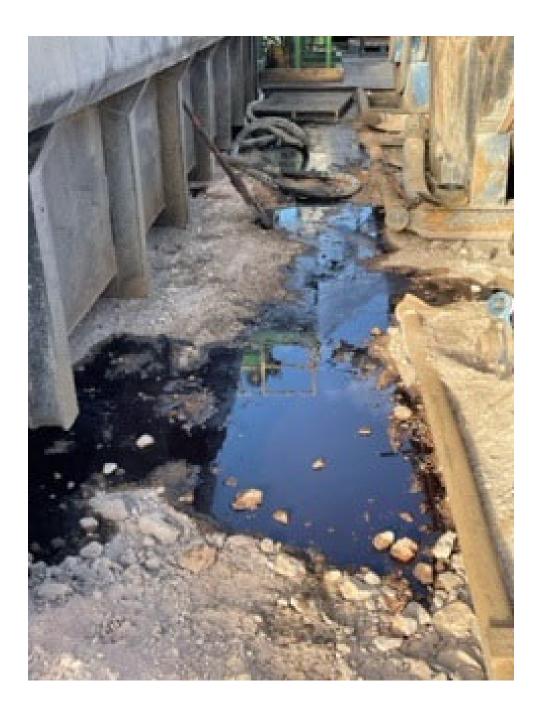
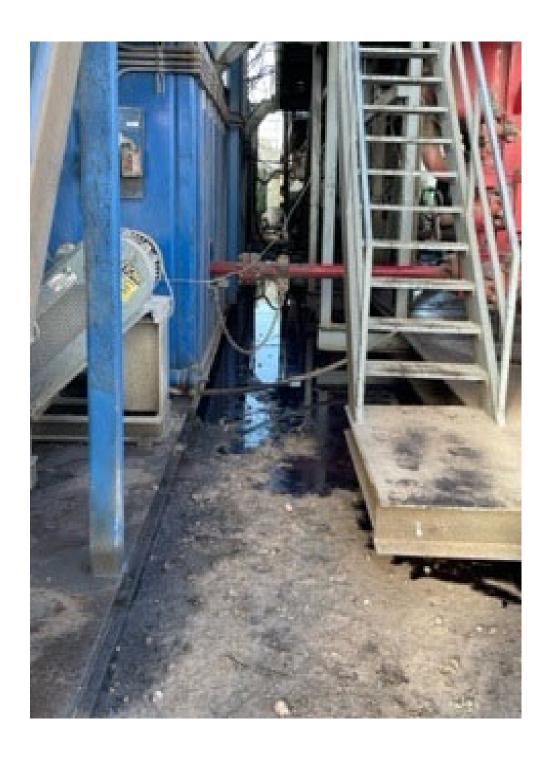
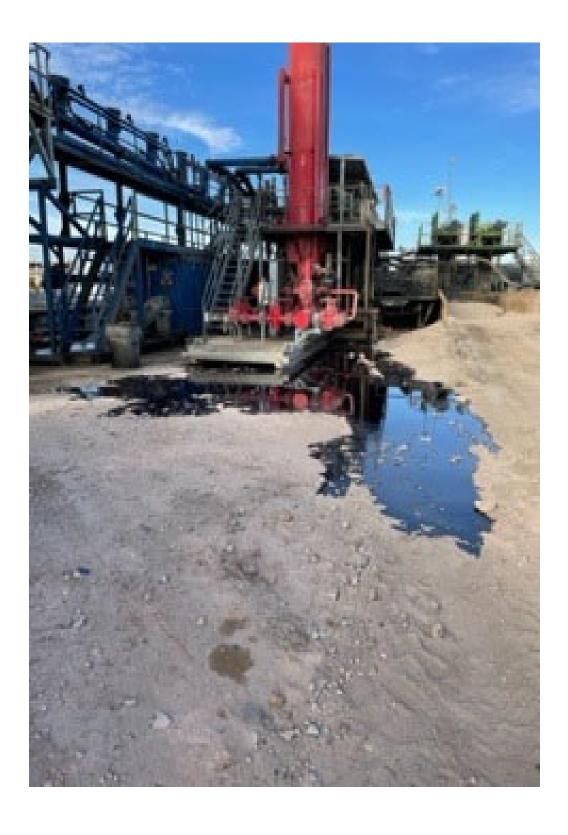
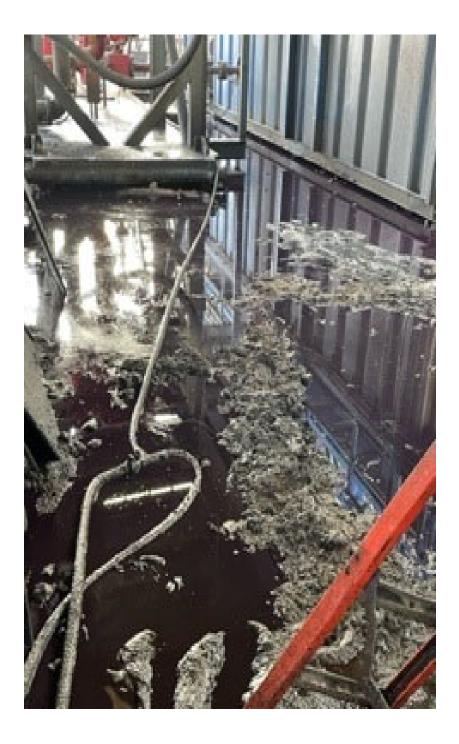
Root Cause: Valve on an open-ended diesel hose was left on.

Remediation: Got rig vac and started sucking diesel off ground while other EE squeegeed diesel to vac. Once the suckable fluid was sucked up the contaminated dirt was scraped up and put in 3-sided cuttings bin. The remainder fluid and contaminated dirt under rig equipment will be remediated once drilling rig is off location. An estimated 19 bbls of the 24 bbls was recovered and put in the OBM active system.
