SITE REMEDIATION AND CLOSURE REPORT REPORTABLE RELEASE

Spur Energy Partners

Holiday #1H Battery
GPS: Latitude 32.8023071 Longitude -104.2290268
Eddy County, NM
Incident ID No. NAPP2119561140

Incident ID: NAPP2119561140

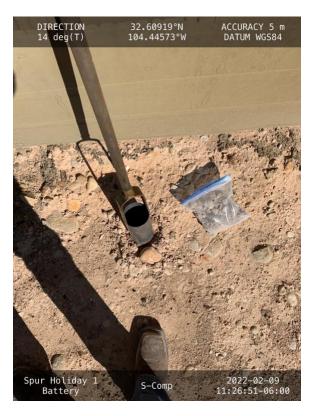
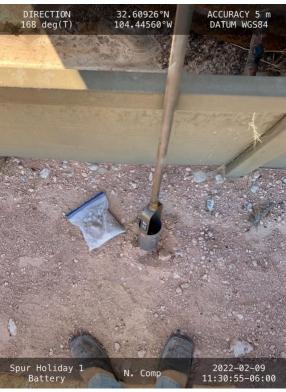
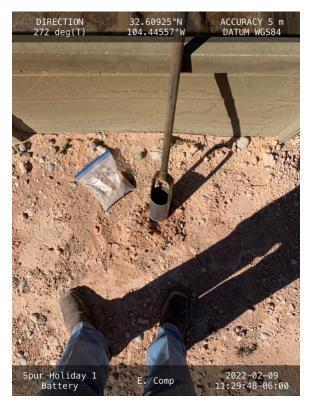
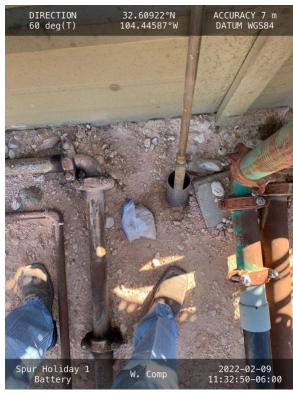
The liner was cleaned prior to the inspection. The 48-hour notification was given to the state on 2-7-22, see Appendix F. During the inspection, there were no obvious rips or tears in the liner to make me believe that the liner needs any repair or has lost the integrity to contain any spilled fluids. The liner report can also be found in Appendix F.

Liner Inspection Composite Samples From Around The Containment

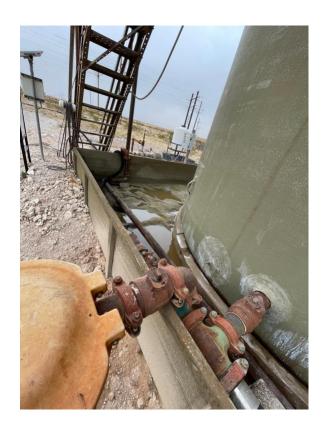
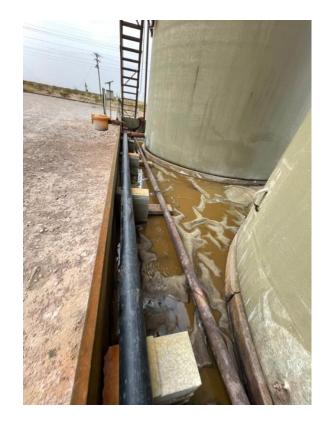
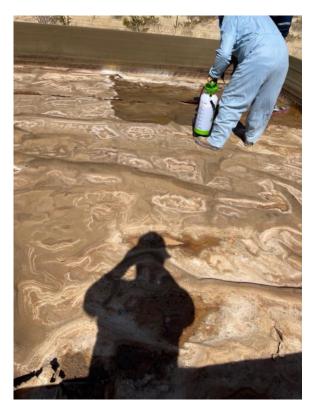
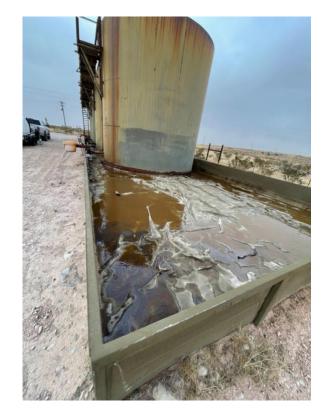
Cleaned & Completed
