# SITE REMEDIATION AND CLOSURE REPORT REPORTABLE RELEASE

# **Spur Energy Partners**

Holiday #1H Battery
GPS: Latitude 32.8023071 Longitude -104.2290268
Eddy County, NM
Incident ID No. NRM2026056833

Incident ID: NRM2026056833

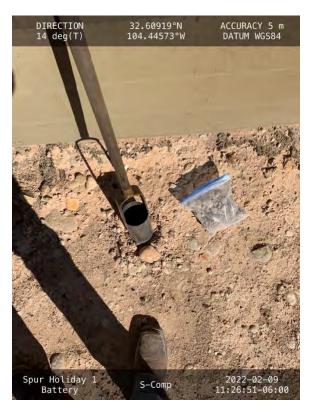
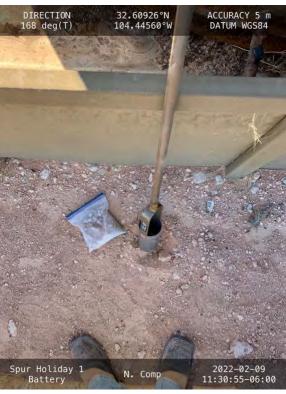
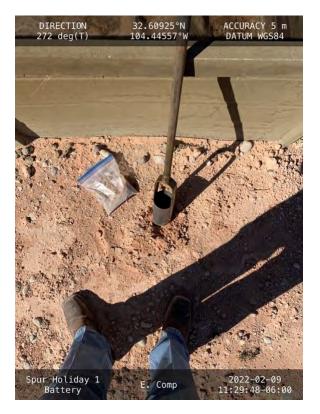
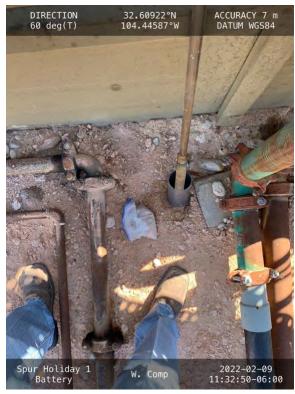
# **Liner Inspection Composite Samples From Around The Containment**

The liner was cleaned prior to the inspection. The 48-hour notification was given to the state on 2-7-22, see Appendix F. During the inspection, there were no obvious rips or tears in the liner to make me believe that the liner needs any repair or has lost the integrity to contain any spilled fluids. The liner report can also be found in Appendix F.

Based on the Liner Inspection and the composite sample results being below closure criteria no remediation is needed for this incident.
