July 8, 2020

**Subject: Liner Inspection and Closure Report**  
**Cotton Draw 237H**  
**Incident Number: NOY1804748816**  
**Lea County, New Mexico**

Devon Energy Production Company (Devon) (Client) retained HRL Compliance Solutions, Inc. (HRL) to conduct a liner inspection and prepare this closure report for the February 2018 release at the Cotton Draw Unit 237H well pad (Site). The Site is in Lea County, New Mexico (Figure 1).

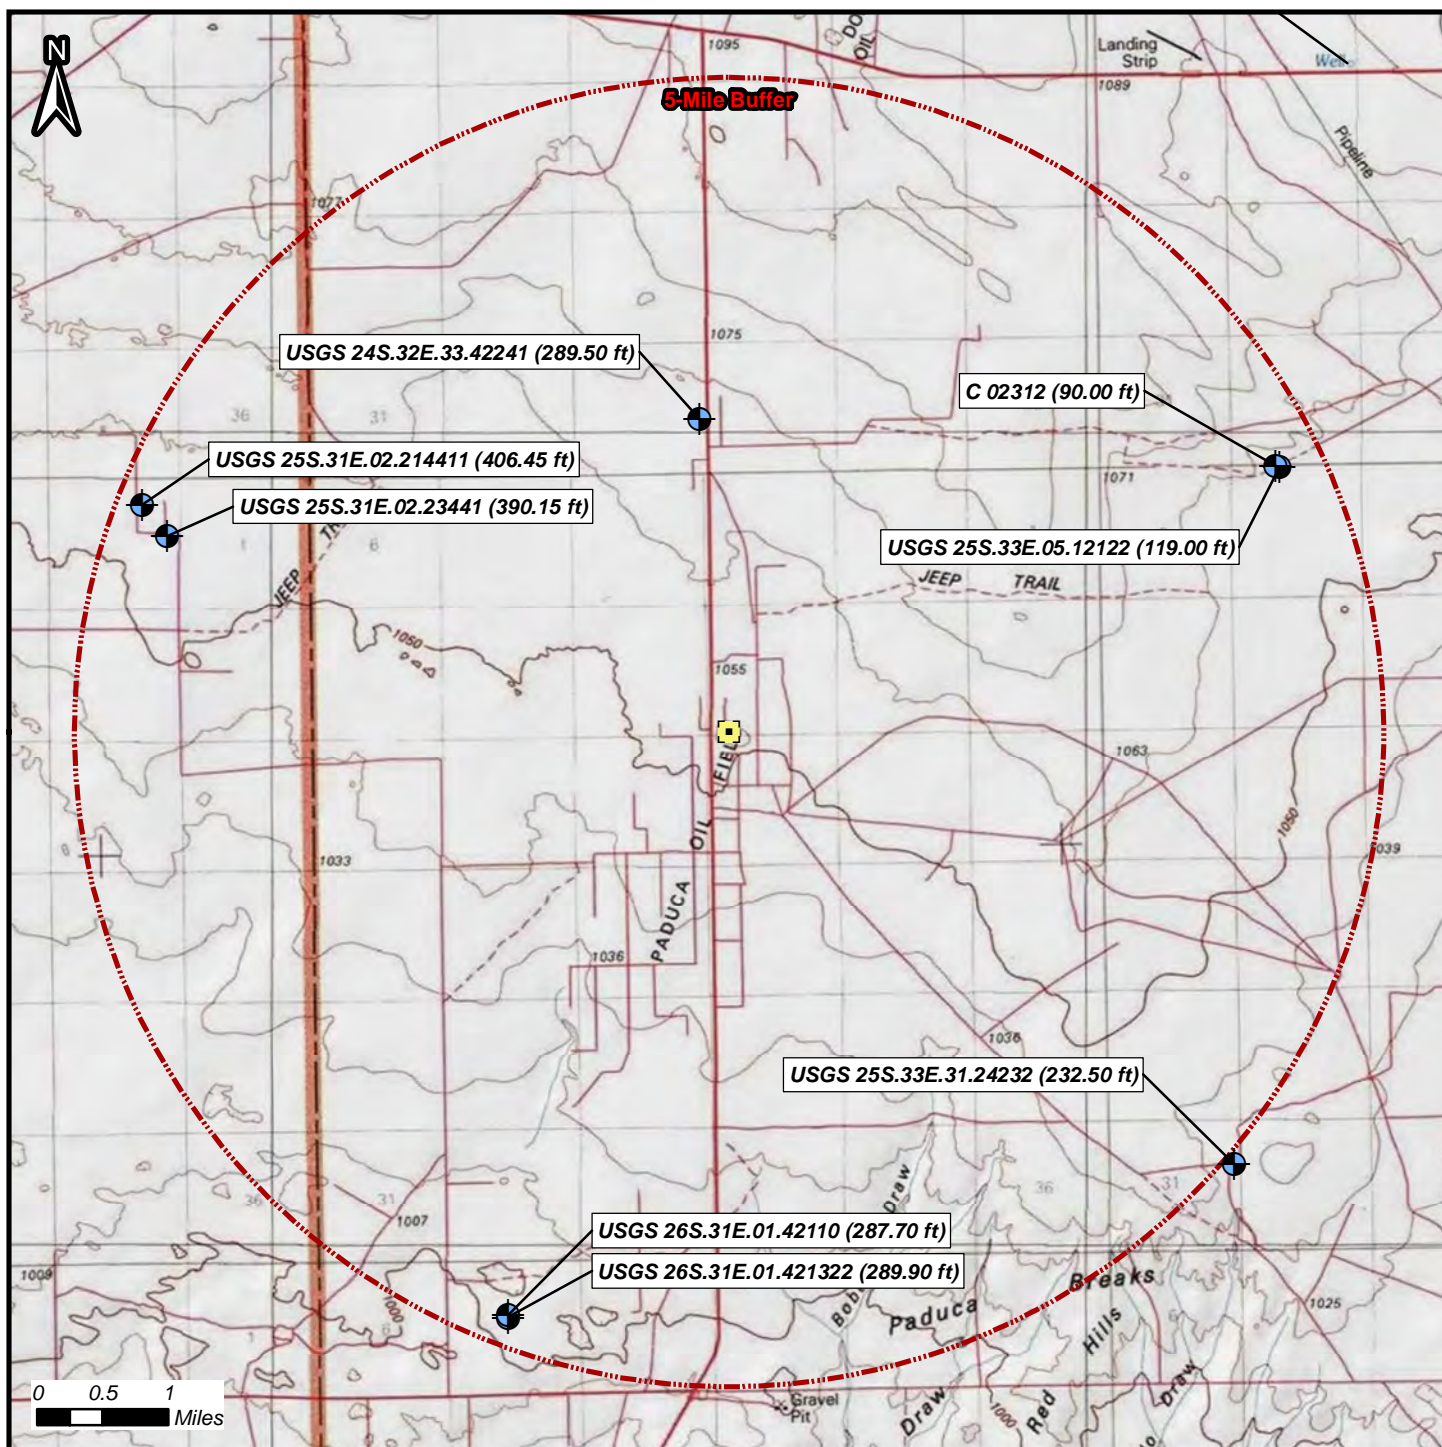
**Figure 2: Depth to Groundwater Map**

Depth to groundwater at the release was estimated by evaluating data from the New Mexico Office of the State Engineer (NMOSE) and United States Geological Survey (USGS) (Figure 2). The nearest groundwater well was approximately 2.4 miles from the Site; the depth to water in this well was 289.50 feet below ground surface (bgs).

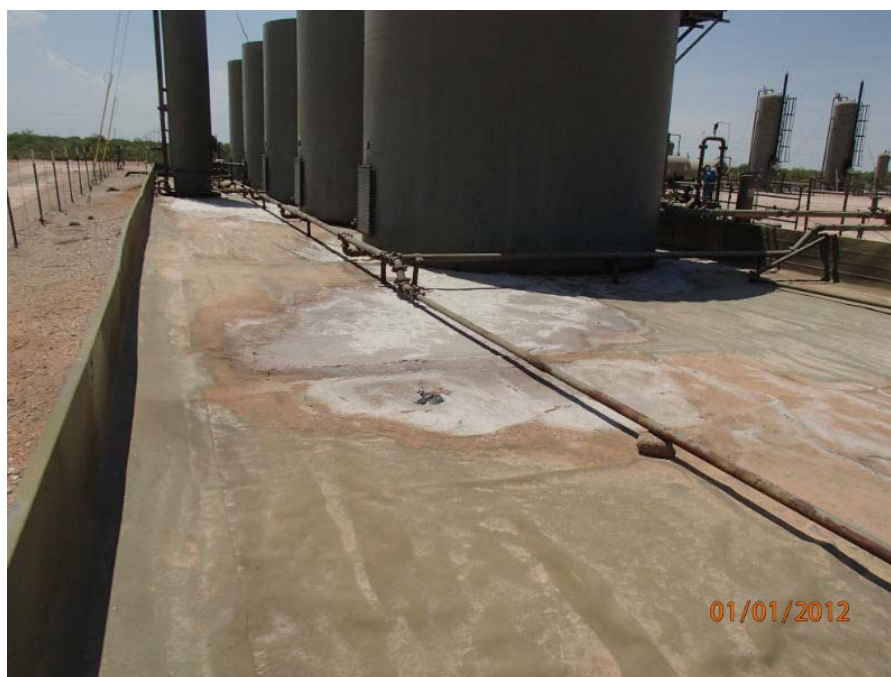
On June 22, 2020, after the released fluid was removed, HRL conducted an inspection to evaluate the integrity of the liner (Attachment B, Photographs). No tears or holes were observed, and salt crust was observed within the containment structure. Based on this inspection, HRL has determined that the liner remains intact and had the ability to contain the release (Attachment C, Inspection Form).

View of the  
secondary  
containment to  
the west

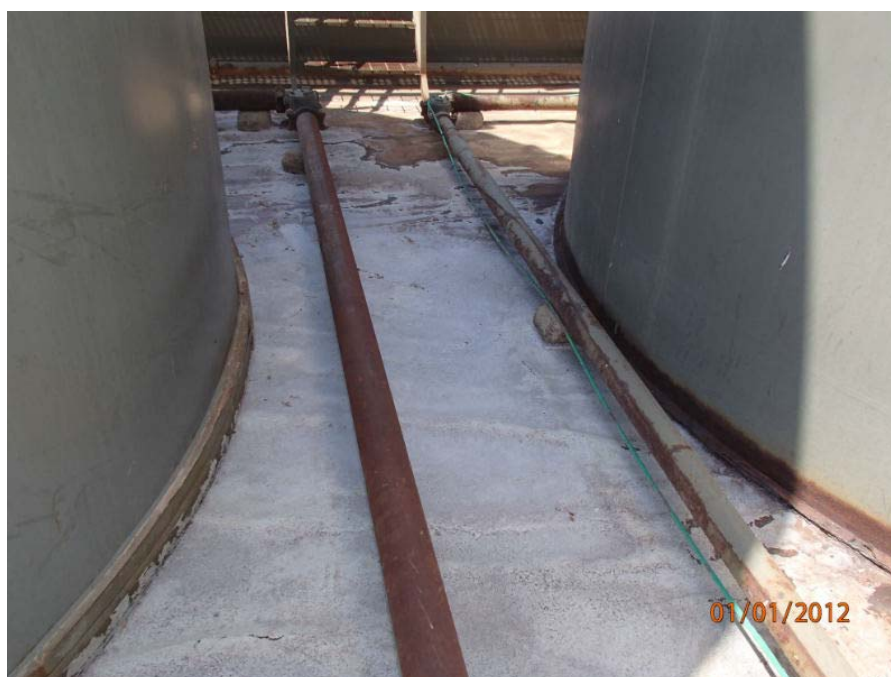
View of the  
secondary  
containment in  
between tanks

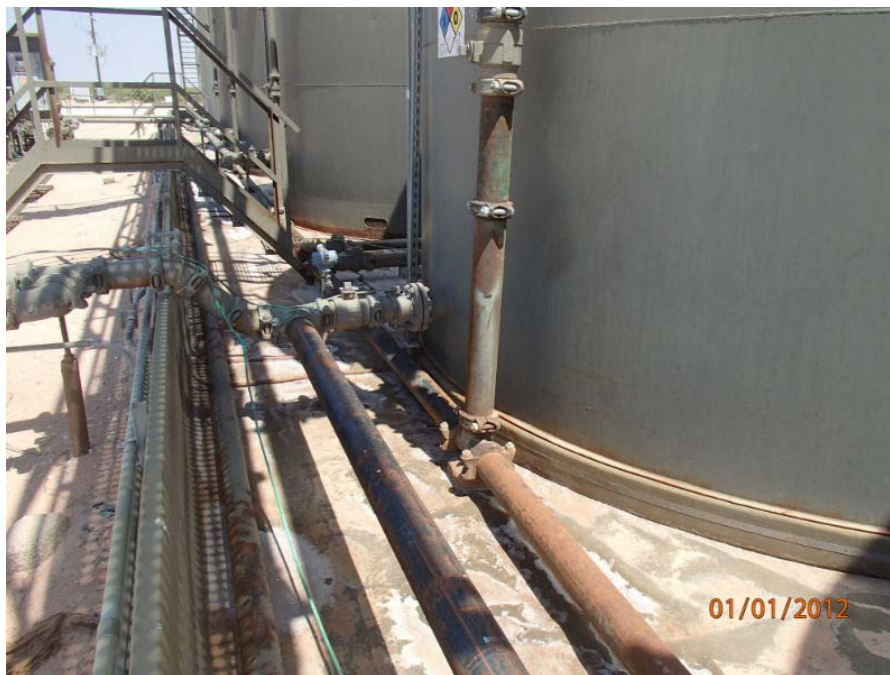
View of the  
secondary  
containment to  
the east

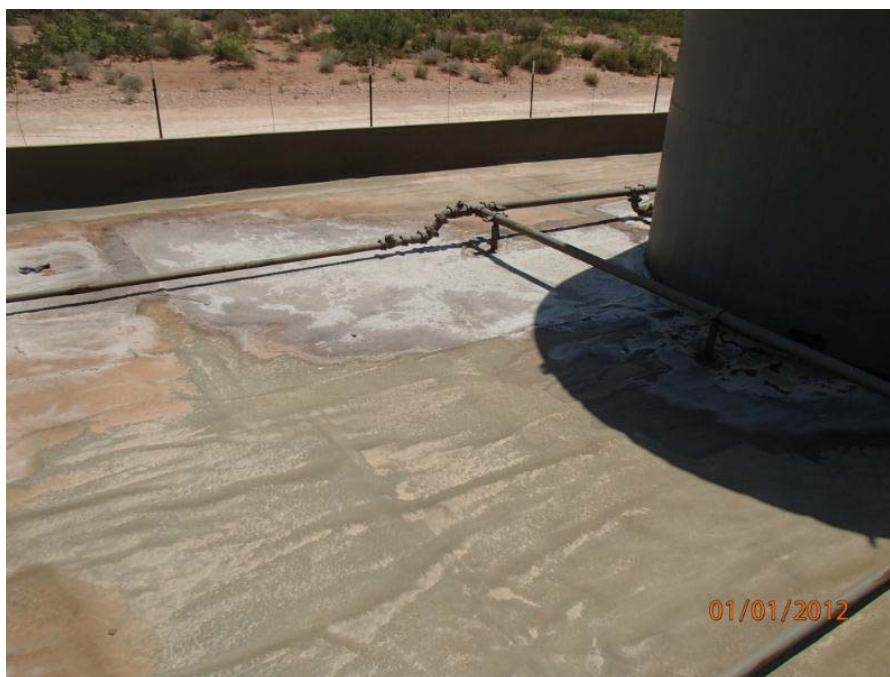
View of the  
secondary  
containment

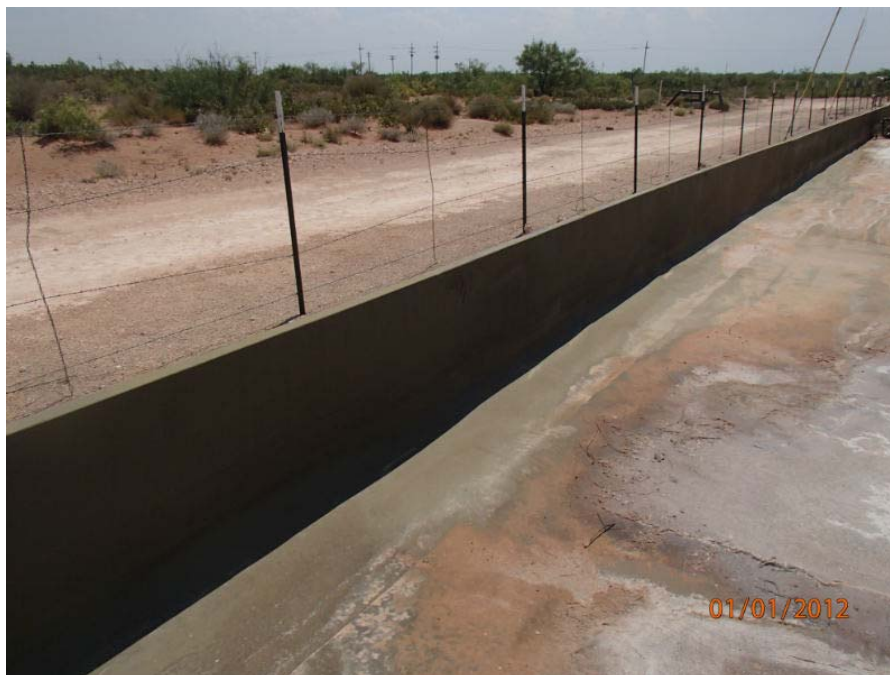
View of the  
secondary  
containment

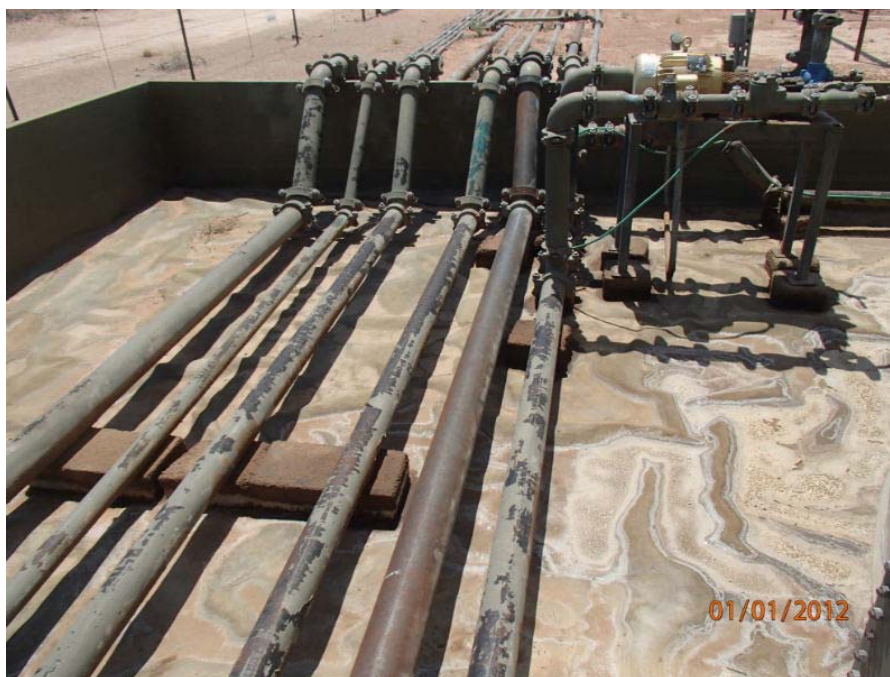
View of the  
secondary  
containment
