Pima Environmental Services, LLC  
1601 N. Turner Ste 500  
Hobbs, NM 88240  
575-964-7740

March 15<sup>th</sup>, 2020

**Re: Site Assessment and Closure Report  
Burton Flats Deep Unit #52-56 Battery  
API No. 30-015-40693  
GPS: Latitude 32.511694 Longitude -104.169029  
UL "H", Sec. 3, T21S, R27E  
Eddy County, NM  
NMOCD Ref. No. NHMP1416430522 (2RP-2343)**

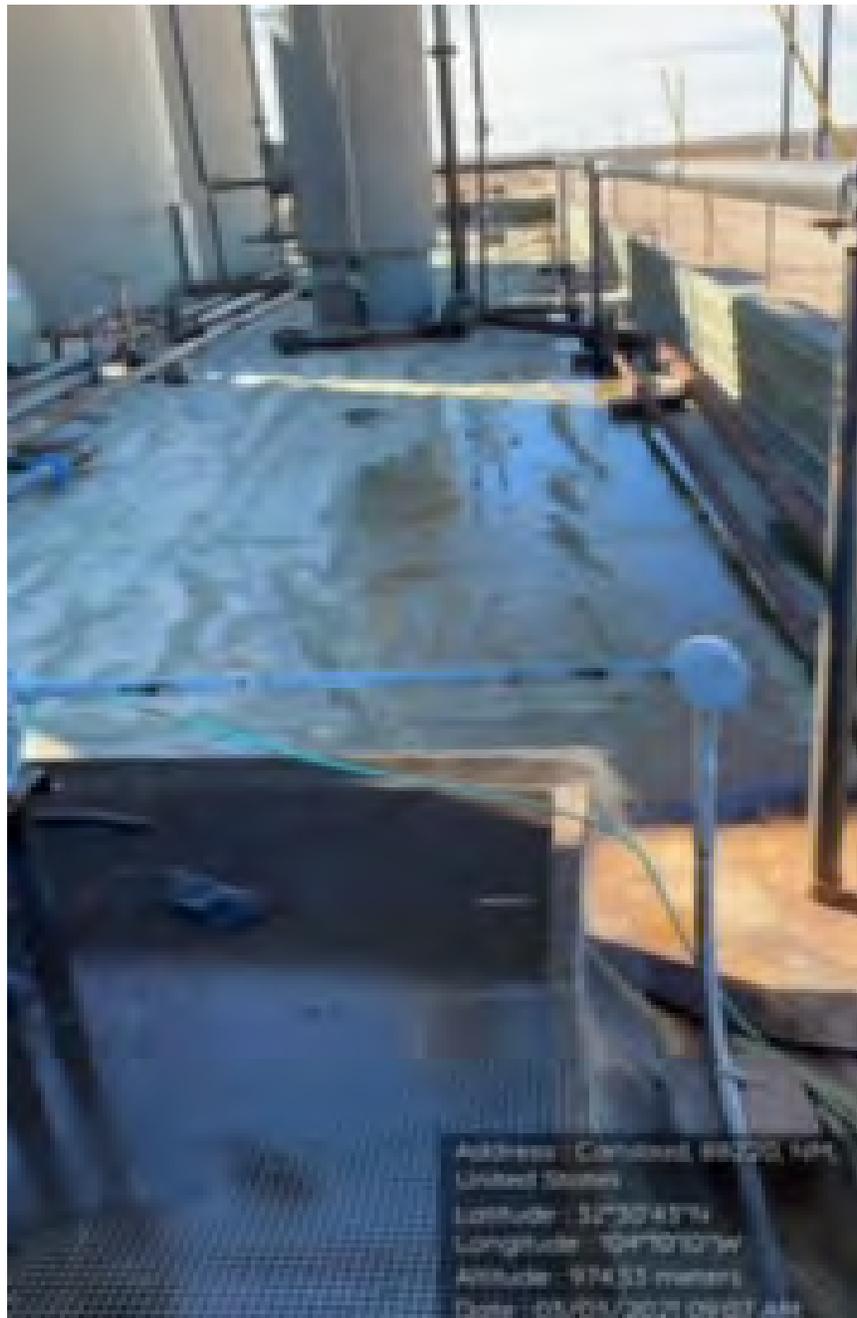
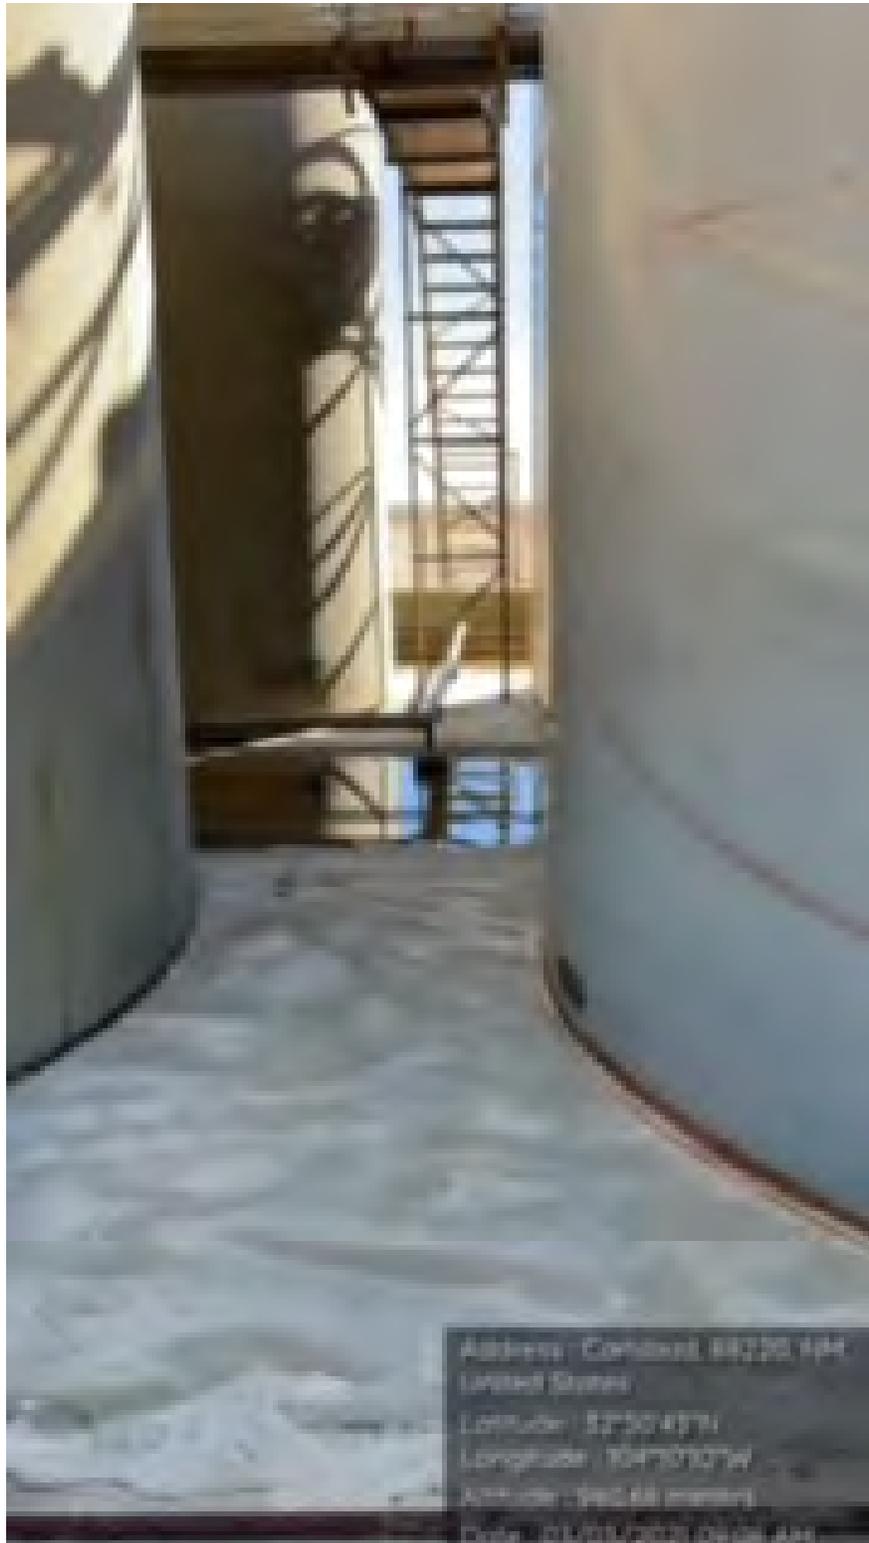
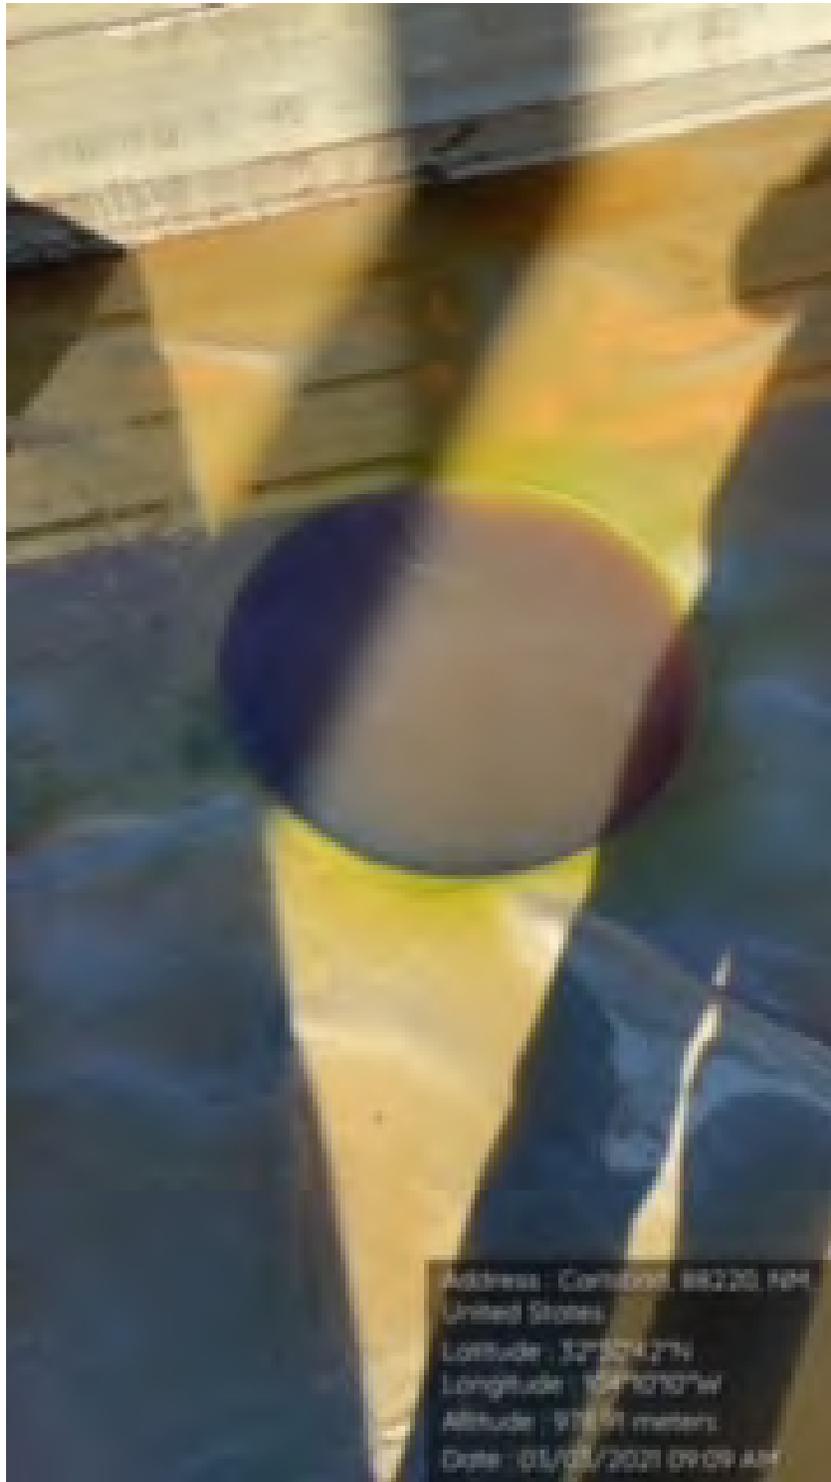
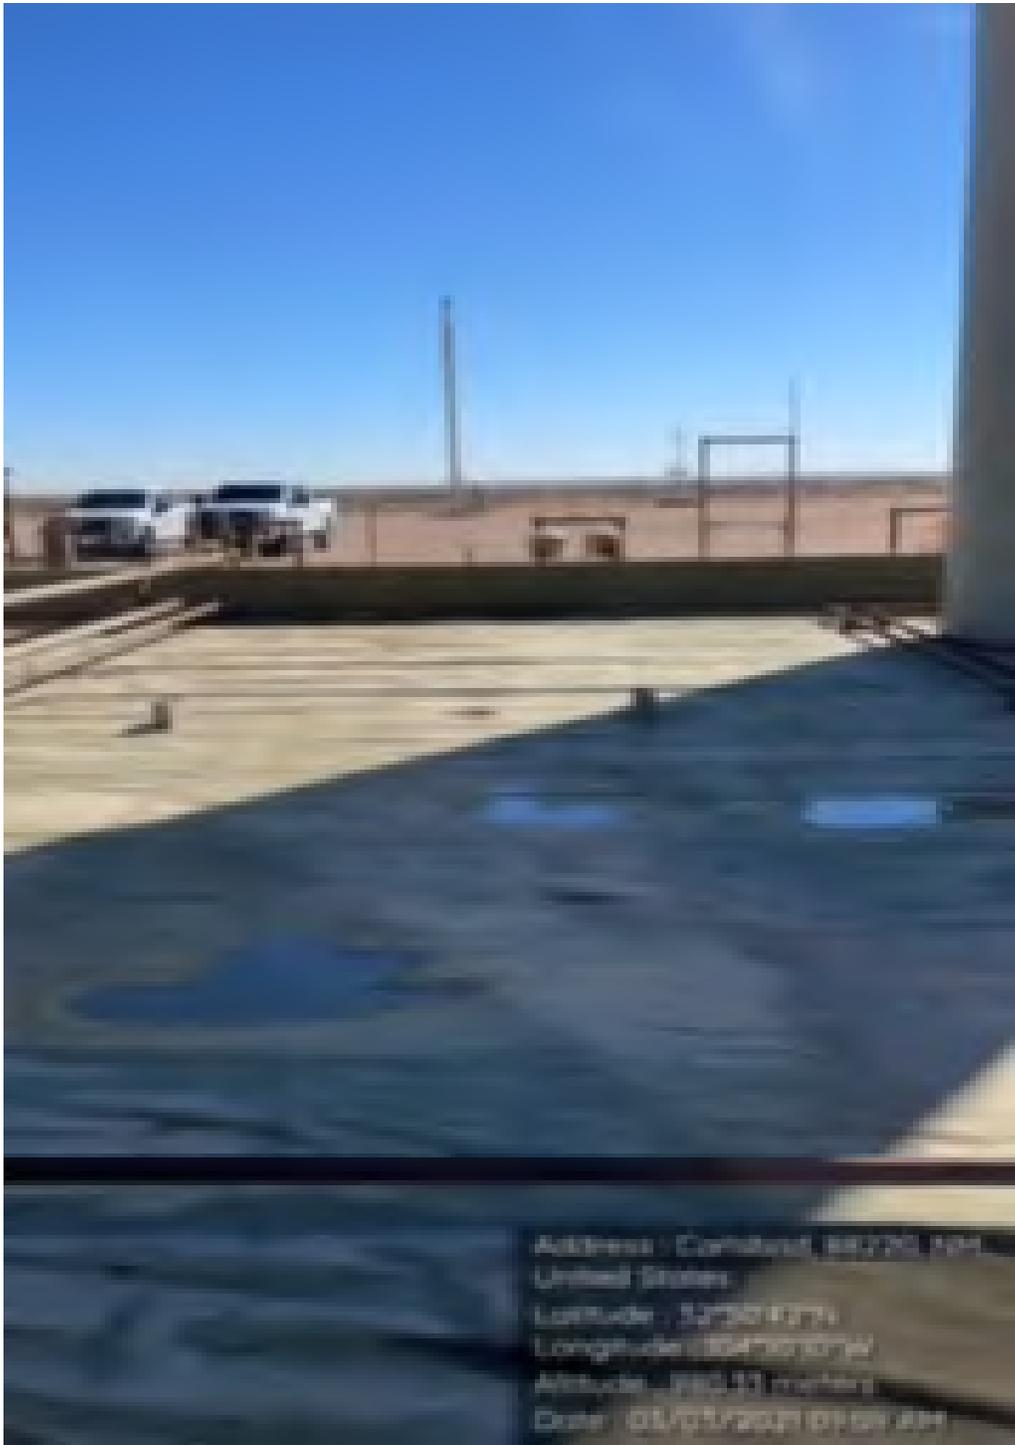
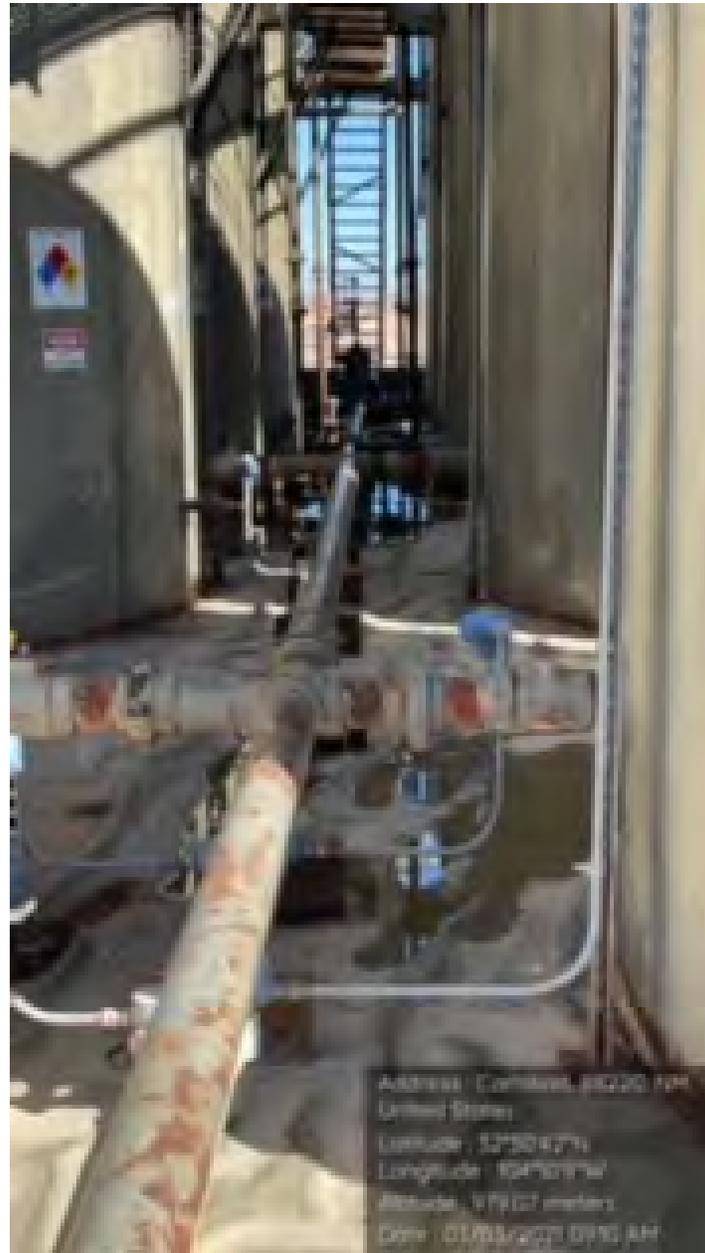
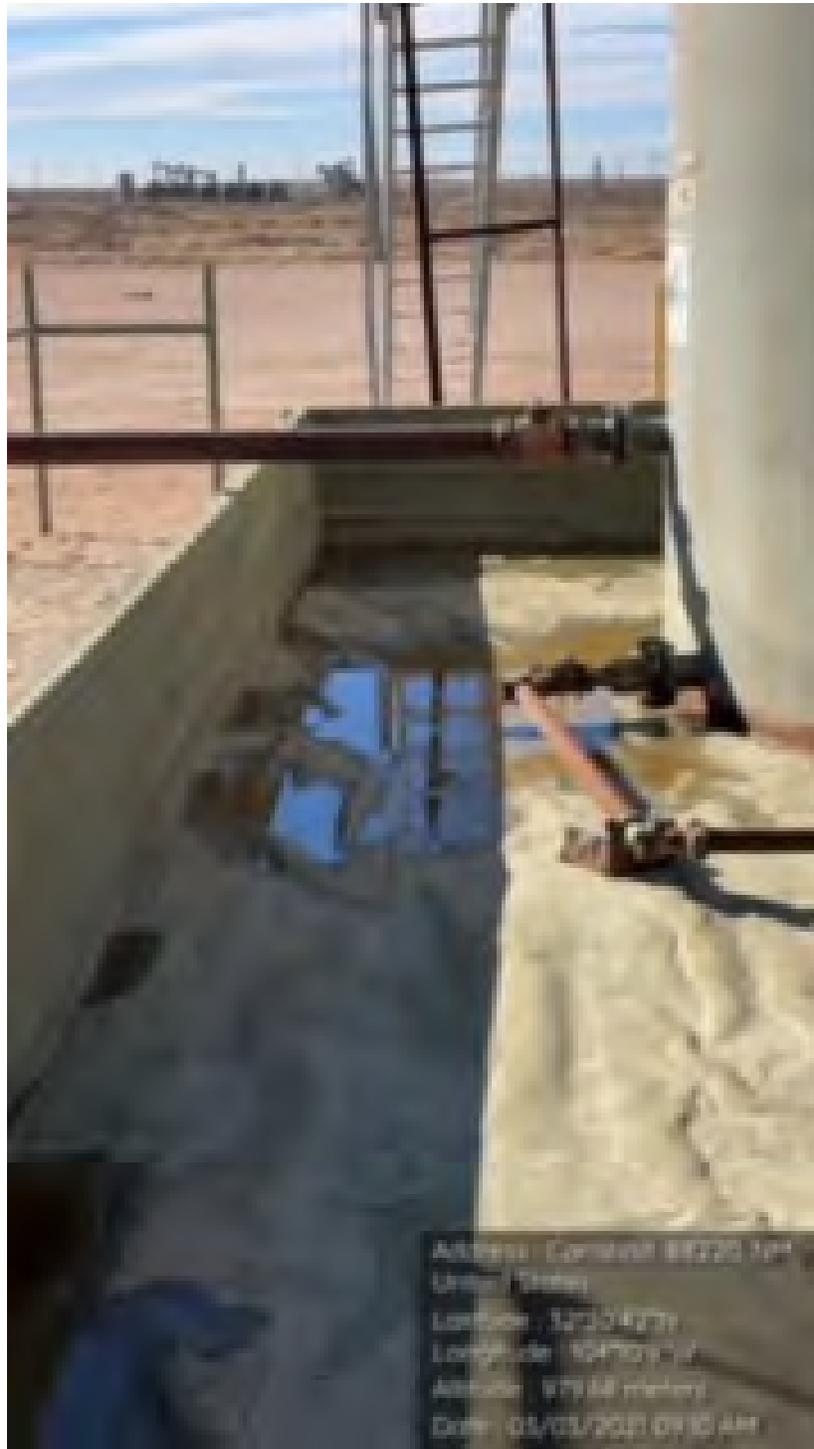
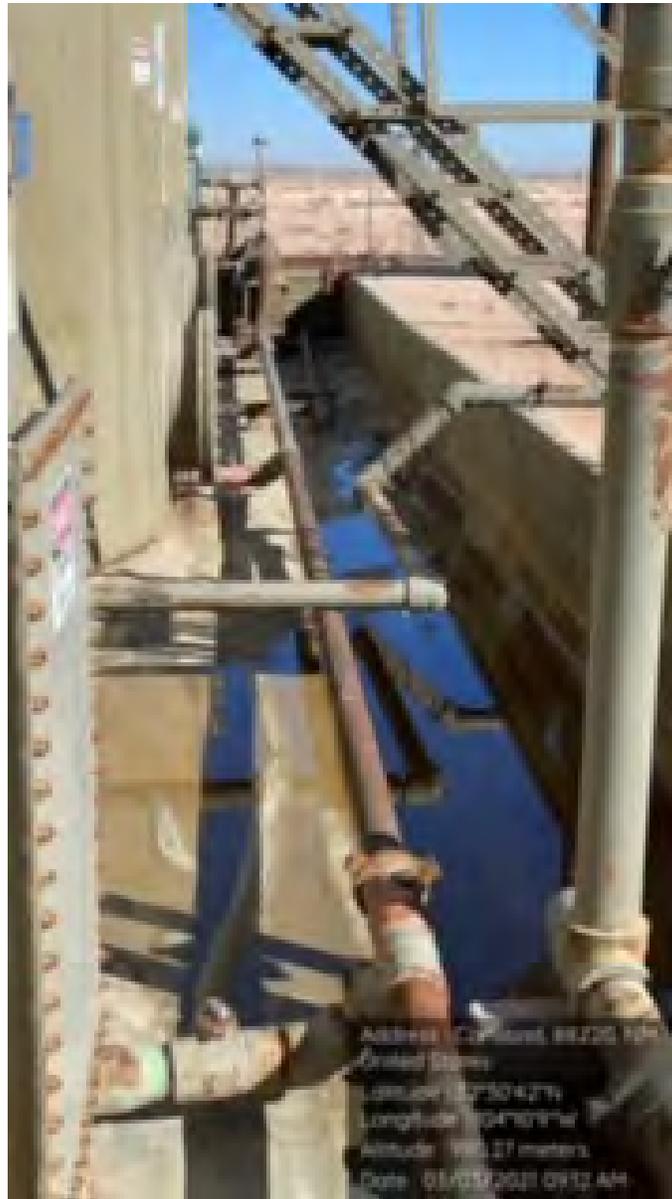
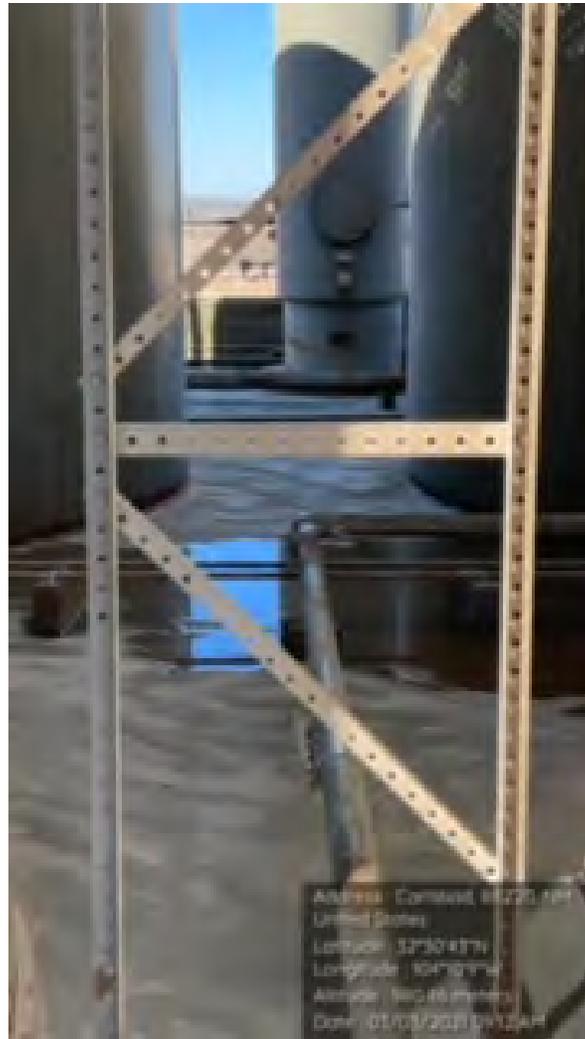
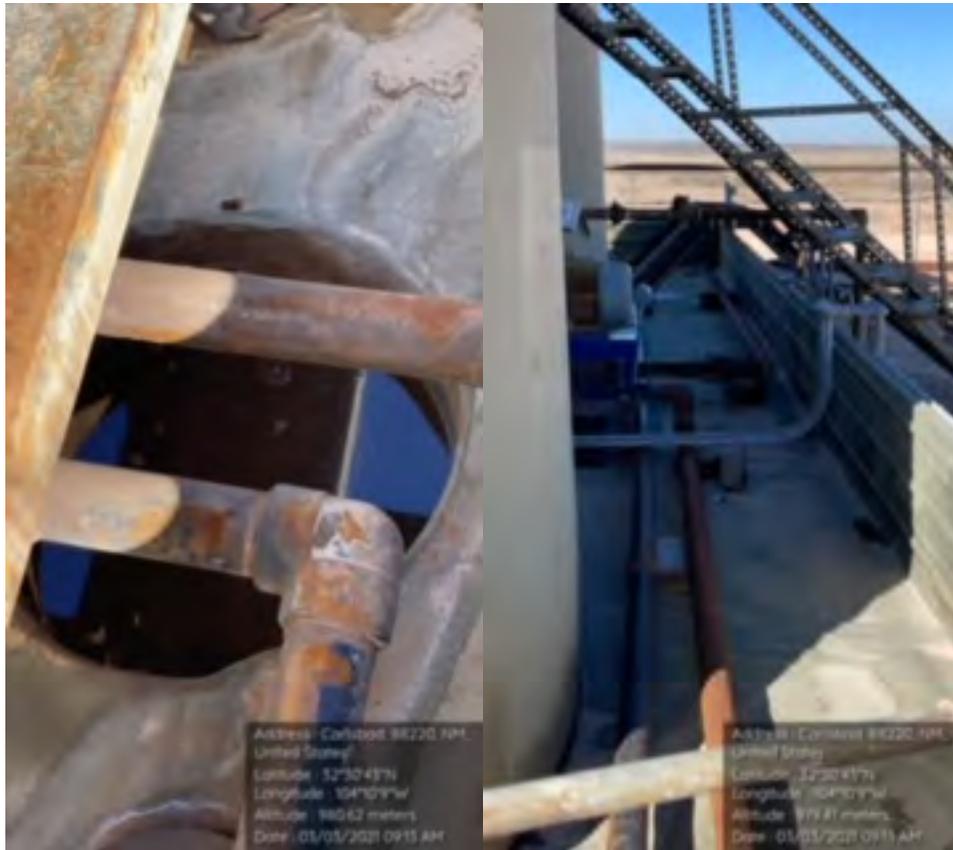
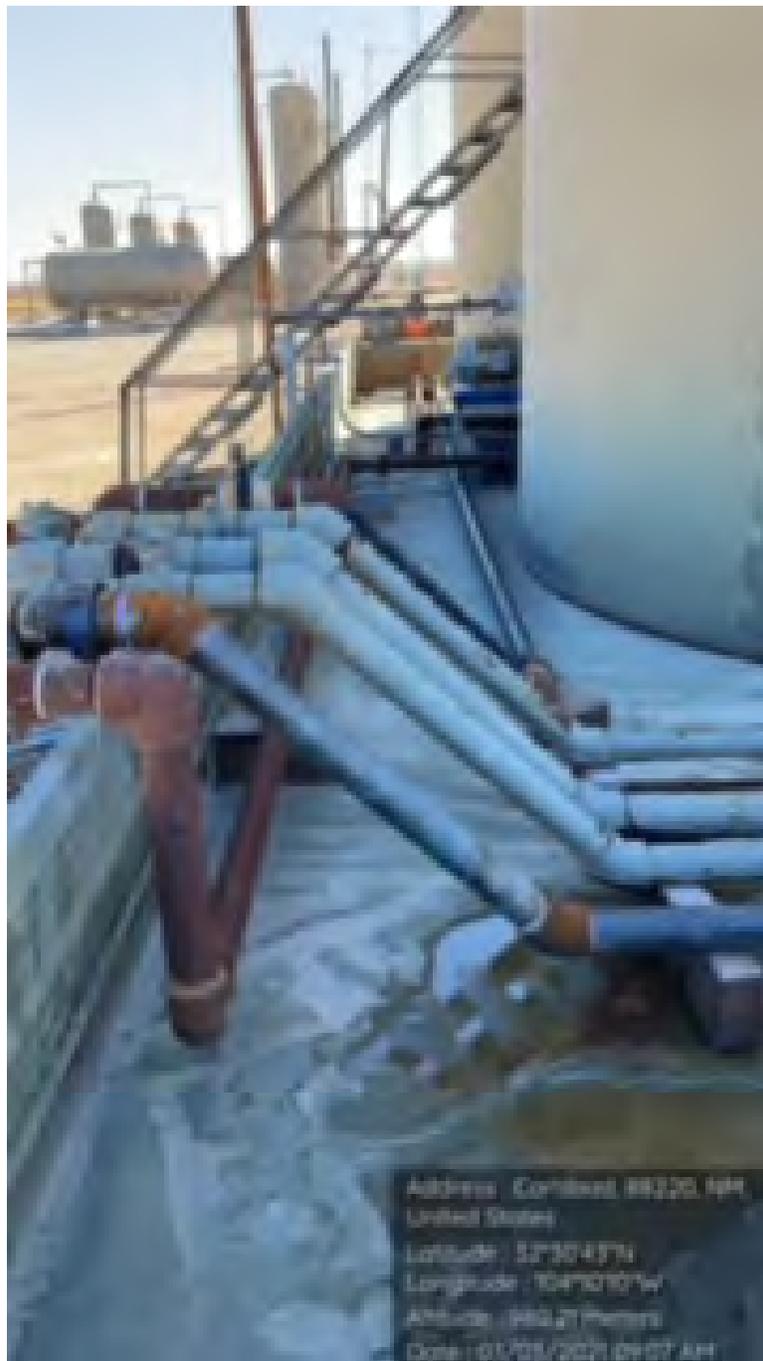
### Liner Photographs

On March 3<sup>rd</sup>, 2021 Pima Environmental conducted a site assessment and inspected the liner in question. We concluded that this liner has maintained its integrity and ability to contain the released fluids involved in this incident. The liner inspection report and photo documentation can be found in Appendix D.

Visualization	Yes	No	Comments
Is there a tear in the liner?		<input checked="" type="checkbox"/>	
Are there holes in the liner?		<input checked="" type="checkbox"/>	there's previous holes that have been patched already.
Is the liner retaining any fluids?	<input checked="" type="checkbox"/>		most likely from rain & snow this past week.
Does the liner have integrity to contain a leak?	<input checked="" type="checkbox"/>
