Release Notification

Nailed It CTB A Spill in containment

Incident ID: nAPP2229929598

Nailed It CTB A Liner Inspection

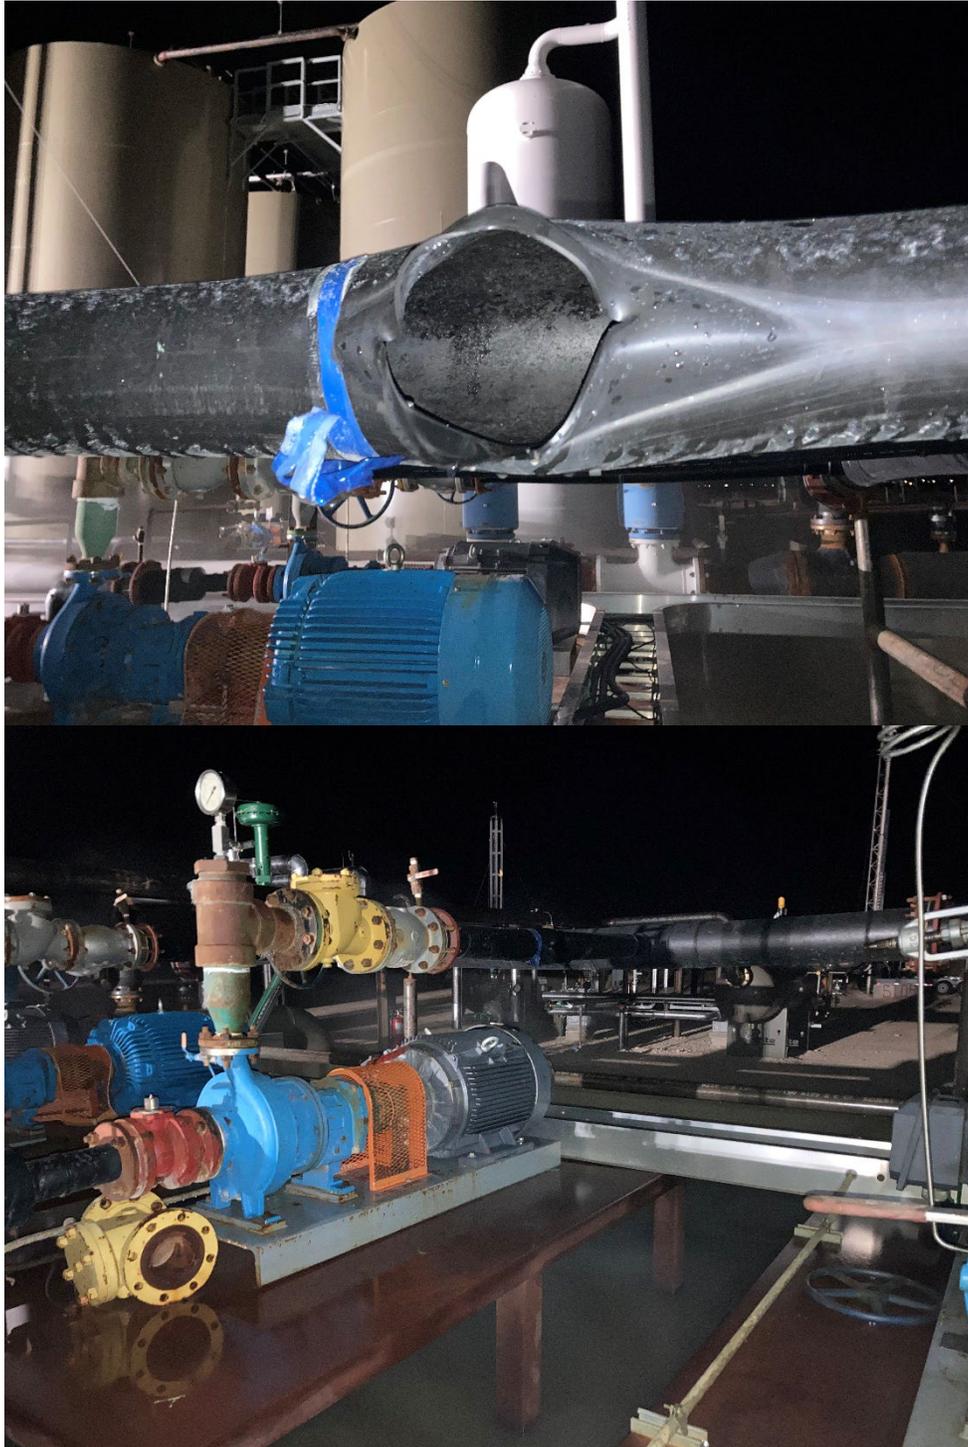
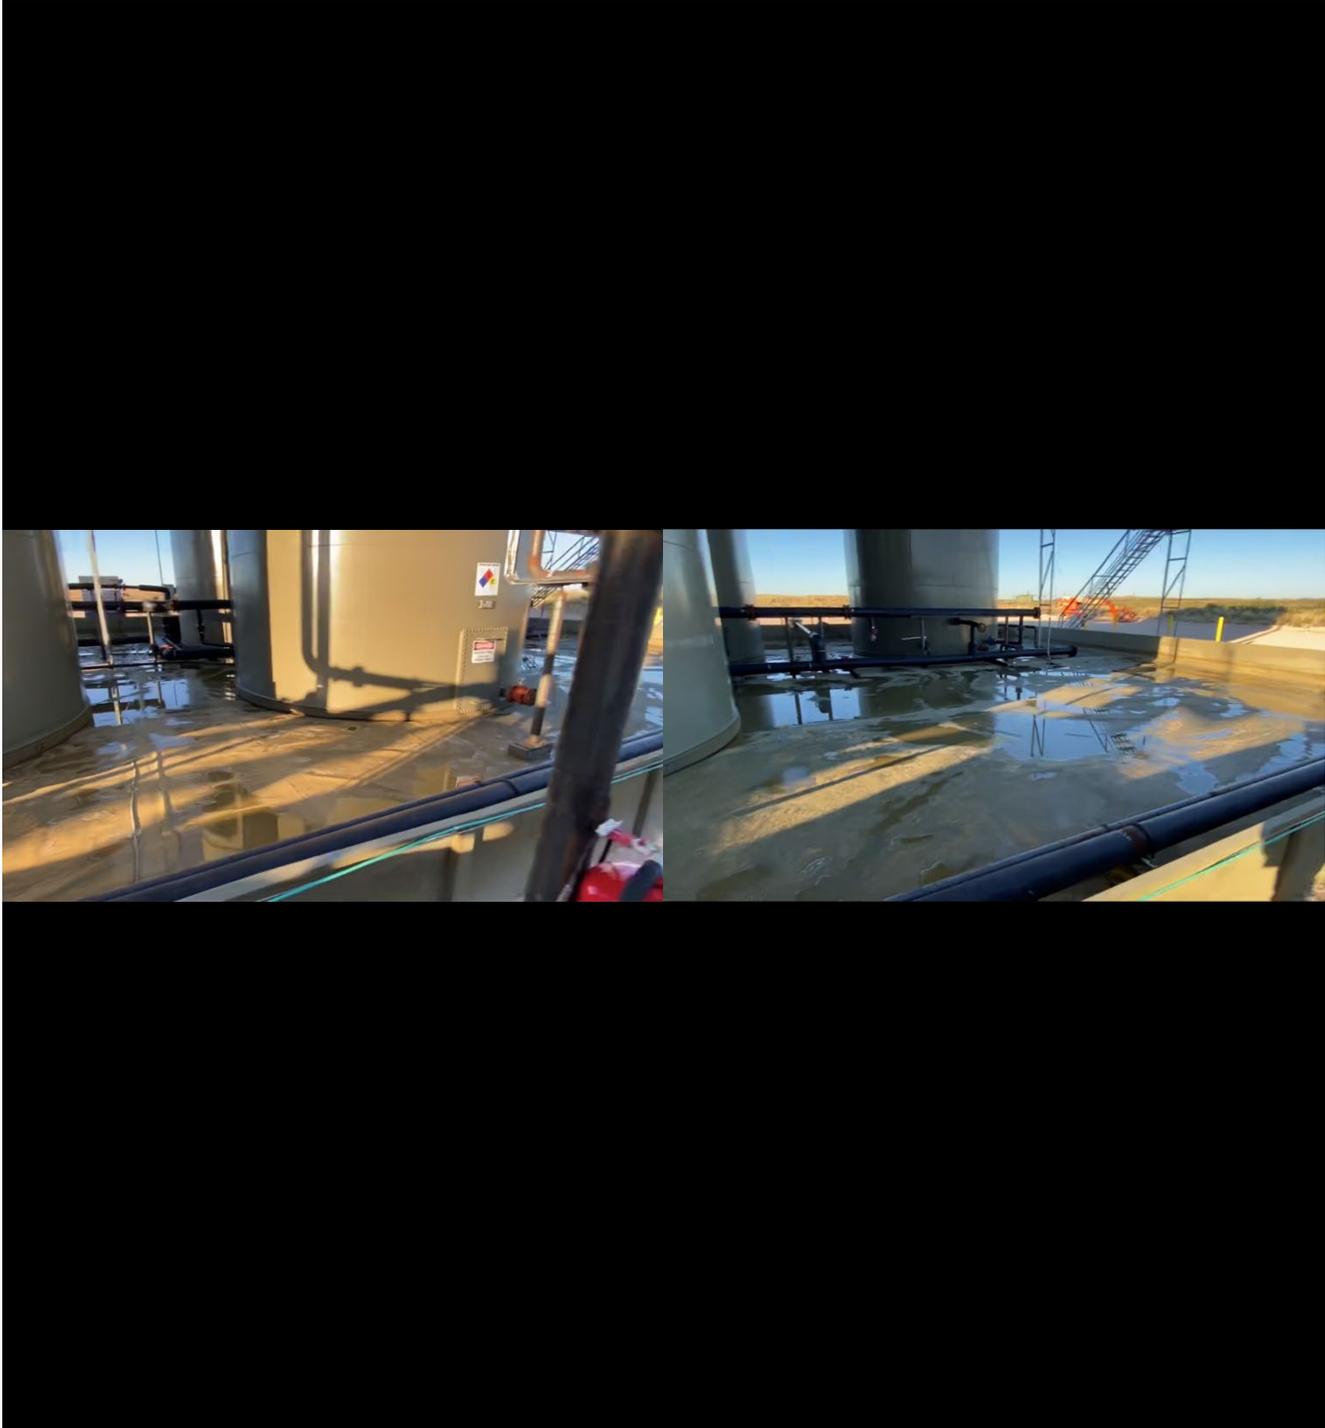
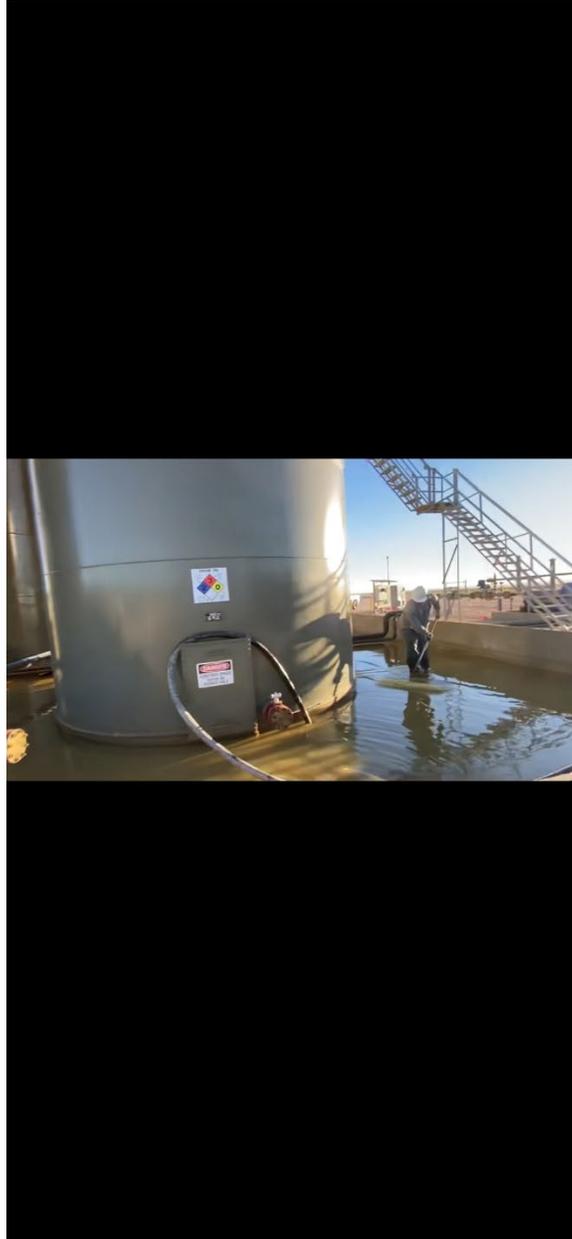
Nailed It CTB Tank Spill in containment

At 5:45 AM a release was noticed by the field operator of the Nailed It CTB A. Tap Rock's water supplier had their ESD valve shut due to high line pressure; once it opened back up it had over 200 PSI on the line. Tap Rock's SWD pumps is set at 205 PSI and the check valve on the skid leaked back enough to pressure up the polyline and caused the line to rupture spilling produced water into the containment area. Once the leak was found, operators immediately shut in the facility and isolated tanks feeding the SWD pumps. A Vac Truck was called and all water was vacuumed out of the containment. Pictures of the spill and liner integrity test were taken and are attached below:

- Actions that have been or will be taken to prevent a recurrence of the incident – Construction crew came back and replaced burst poly line. Additionally, Tap Rock will replace all poly line with a higher rated line to prevent this from happening again.

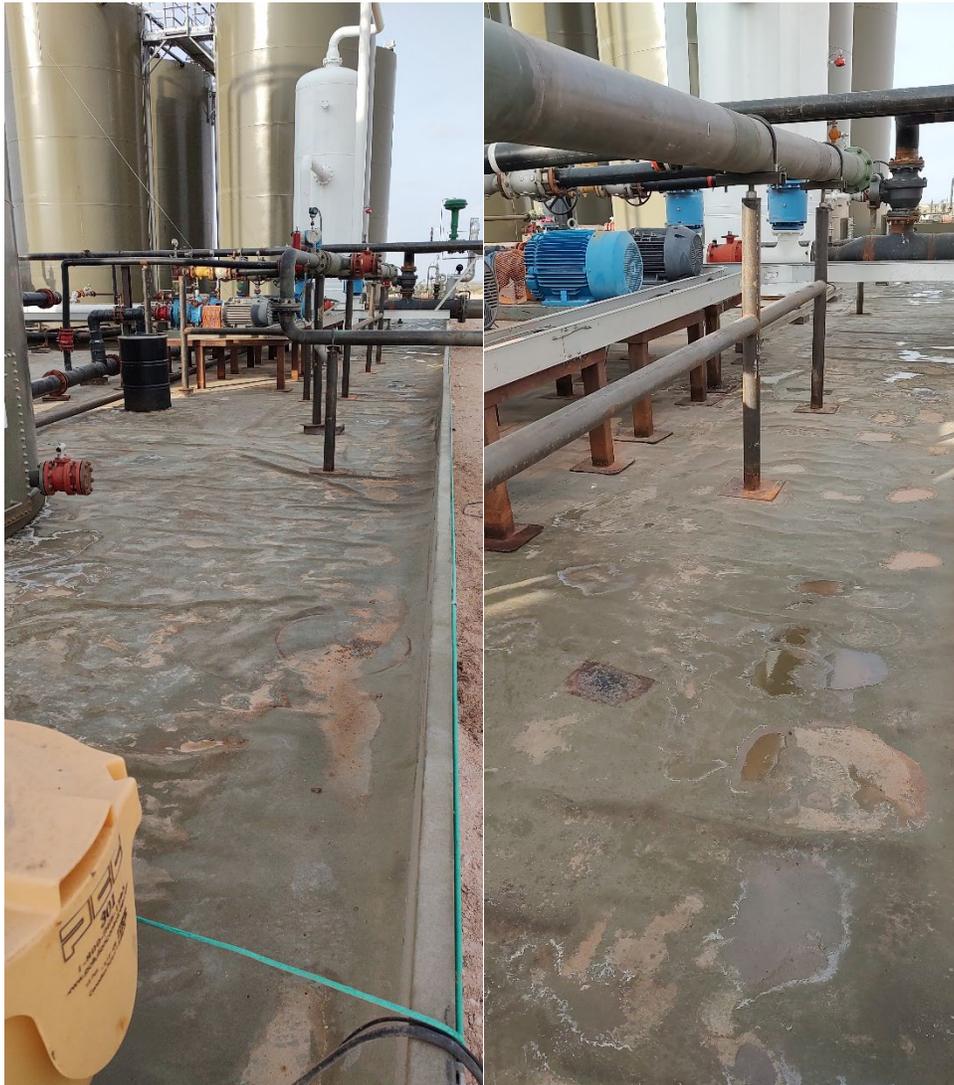
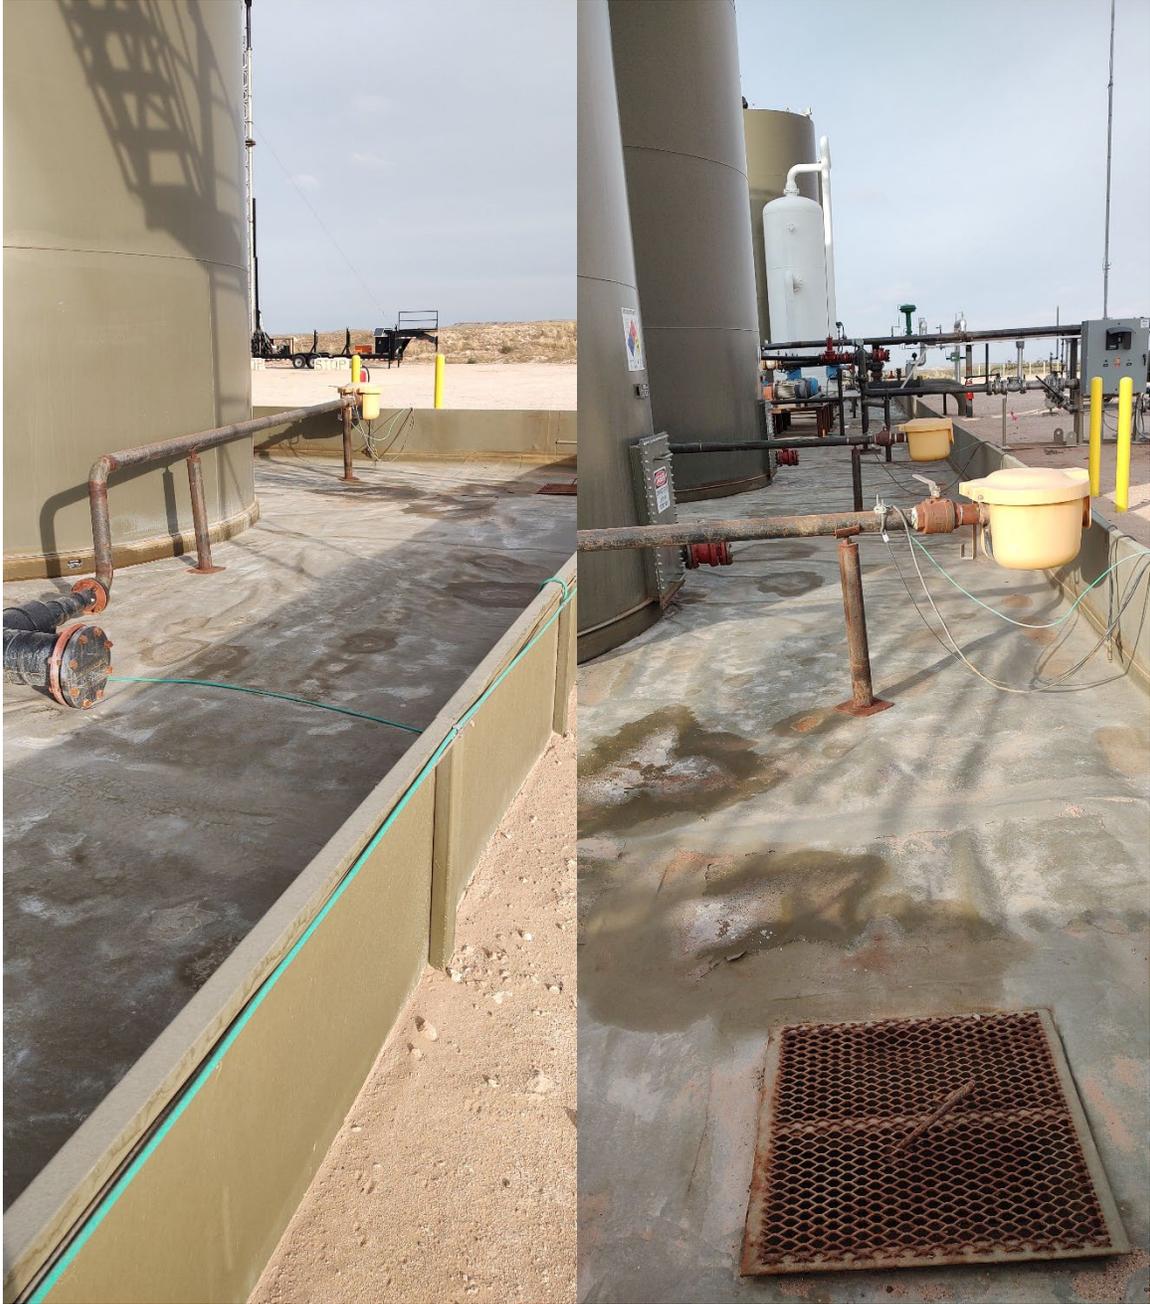
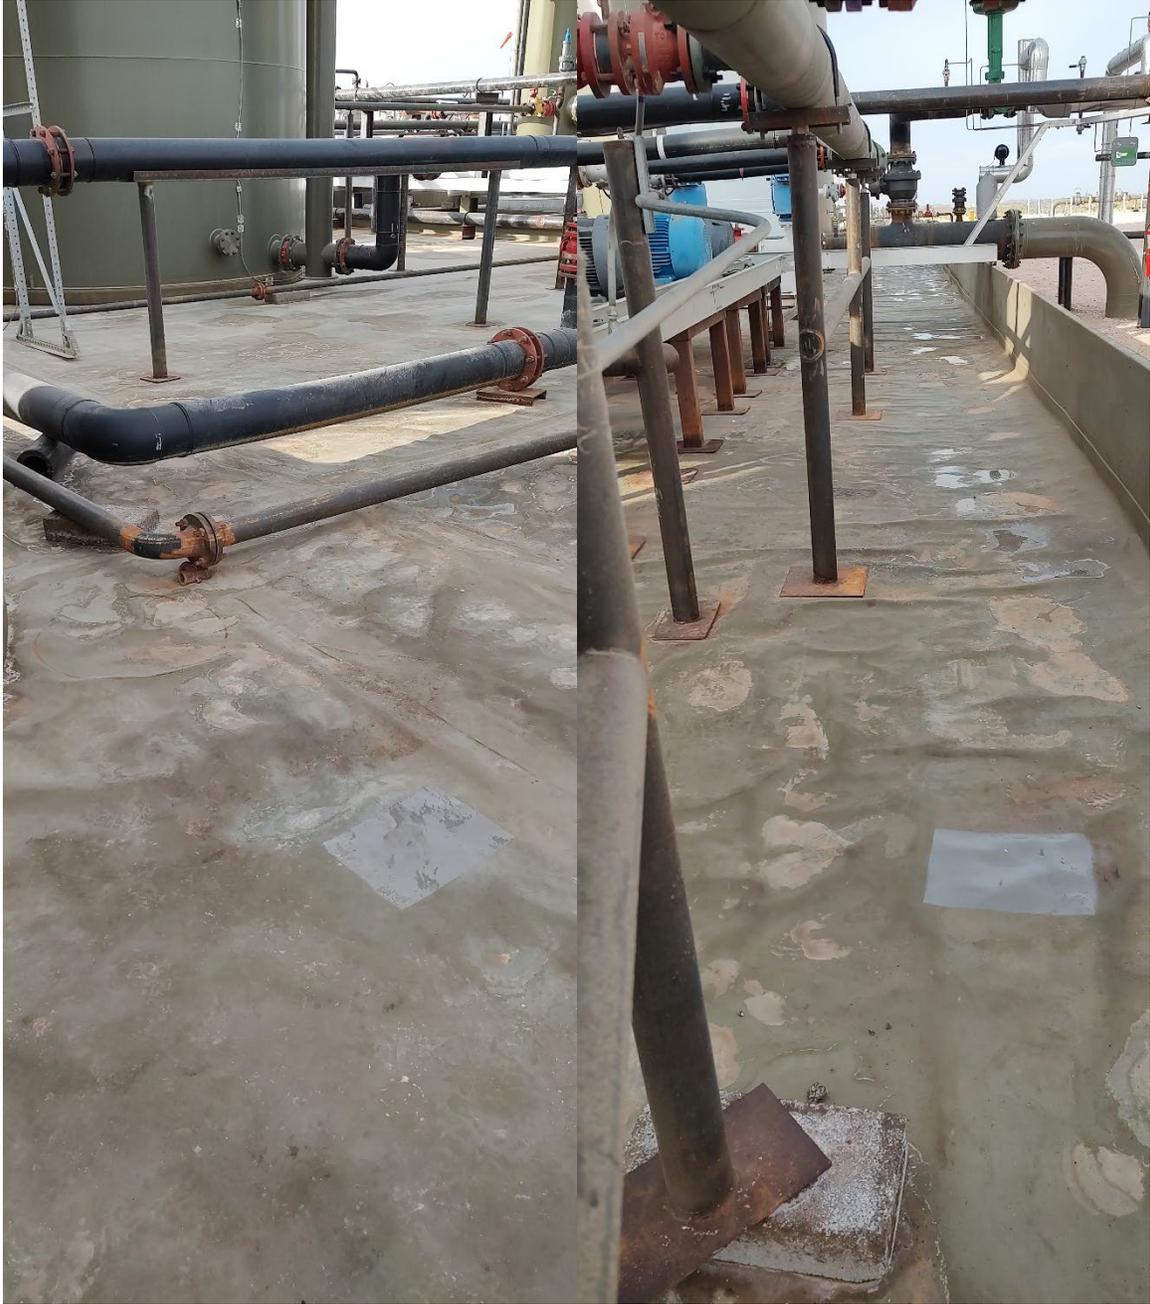
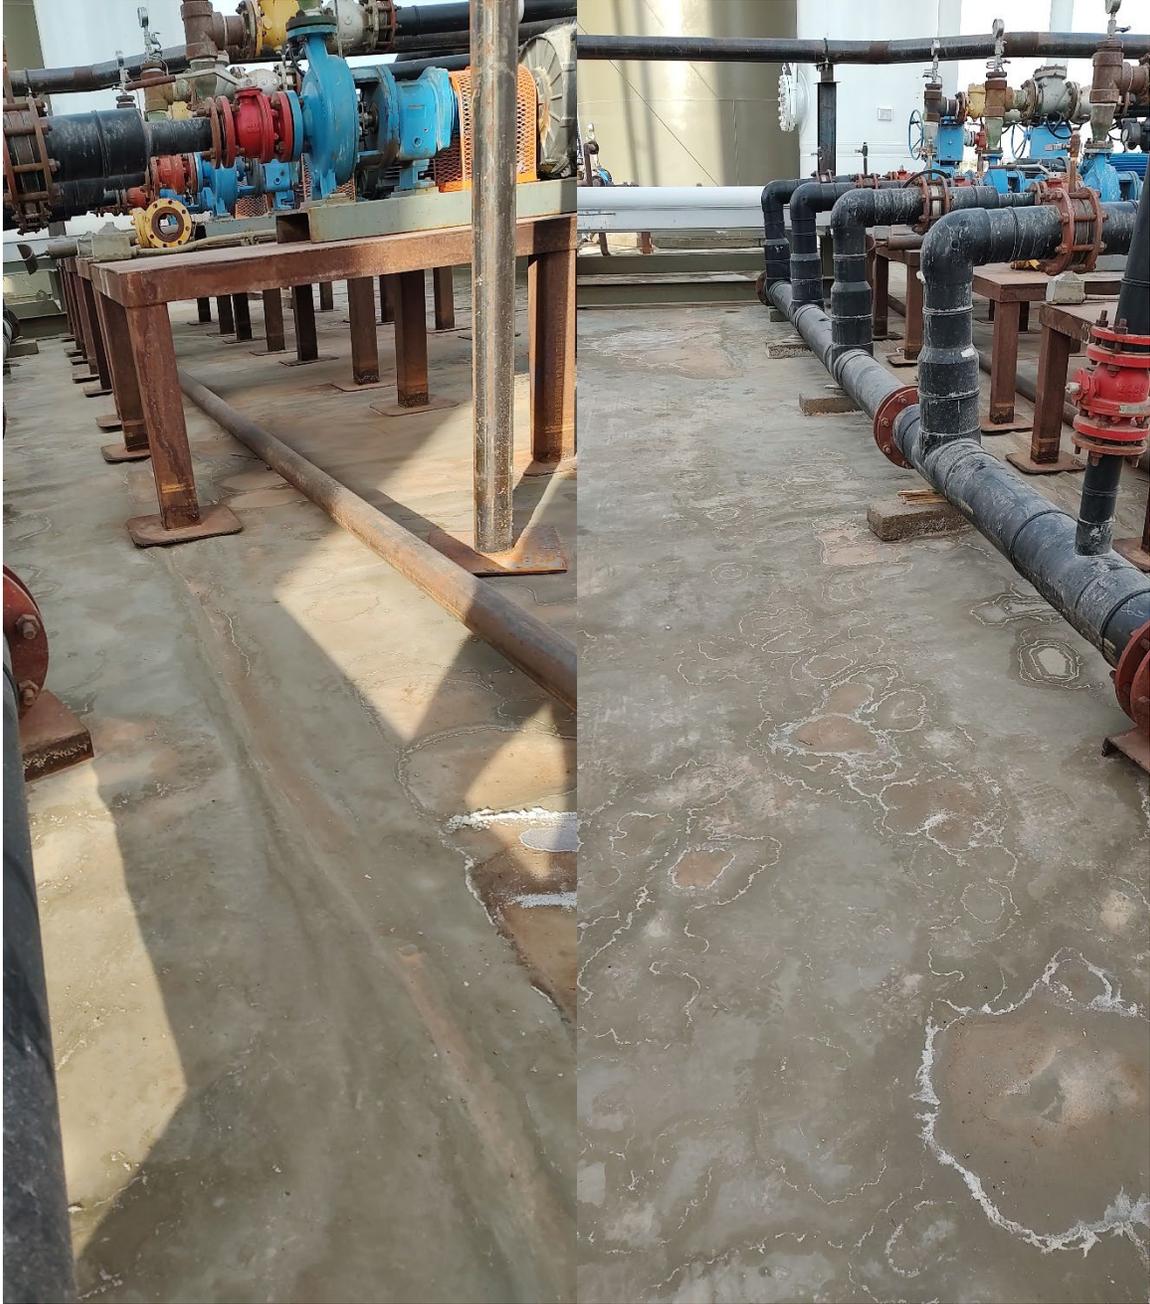
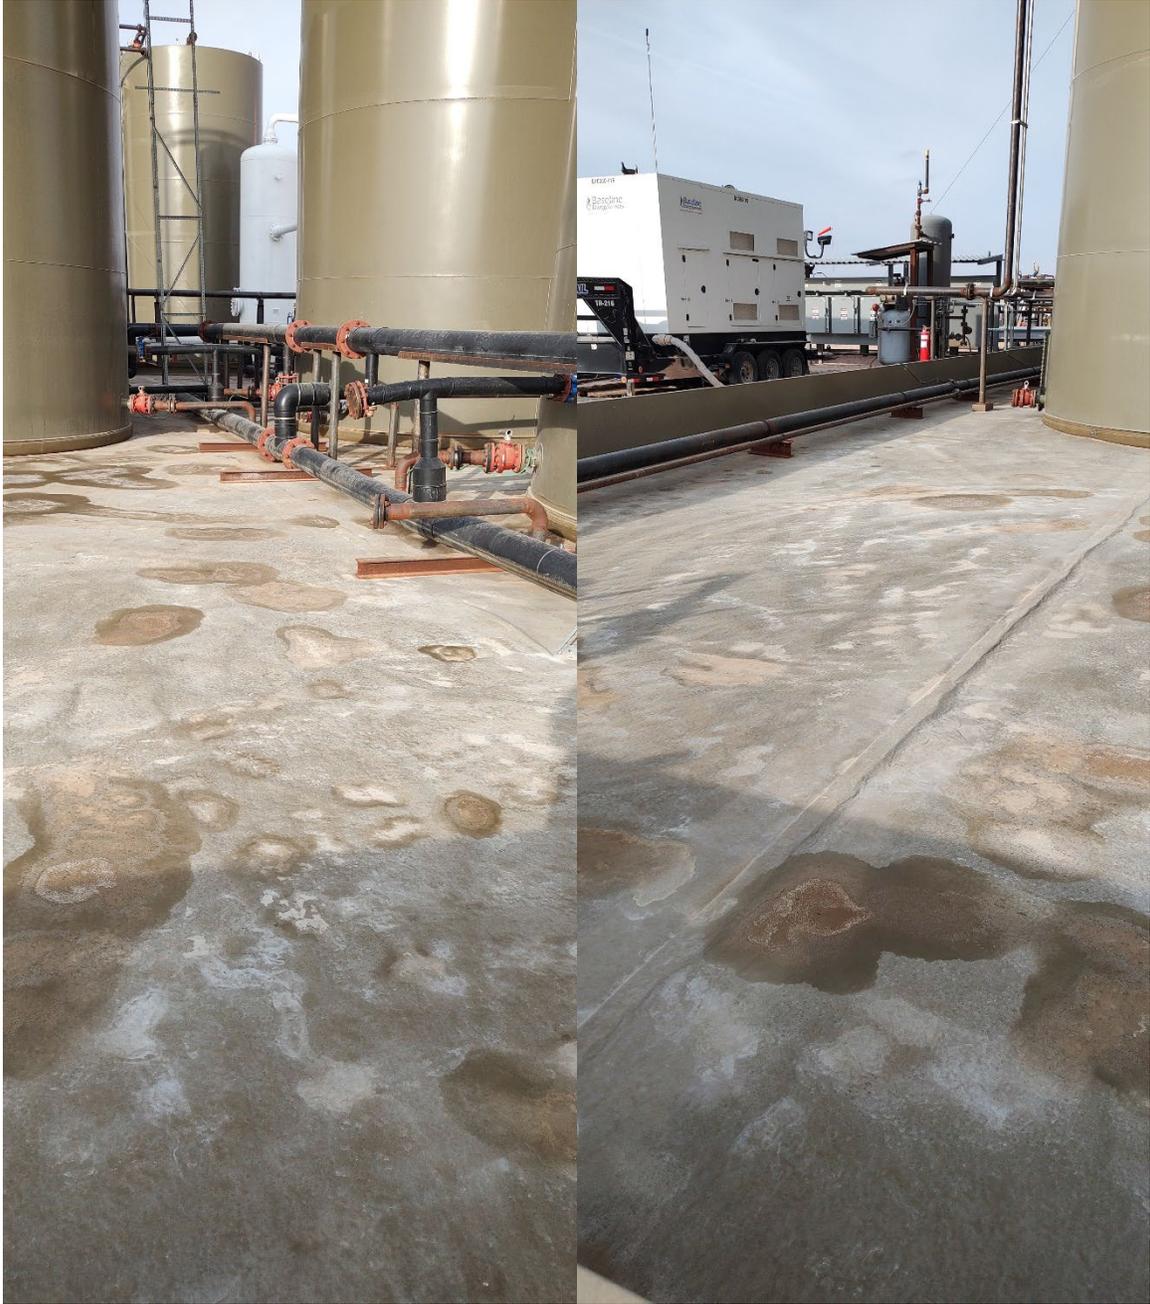
Tap Rock reached out to NMOCD as well as BLM to request formal liner inspection on 11/18/2022 at 8:00AM. Pictures of the inspection have been attached below:
