December 20, 2022

**Re: Site Assessment, Liner Cleaning, Liner Inspection, and Closure Report
 Empire St. SWD 15 #1
 API No. 30-015-39771
 GPS: Latitude 32.8343163 Longitude -104.06665
 UL "K", Sec. 15, T17S, R29E
 Eddy County, NM
 NMOCD Ref. No. NAPP2229845741**

Paragon Environmental, LLC (Paragon) has been contracted by Spur Energy Partners (Spur) to perform a site assessment, conduct a liner inspection, and write a closure report for the release site known as the Empire St. SWD 15 #1 (Empire). Details of the release are summarized below:

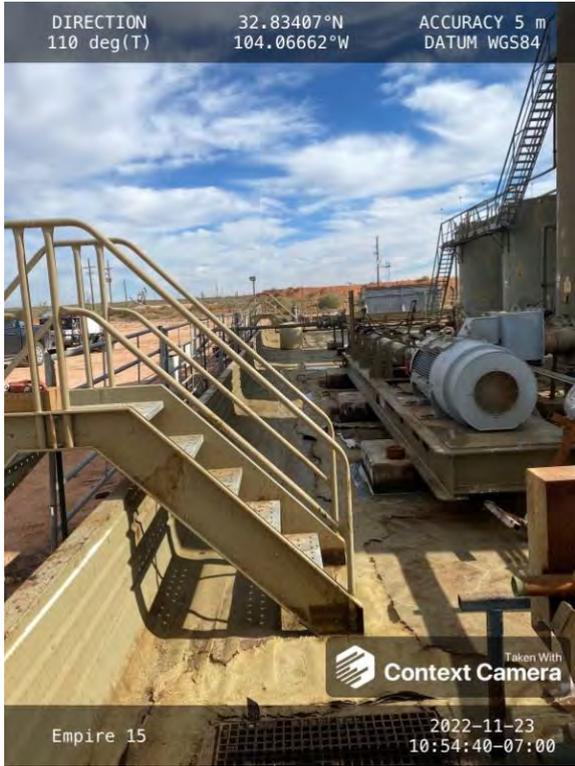
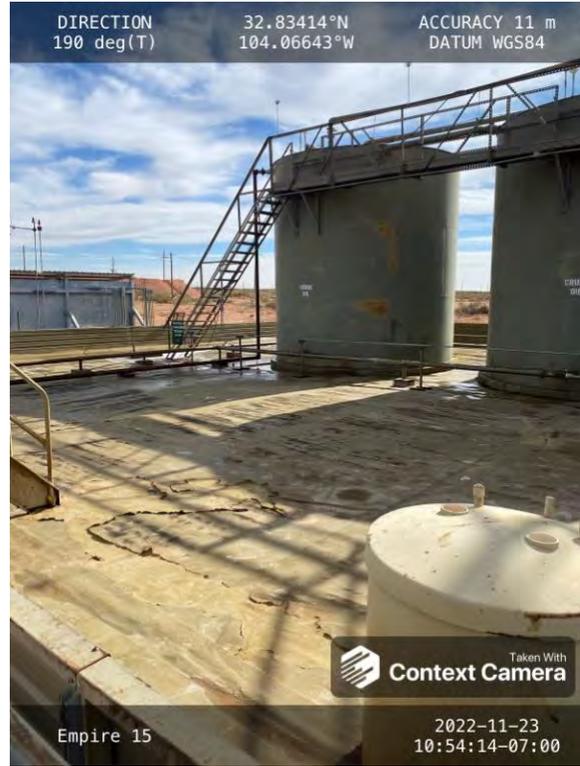
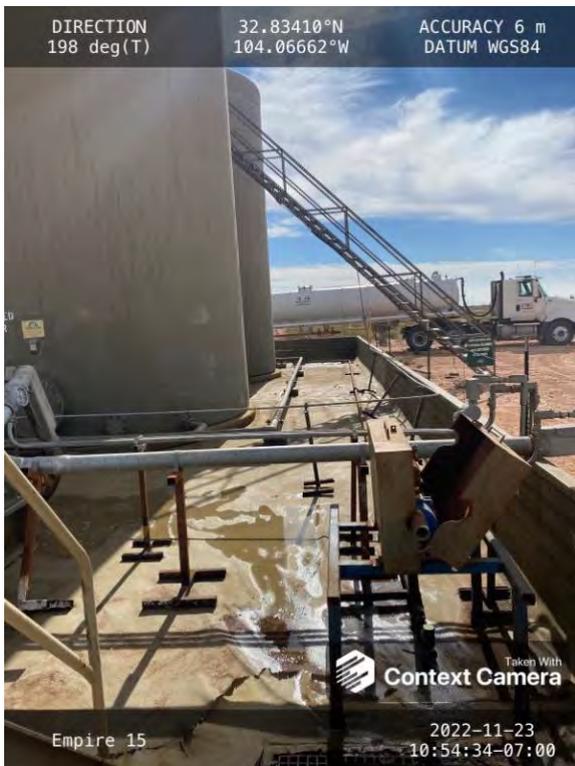
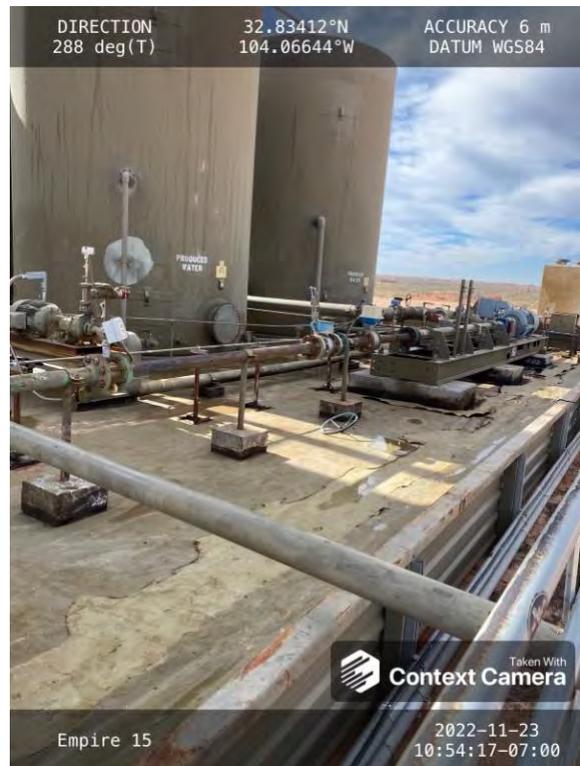
Liner Inspection Photos

During the Liner Inspection, it was determined that it had the integrity to hold fluids. A copy of the liner inspection can be found in Appendix D.

Visualization	Yes	No	Comments
Is there a tear in the liner?		X	
Are there holes in the liner?		X	
Is the liner retaining any fluids?		X	
Does the liner have integrity to contain a leak?	X

On October 24, 2022, Spur mobilized a vacuum truck to recover the produced water. After cleaning the liner and performing the inspection, it was determined that no further remediation was needed.
