Date: April 18, 2023  
Subject: Soil Remediation Work Plan/Variance Request  
Old Indian Draw Gathering Line Northern Area  
Incident# NCLB0525655219  
Eddy County, New Mexico

MCBU  
OLD INDIAN DRAW ~ GATHERING LINE NORTH  
INCIDENT NUMBER: NCLB0525655219  
EDDY COUNTY, NEW MEXICO

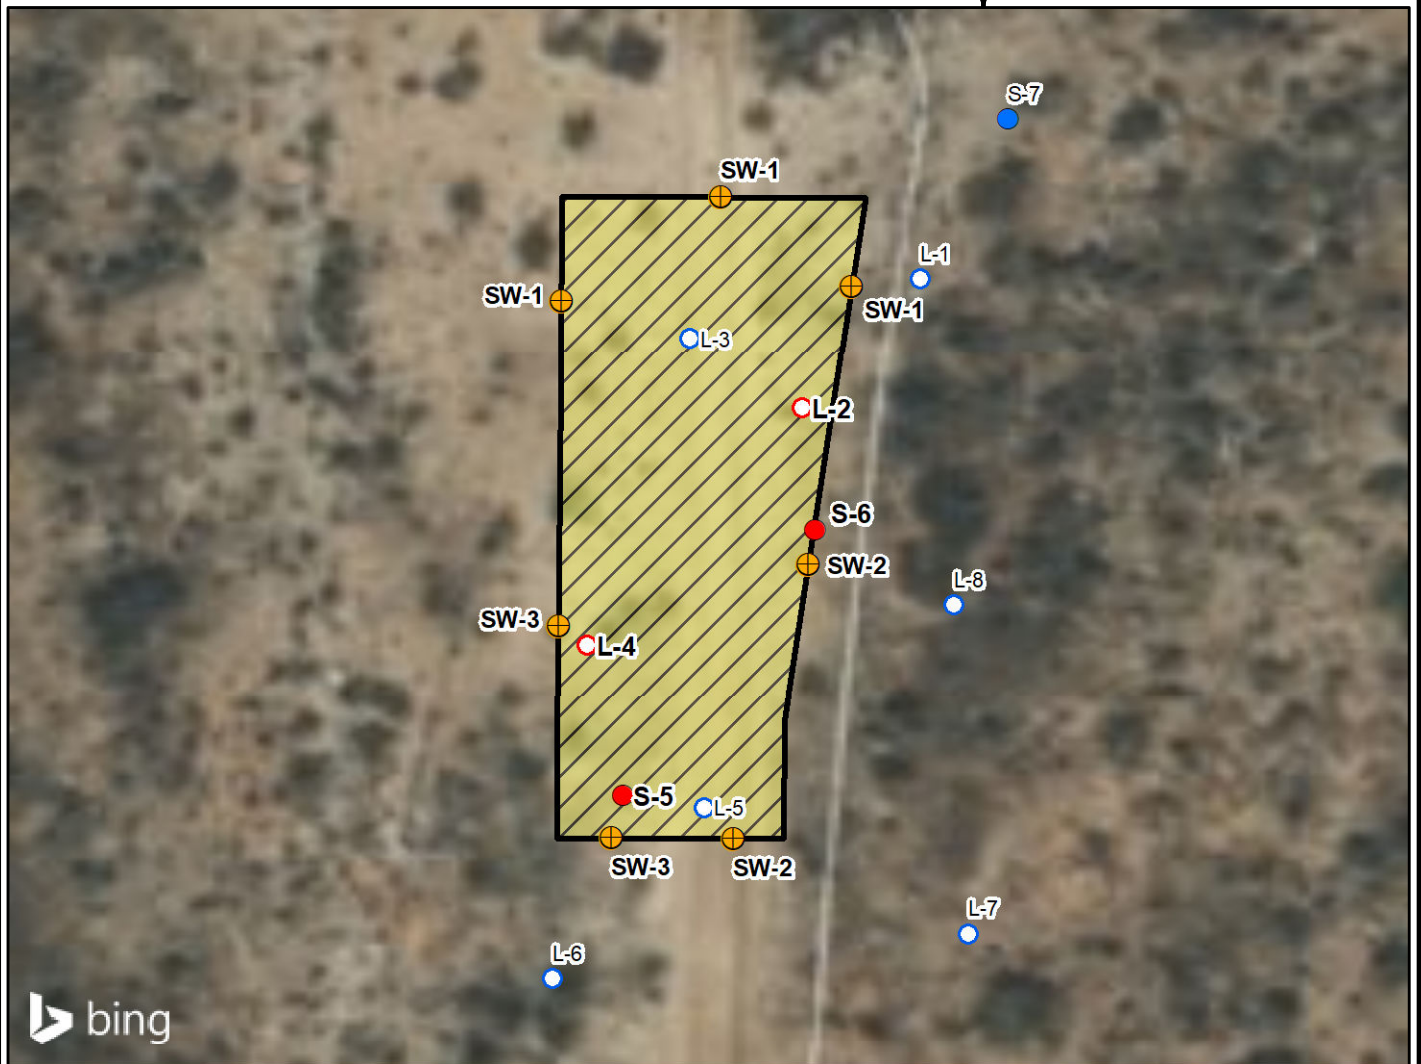
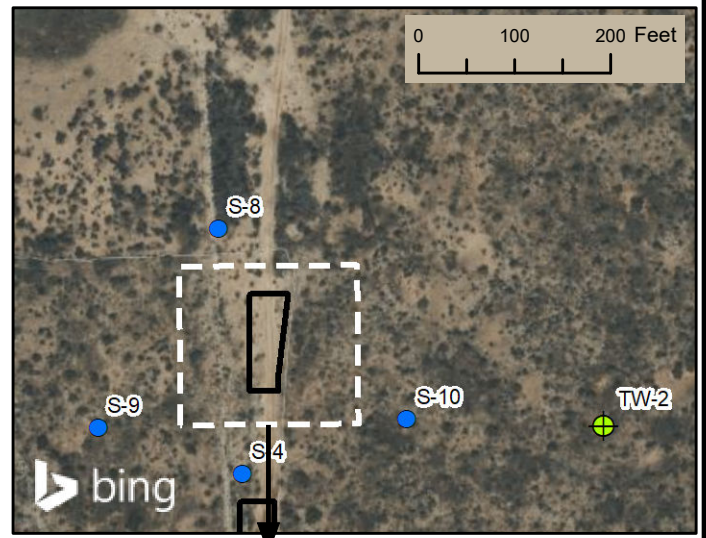
FIGURE  
**2**

- All sidewall composite confirmation soil samples were reported below the applicable NMOCD closure criteria stipulated in Table I of part 19.15.29.12 for a site with depth to groundwater less than 50 feet bgs for chloride, Total TPH, BTEX, and benzene.
- 11 of the 21 base composite confirmation soil samples were reported below the applicable NMOCD closure criteria for chloride. Reported chloride concentrations above the applicable NMAC closure criteria of 600 mg/kg ranged from 671 mg/kg in soil sample B-20 up to 2,210 mg/kg in soil sample B-21. No base composite confirmation soil samples were reported above the applicable NMOCD closure criteria for a site with depth to groundwater less than 50 feet bgs for Total TPH, BTEX, or benzene.

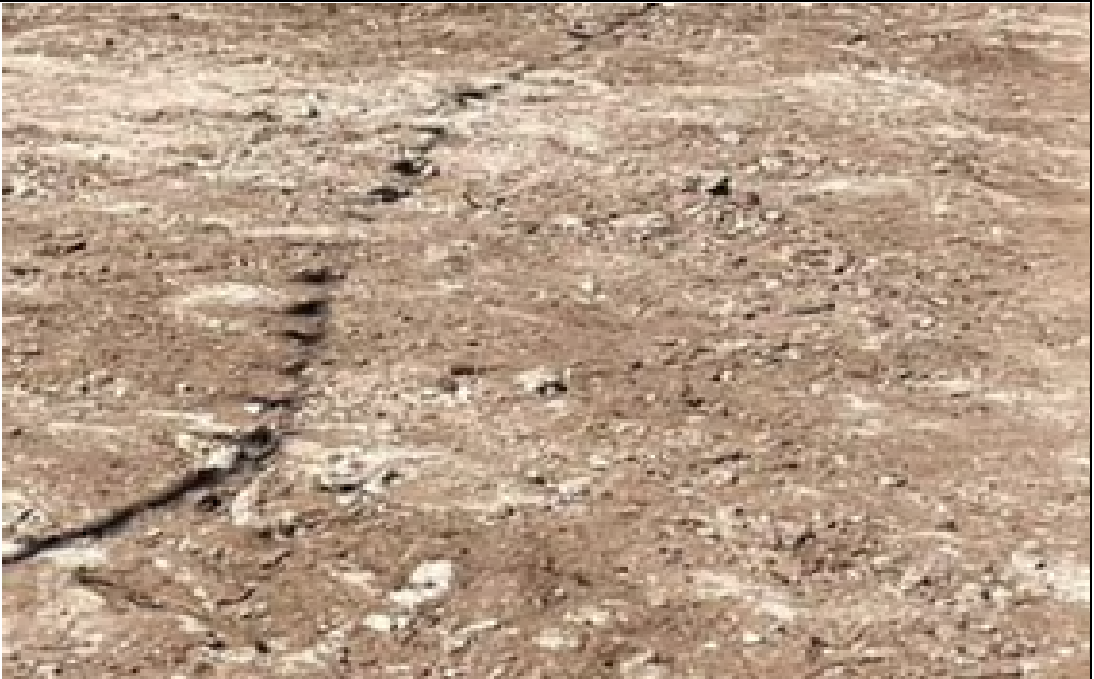
ARCADIS		PHOTOGRAPHIC LOG	
<b>Property Name:</b> Old Indian Draw Gathering Line Northern Area		<b>Location:</b> Eddy County, NM	<b>Case No.</b> NCLB0525655219
<b>Photo No.</b> 1	<b>Date:</b> 02/23/2023

On March 8, 2023, Arcadis began excavation activities within the impacted area assuming the most stringent NMOCD closure criteria for soil. A resilient calcrete rock layer was encountered across the release area at depths of approximately 1-foot bgs to 2.5 feet bgs. Repeated attempts to break through the resilient calcrete rock layer utilizing an excavator equipped with a trenching bucket and "rock teeth" yielded limited results.

<b>Direction Photo Taken:</b> Facing N			
<b>Description:</b> View calcrete rock layer within the release area.

- Due to the resilient calcrete rock layer encountered at shallow depths across the release area, Arcadis is requesting a variance to limit excavation activities to include only removing impacted soil affected above the NMOCD Reclamation Standards present within the release area to the maximum extent practicable (to the surface of the calcrete layer).

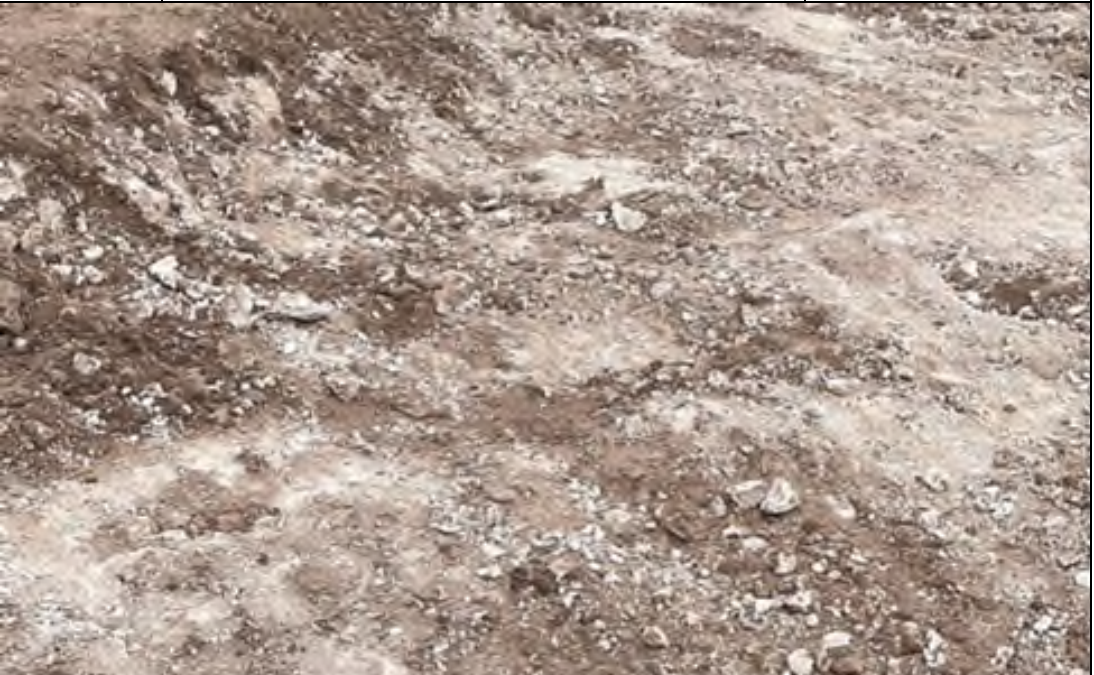
ARCADIS		PHOTOGRAPHIC LOG	
<b>Property Name:</b> Old Indian Draw Gathering Line Northern Area		<b>Location:</b> Eddy County, NM	<b>Case No.</b> NCLB0525655219
<b>Photo No.</b> 2	<b>Date:</b> 02/23/2023

<b>Direction Photo Taken:</b> Facing NW			
<b>Description:</b> Additional view of calcrete rock layer.

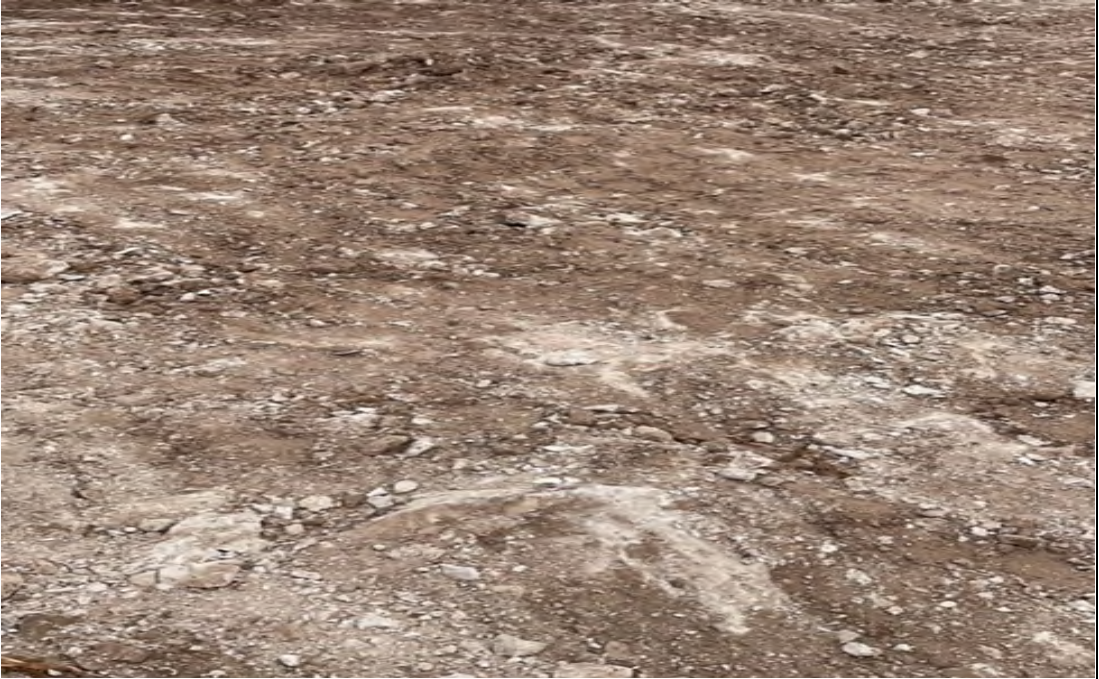
ARCADIS		PHOTOGRAPHIC LOG	
<b>Property Name:</b> Old Indian Draw Gathering Line Northern Area		<b>Location:</b> Eddy County, NM	<b>Case No.</b> NCLB0525655219
<b>Photo No.</b> 3	<b>Date:</b> 02/23/2023

<b>Direction Photo Taken:</b>  N			
<b>Description:</b>  Solid rock layer in release area around 1 feet bgs.

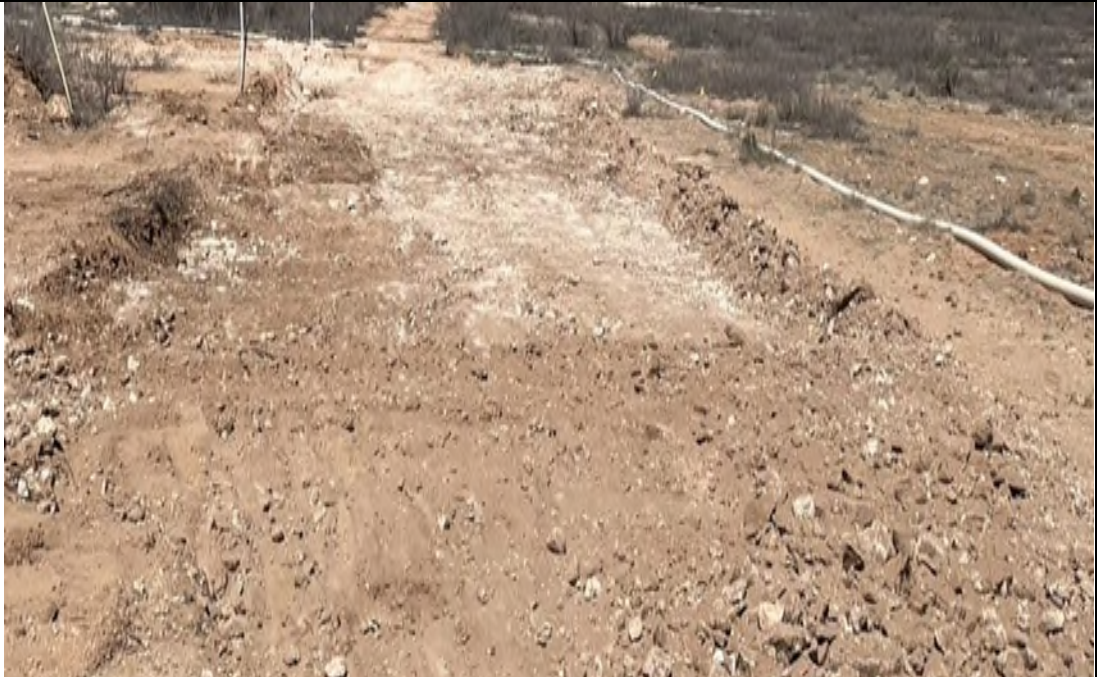
ARCADIS		PHOTOGRAPHIC LOG	
<b>Property Name:</b> Old Indian Draw Gathering Line Northern Area		<b>Location:</b> Eddy County, NM	<b>Case No.</b> NCLB0525655219
<b>Photo No.</b> 4	<b>Date:</b> 02/23/2023

<b>Direction Photo Taken:</b>  N			
<b>Description:</b>  Area excavated to solid rock layer at 1 to 2 feet bgs.
