Re: 2022 Annual Groundwater Monitoring Report

Florance M #047X
San Juan County, New Mexico
Harvest Four Corners, LLC
NMOCD Incident No: nAUTOfAB000185
Remediation Permit Number: 3RP-317-0

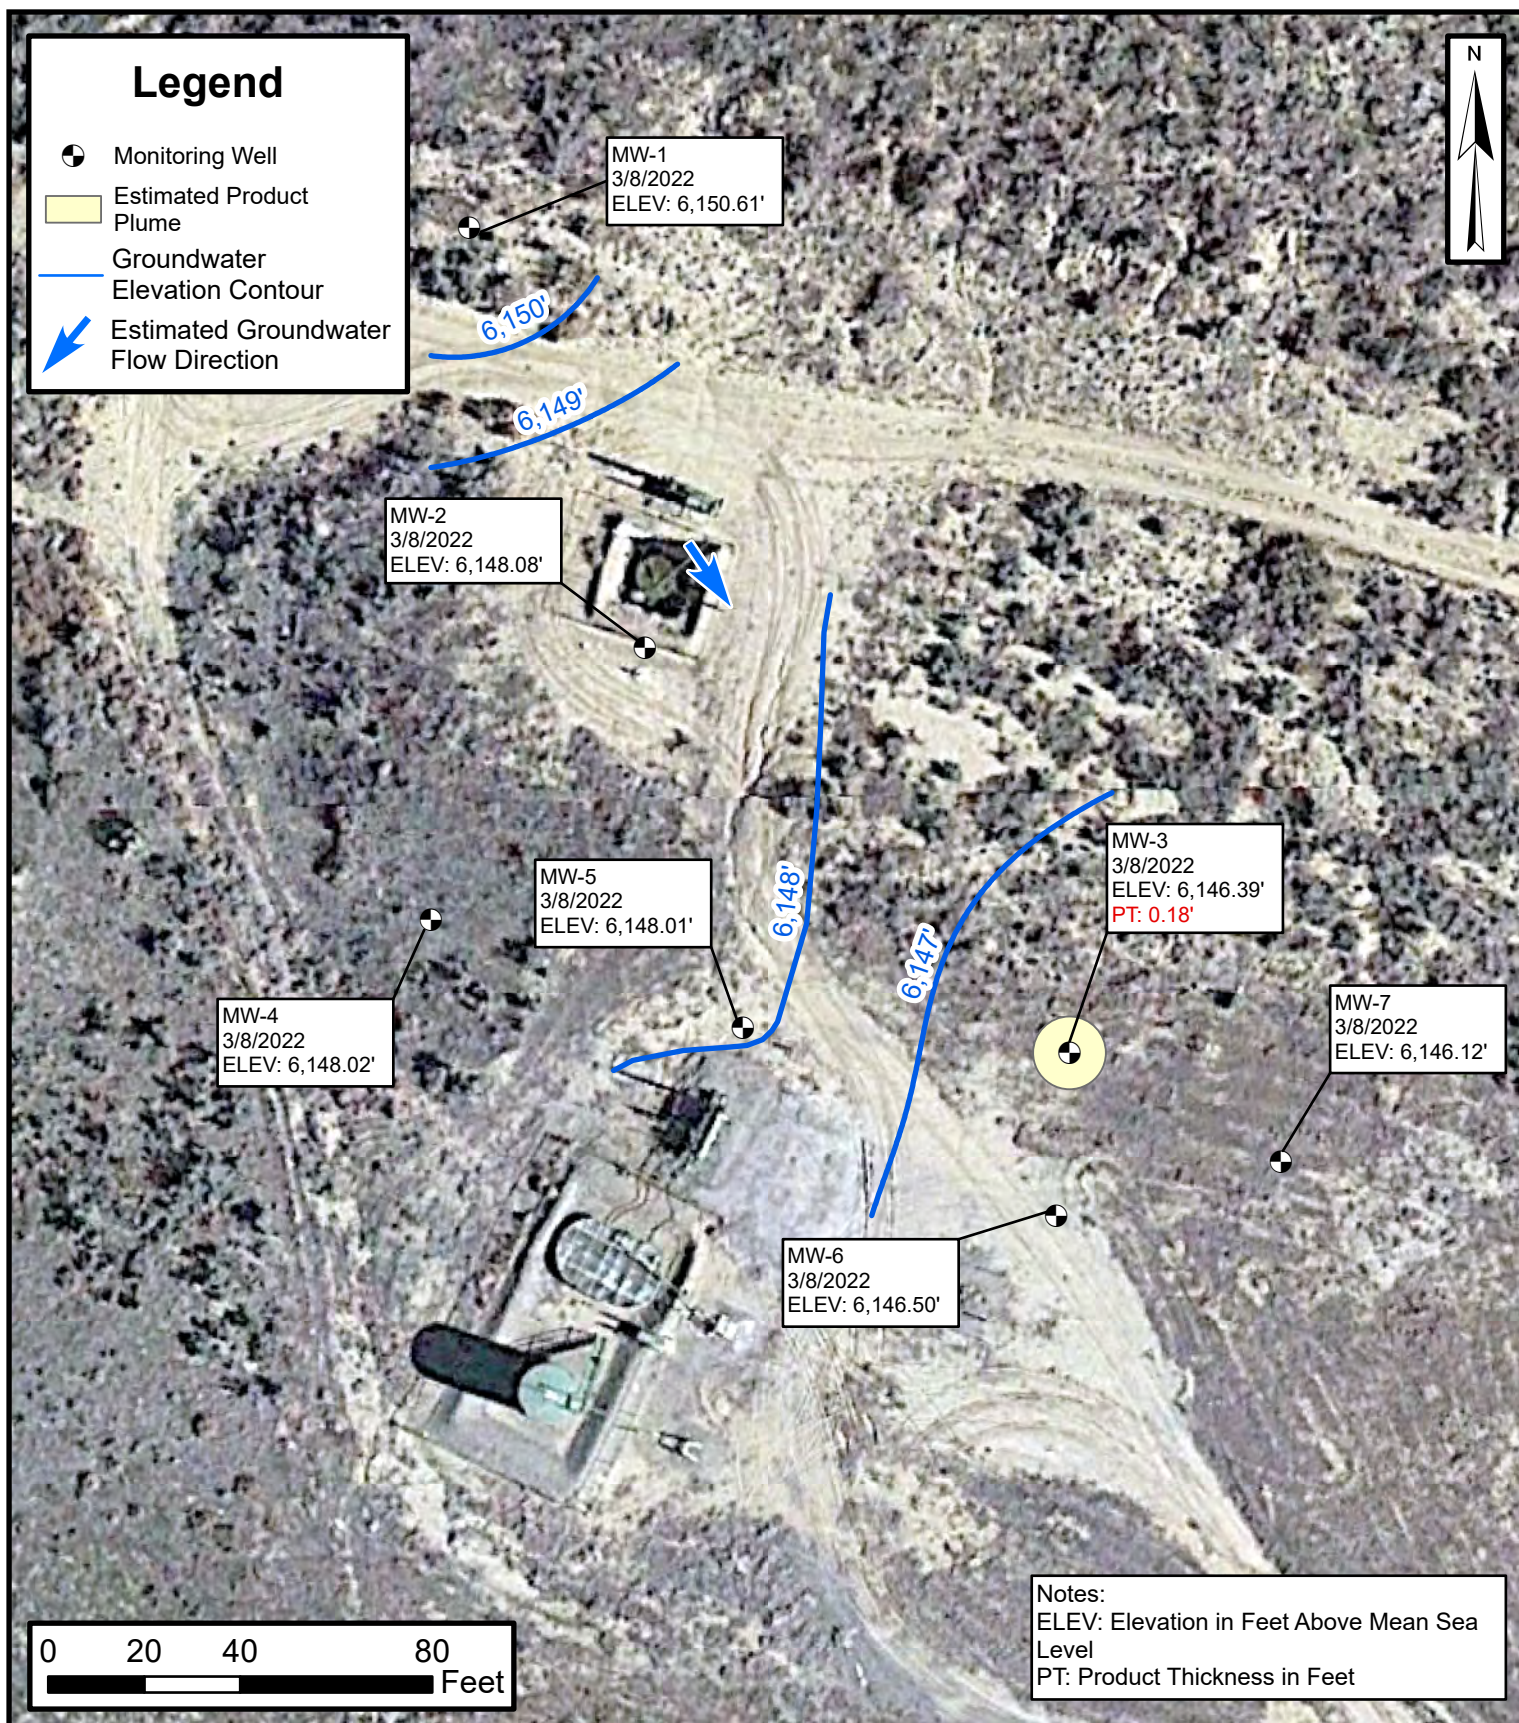
FIGURE
2

Depth to groundwater was collected on March 8, 2022, May 23, 2022, September 12, 2022, and November 7, 2022. Based on data collected during the four quarterly events, the interpreted groundwater-flow direction is to the southeast (contours shown on Figures 2 through 5). Contours were inferred based on groundwater elevations and physical characteristics at the Site (topography, proximity to irrigation ditches, etc.).

Groundwater Elevation (March 2022)

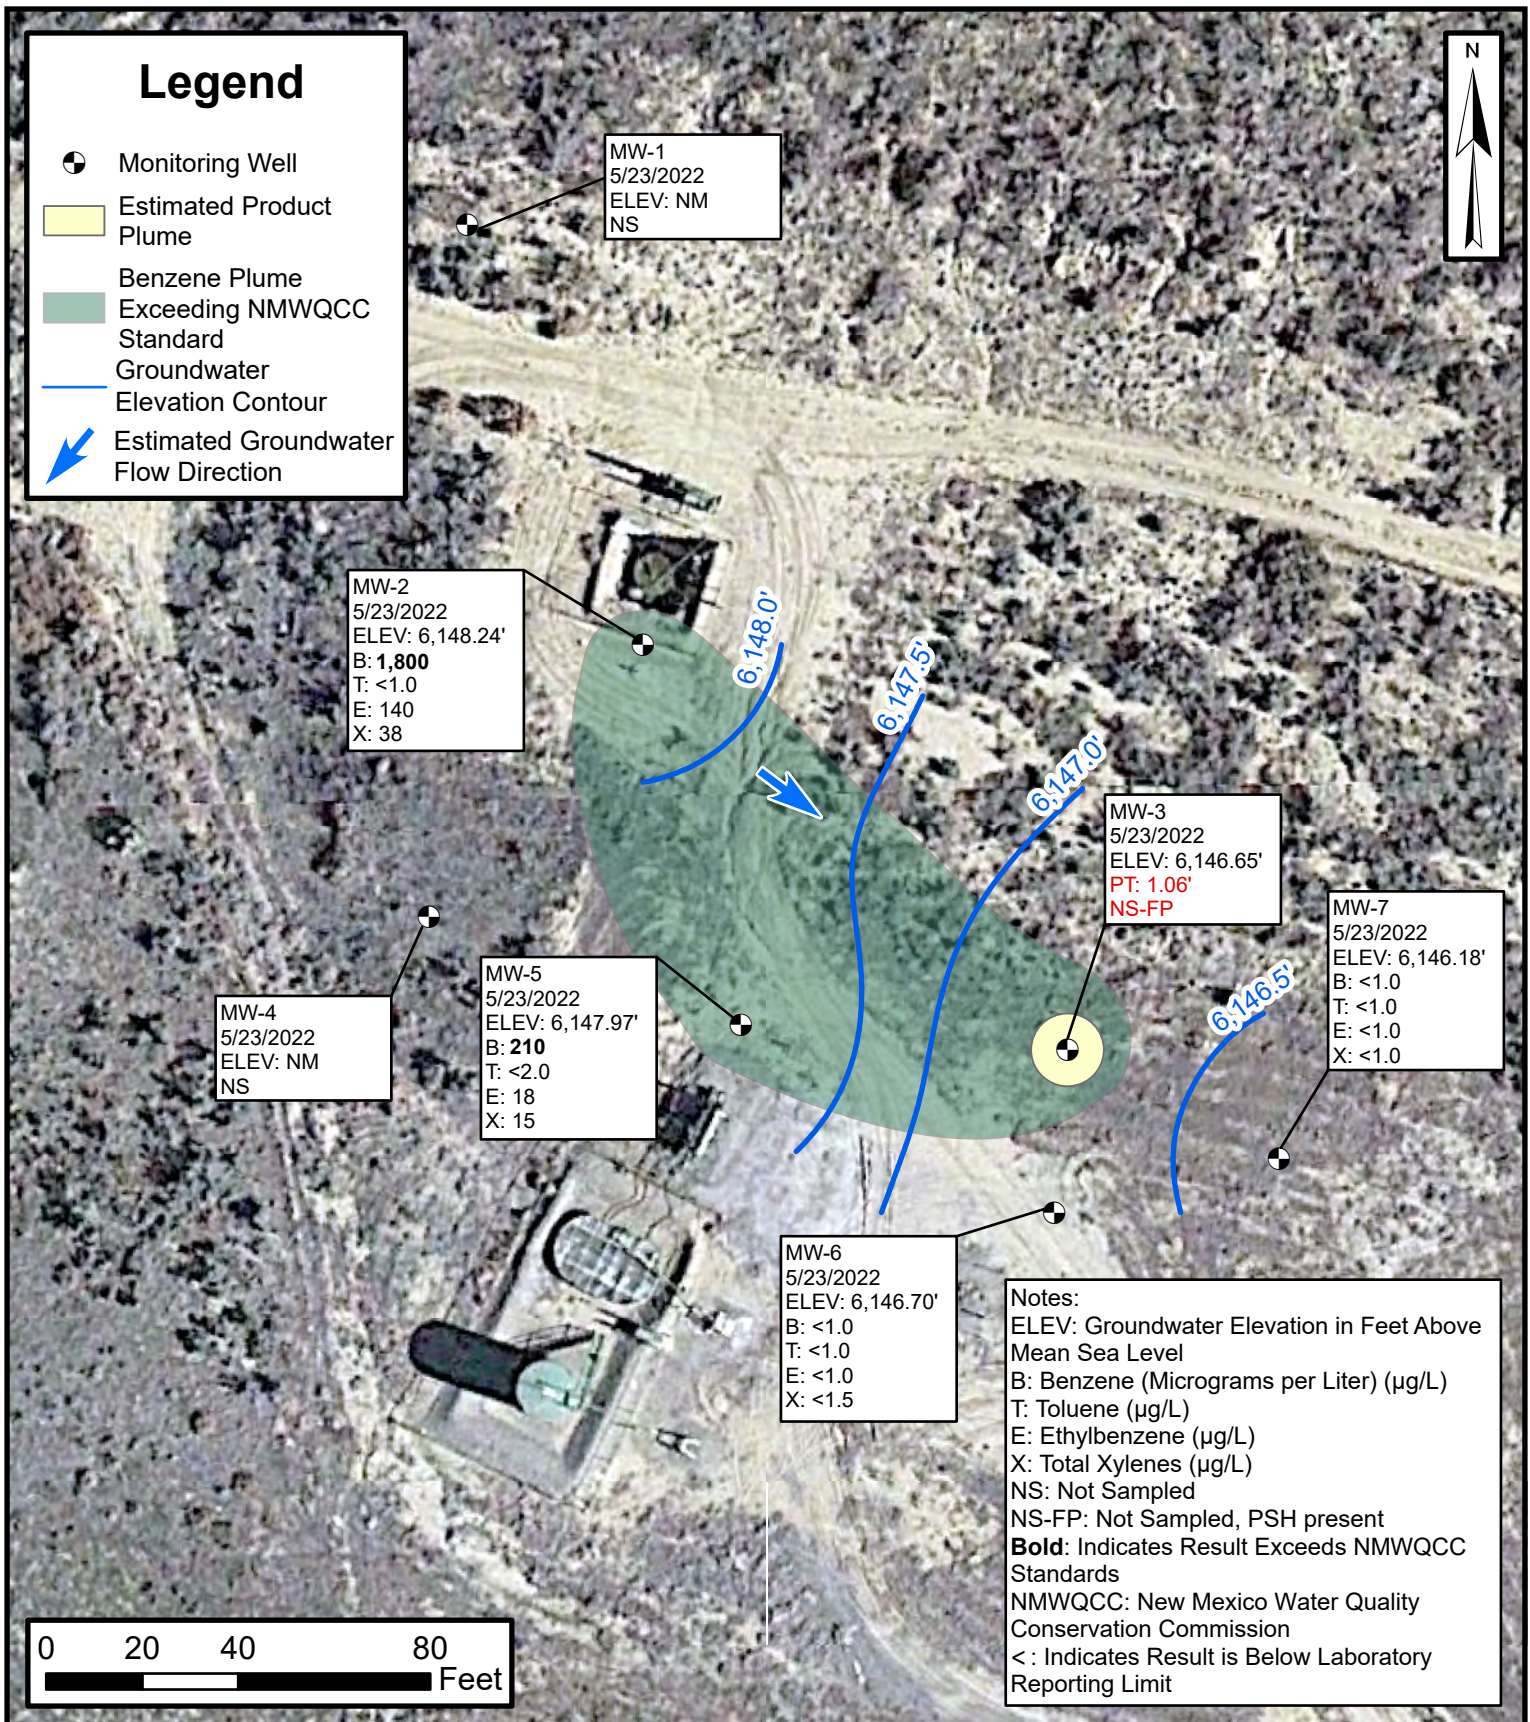
FIGURE
3

All wells on Site, except for MW-1, MW-3, and MW-4, were sampled on May 23, 2022. BTEX constituents in groundwater were detected in monitoring wells MW-2 and MW-5. Groundwater from wells MW-2 and MW-5 contained benzene concentrations of 1,800 µg/L and 210 µg/L, respectively, which exceeds the NMWQCC standards. Monitoring wells MW-6 and MW-7 did not contain detectable concentrations of BTEX compounds in groundwater and were compliant with the NMWQCC standards. BTEX results and approximate plume extent are presented on Figure 3 and summarized in Table 2.

Groundwater Elevation and Analytical Results (May 2022)

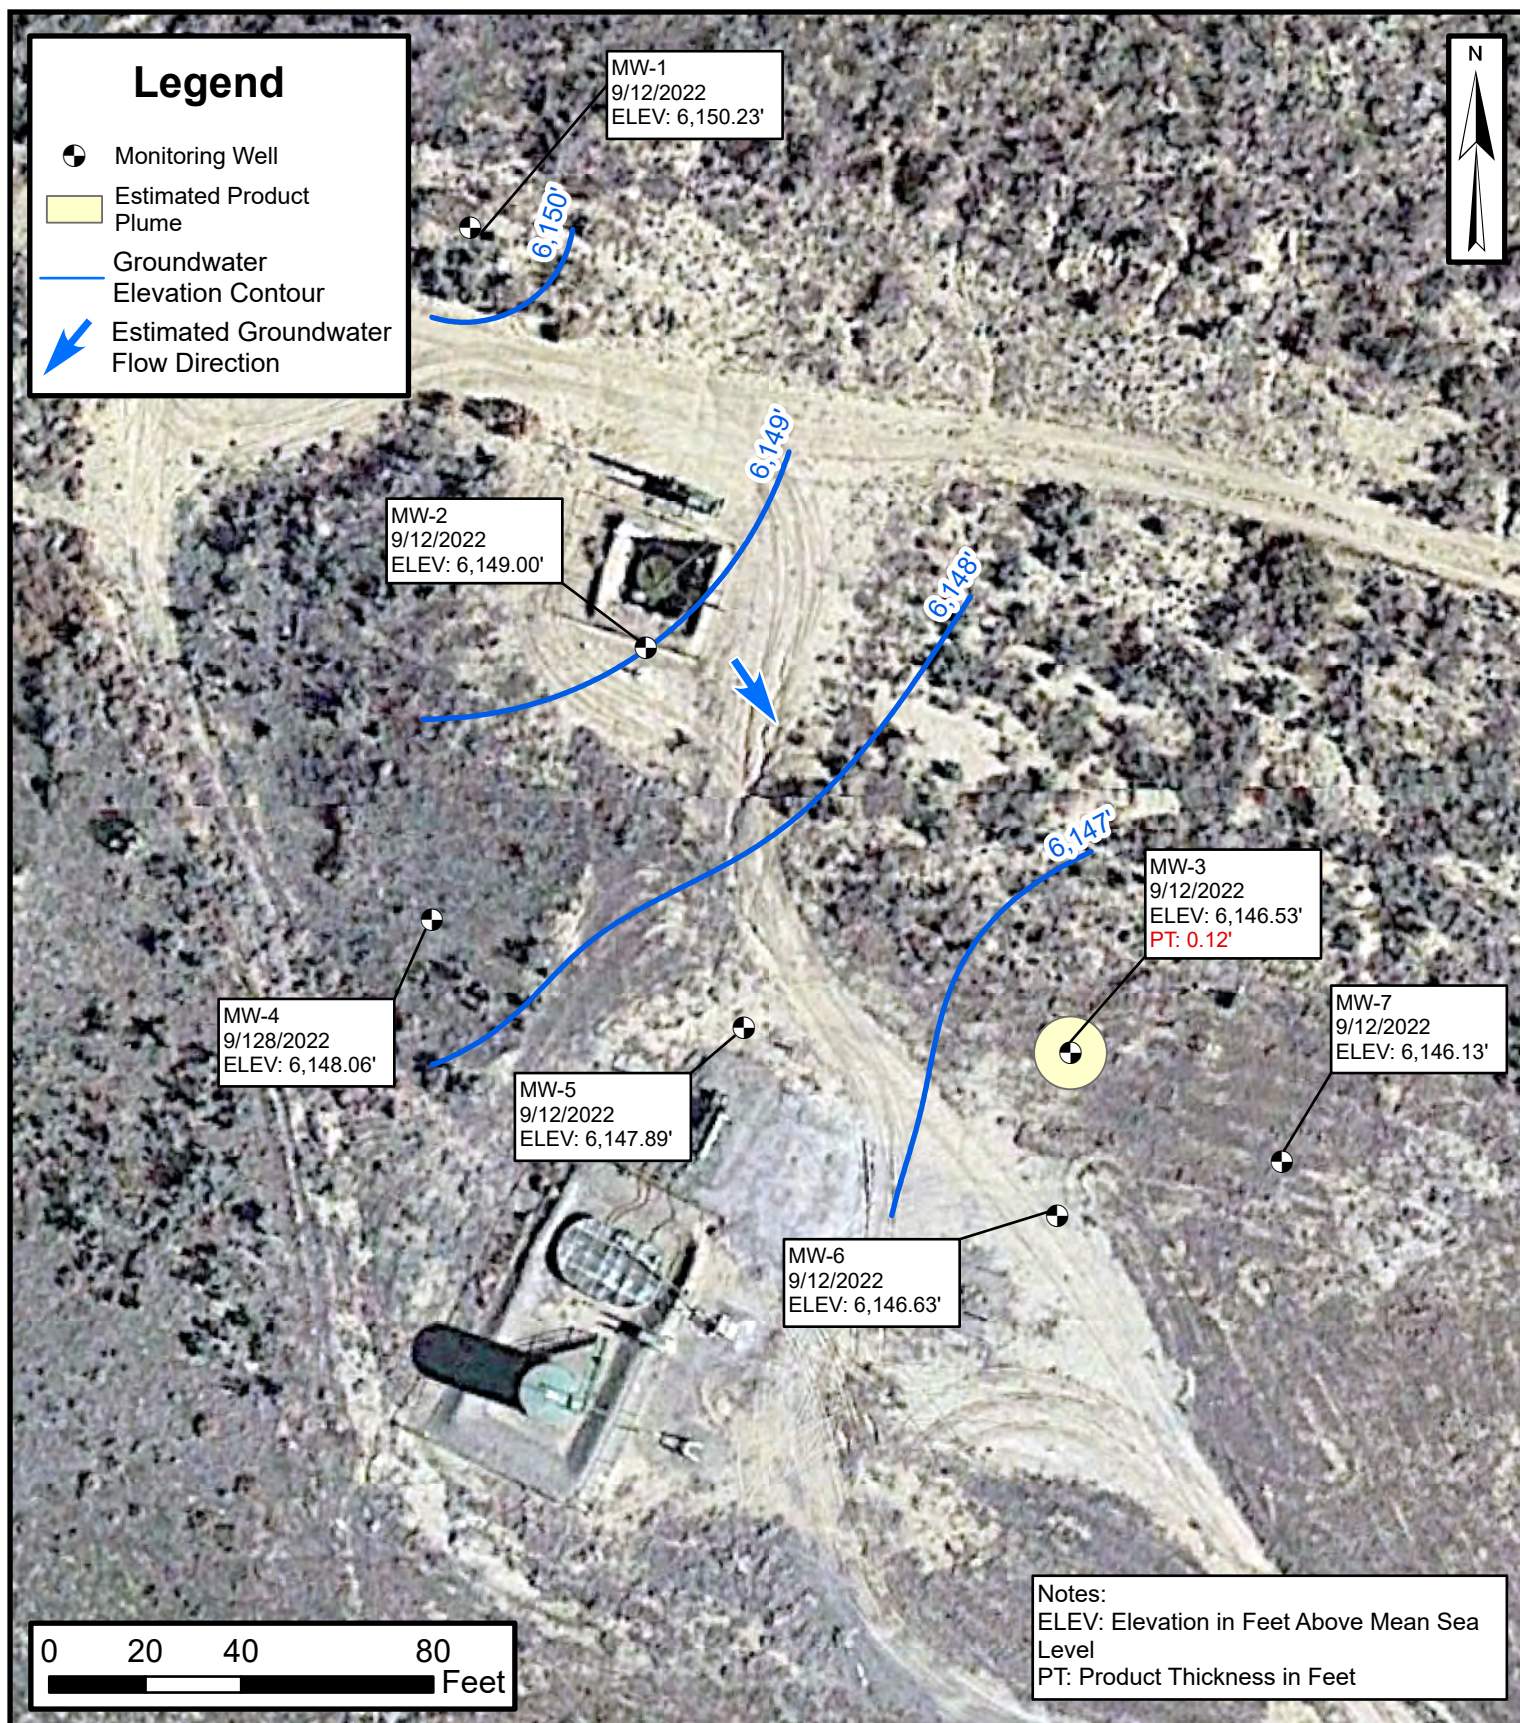
FIGURE
4

Groundwater Elevation (September 2022)

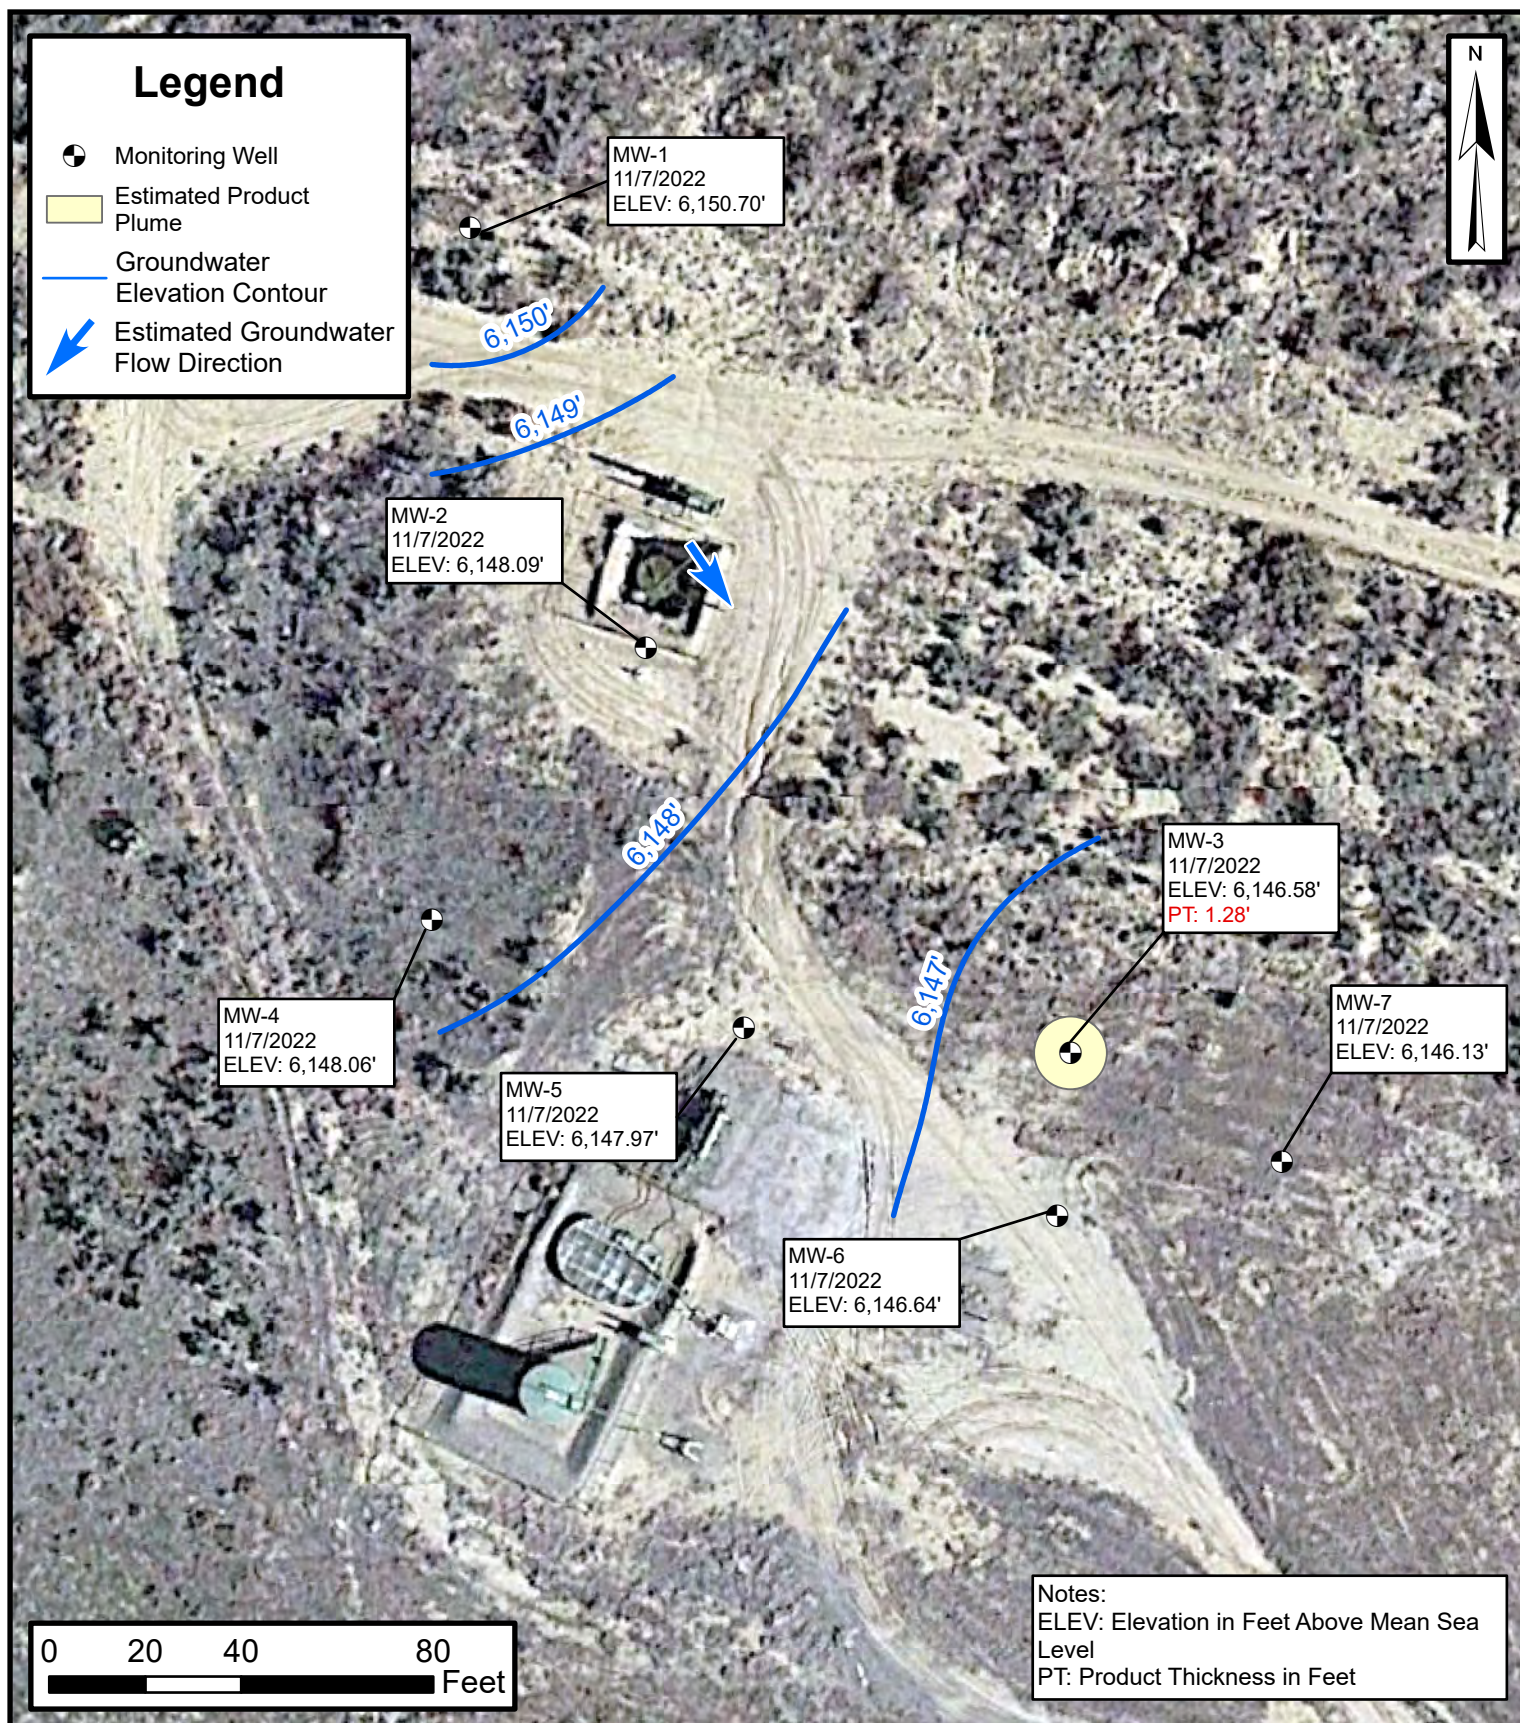
FIGURE
5

Groundwater Elevation (November 2022)
