# **LINER INSPECTION AND CLOSURE REPORT**

## **REPORTABLE RELEASE**

**Spur Energy Partners**  
Halberd 27 St Com 1H Battery  
Incident ID: nAPP2236235169  
Eddy County, NM

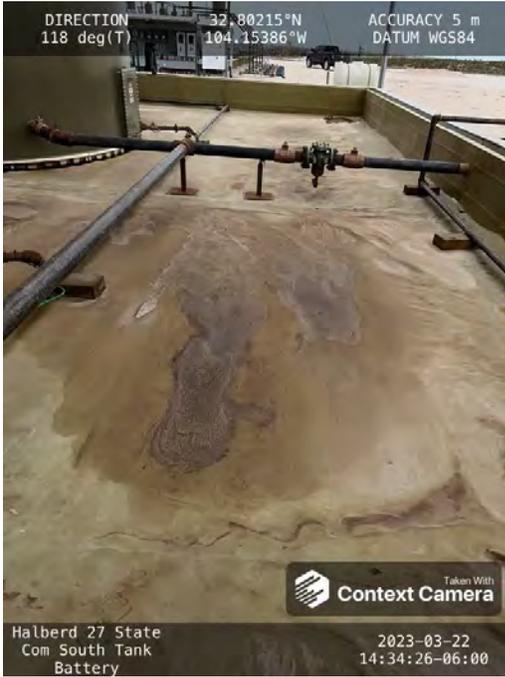
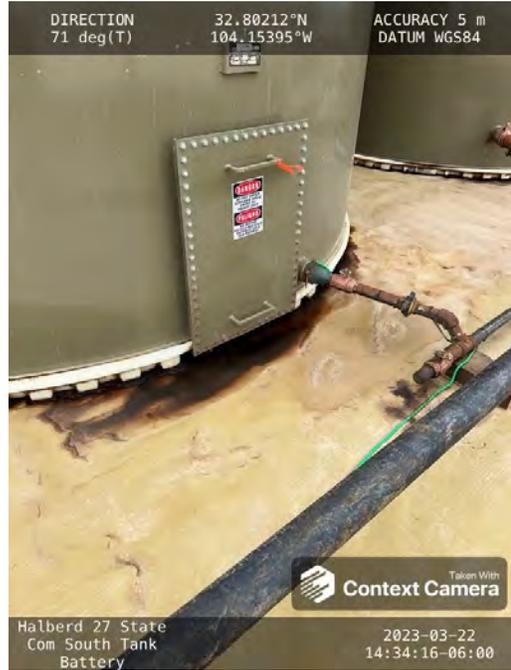
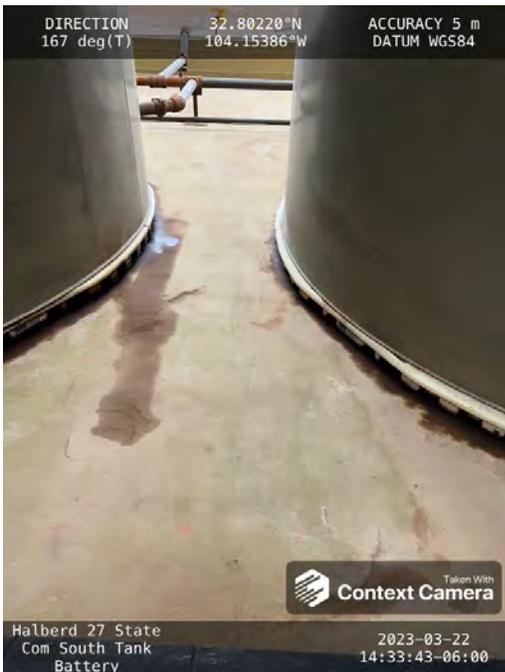
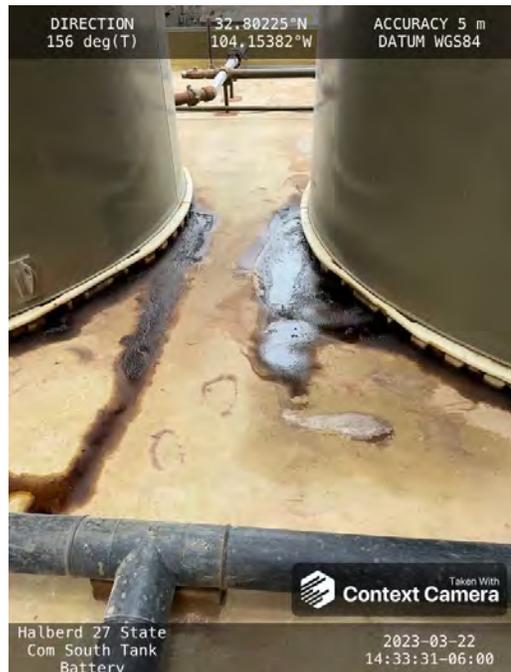
Before Remediation

On March 23, 2023, Paragon went to the Halberd 1H and conducted an initial assessment. There was obvious staining on the liner from the spill. There were no signs outside the containment that the liner had been breached. Therefore, no samples were taken.

On March 24, 2023, Paragon returned to the site with equipment and personnel to conduct cleanup activities. We initially sprayed the affected area with a degreaser. We then power washed and squeegeed the runoff to where the vacuum truck could capture the fluids.

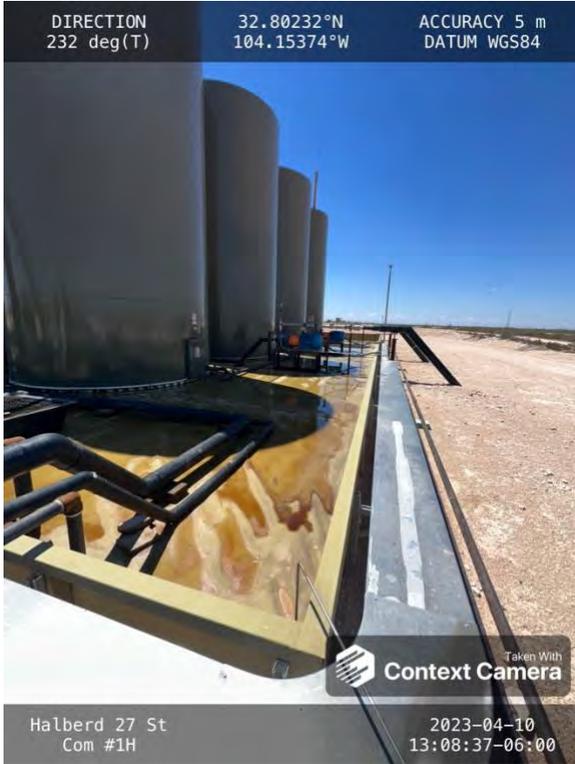
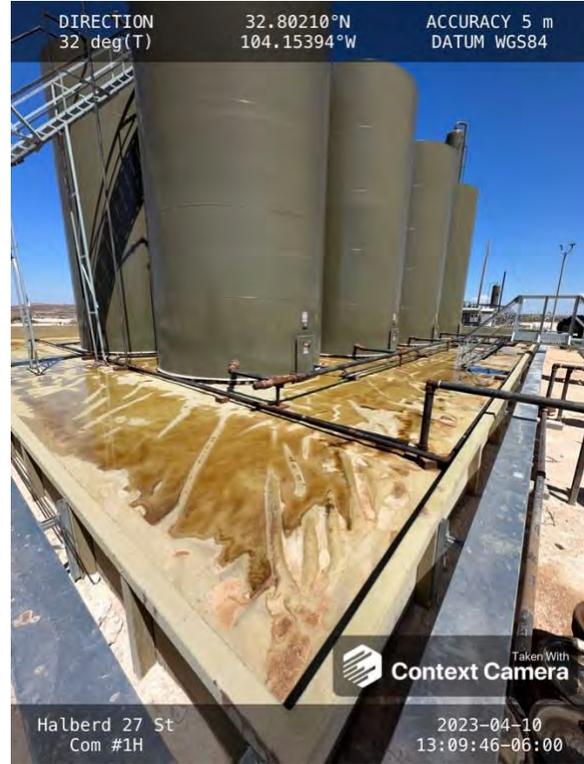
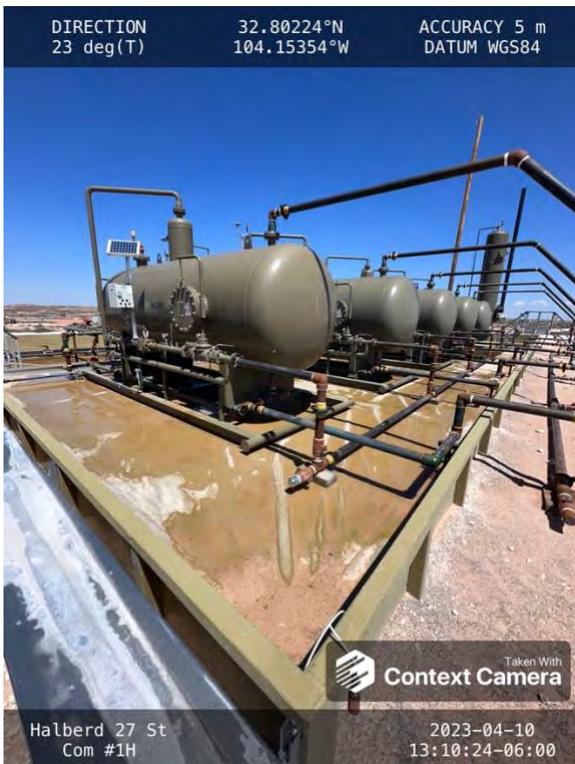
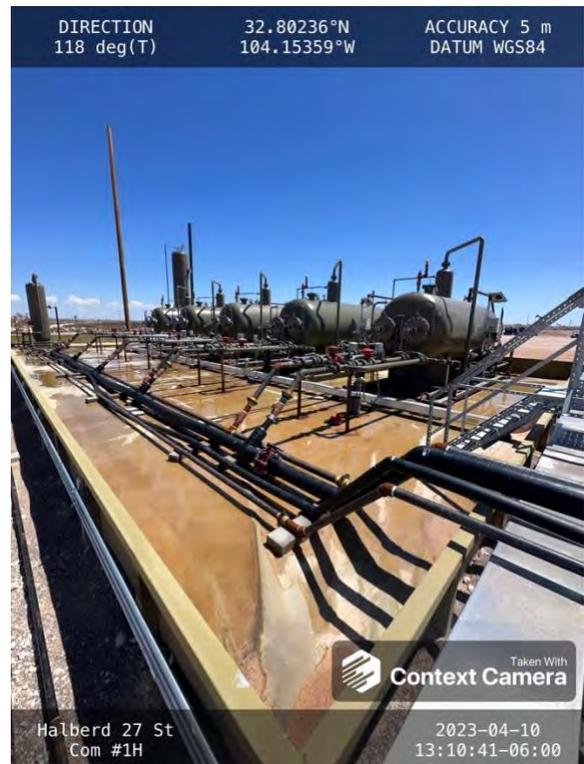
### Photographic Documentation Liner Inspection

On April 10, 2023, Paragon returned to the site to conduct a liner inspection. A 48-hour notification was sent out to the NMOCD on April 5, 2023. During the inspection a 3 inch tear was noticed in the NE corner. This tear was repaired using liner tape. This tear was not in the area that was affected by the release and therefore was not an area of concern for the purpose of this closure. The inspection concluded that the liner was intact and in good condition. The integrity of the liner appears to have the ability to contain spills. See Appendix D for the email notification and liner report.

Visualization	Yes	No	Comments
Is there a tear in the liner?	<input checked="" type="checkbox"/>	<input type="checkbox"/>	3" tear in NE corner of containment
Are there holes in the liner?	<input checked="" type="checkbox"/>	<input type="checkbox"/>	✓      ✓      ✓
Is the liner retaining any fluids?	<input checked="" type="checkbox"/>	<input type="checkbox"/>	Rain water
Does the liner have integrity to contain a leak?	<input checked="" type="checkbox"/>	<input type="checkbox"/>
