**Closure Report  
Bongo Fee 001H  
Eddy County, New Mexico  
Incident ID: NAPP2316653907  
Unit O Sec 13 T24S R27E  
32.2112°, -104.1423°**

**Produced Water Release  
Point of Release: Leak from Corroded Ball Valve  
Release Date: 06.04.2023  
Volume Released: 10.4683 barrels of Produced Water  
Volume Recovered: 10 barrels of Produced Water**

**Re: Closure Report**  
**Bongo Fee 001H (06.04.2023)**  
**Concho Operating, LLC**  
**Incident ID: NAPP2316653907**  
**Site Location: Unit O, S13, T24S, R27E**  
**(Lat 32.2112°, Long -104.1423°)**  
**Eddy County, New Mexico**

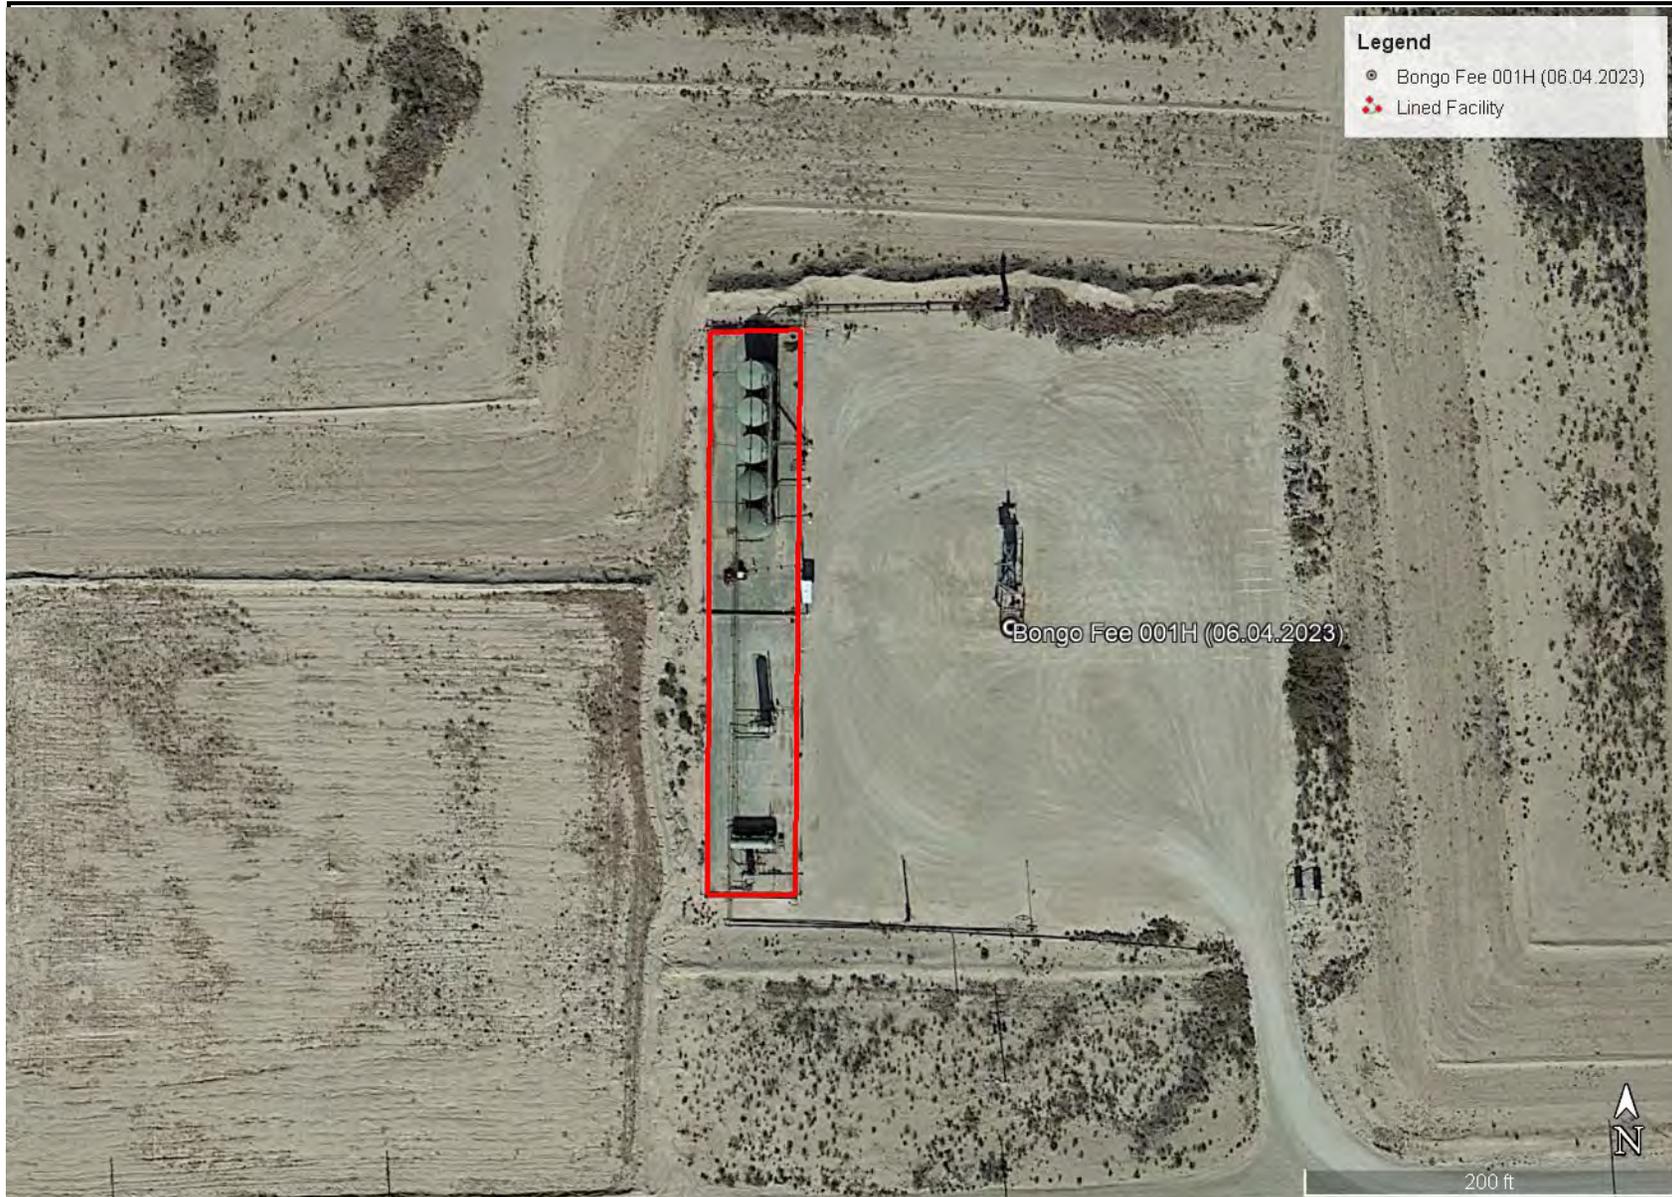
FIGURE 3

Based on the initial C-141 obtained from the New Mexico Oil Conservation Division (NMOCD), the release was discovered on June 4, 2023, caused by a corroded ball valve. It resulted in approximately ten point four-six-eight-three (10.4683) barrels of produced water being released and about ten (10) barrels of produced water being recovered. See Figure 3. The initial C-141 form is attached in Appendix B.

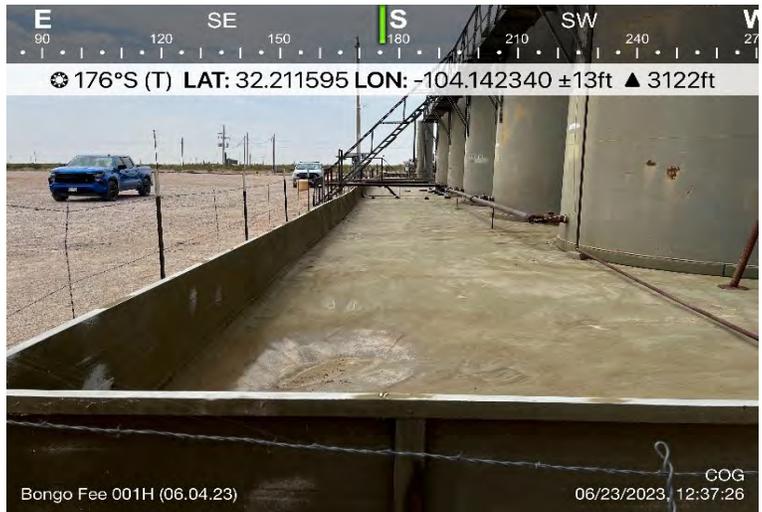
### Photograph No. 1

Resources, LLC personnel inspected the liner visually and determined it to be intact with no integrity issues. Refer to the Photolog.

**Description:**  
View South, area of the lined facility.

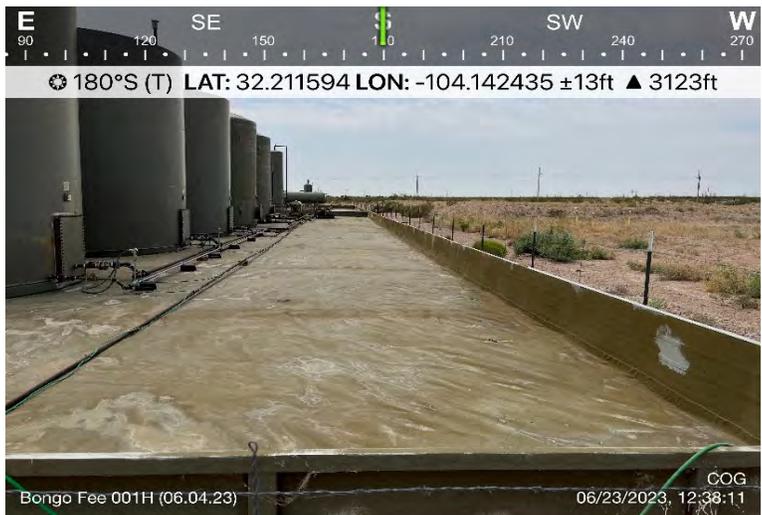
### Photograph No. 2

**Description:**  
View South, area of the lined facility.

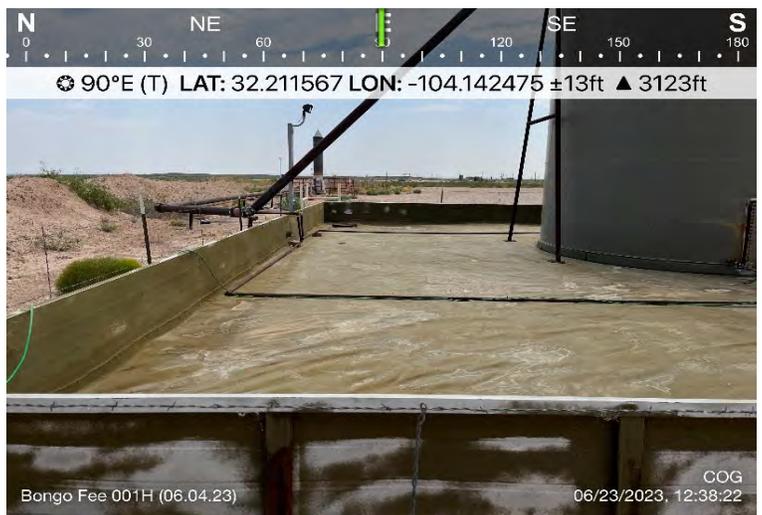
### Photograph No. 3

**Description:**  
View East, area of the lined facility.

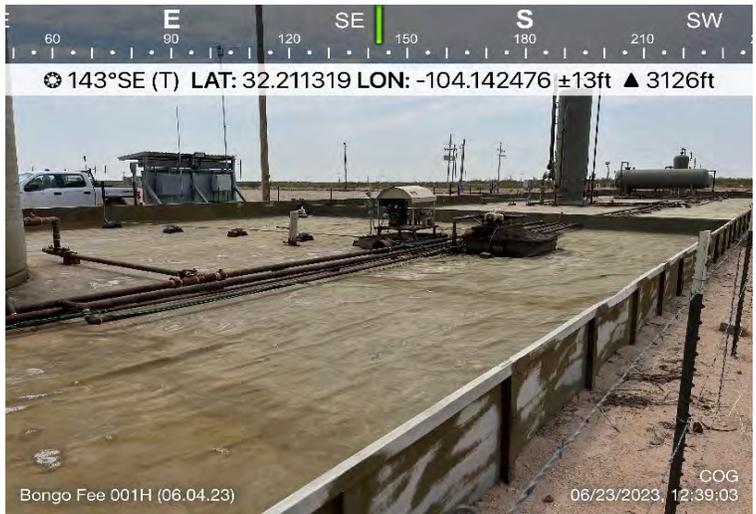
### Photograph No. 4

**Description:**  
View Southeast, area of the lined facility.

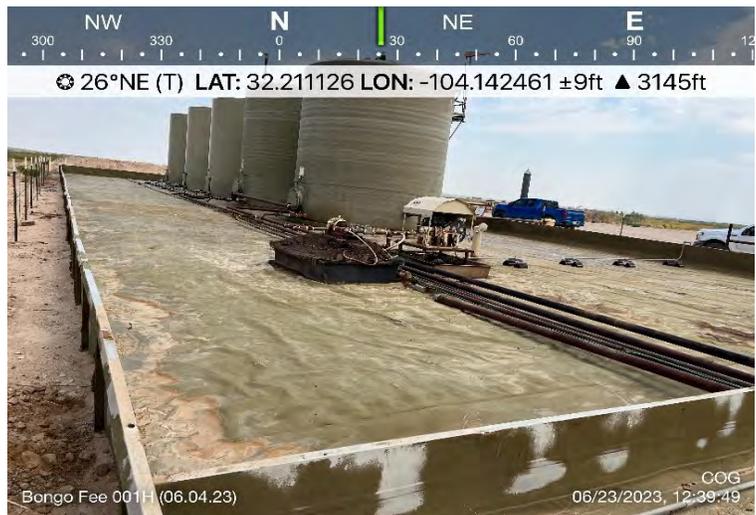
### Photograph No. 5

**Description:**  
View Northeast, area of the lined facility.

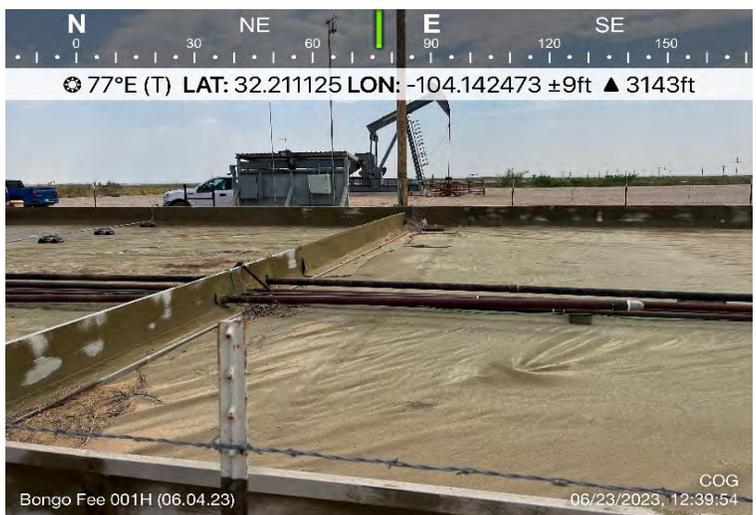
### Photograph No. 6

**Description:**  
View East, area of the lined facility.

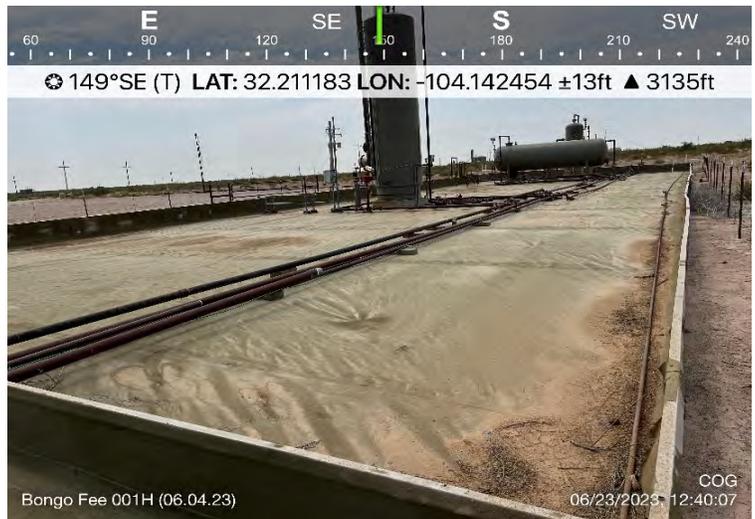
### Photograph No. 7

View Southeast, area of the lined facility.

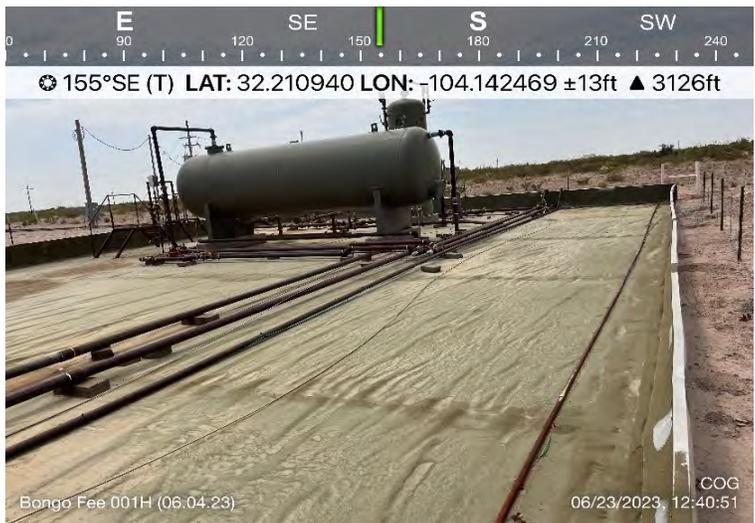
### Photograph No. 8

View Southeast, area of the lined facility.

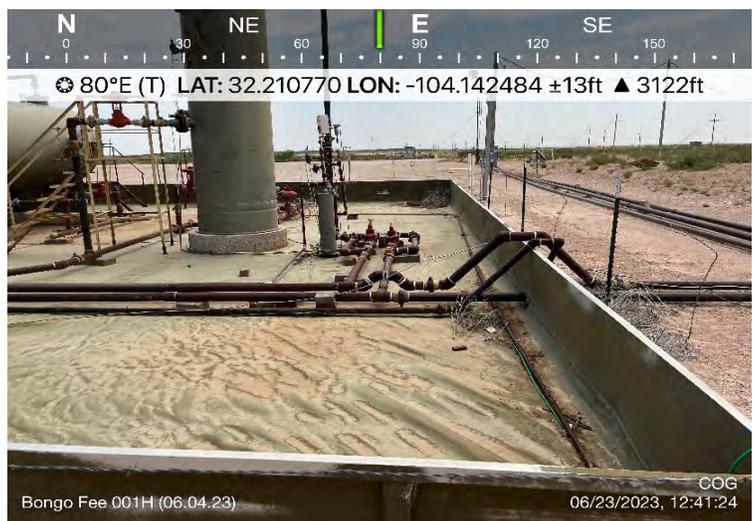
### Photograph No. 9

View East, area of the lined facility.

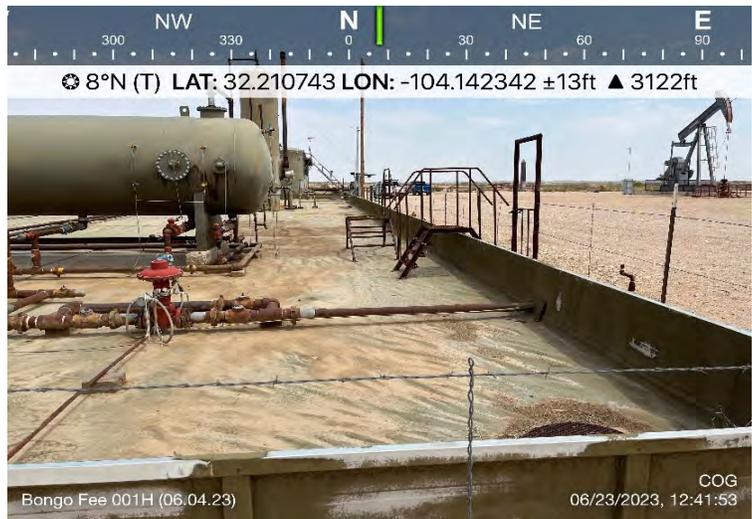
### Photograph No. 10

**Description:**  
View North, area of the lined facility.

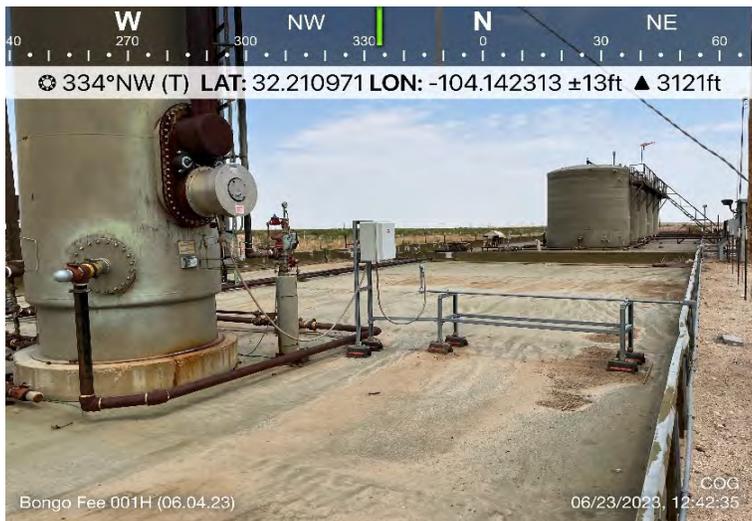
### Photograph No. 11

**Description:**  
View Northwest, area of the lined facility.

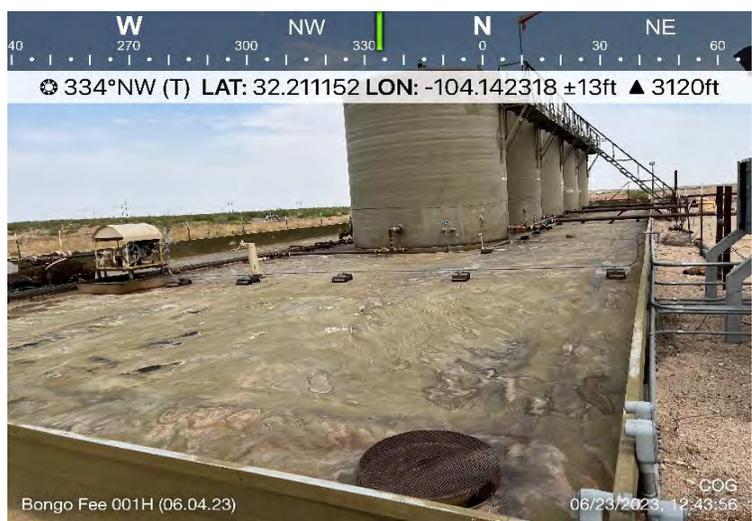
### Photograph No. 12

**Description:**  
View Northwest, area of the lined facility.

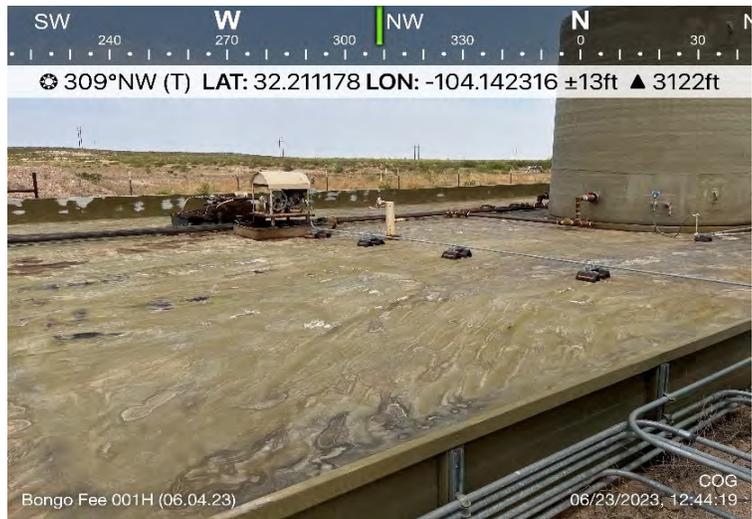
### Photograph No. 13

**Description:**  
View Northwest, area of the lined facility.

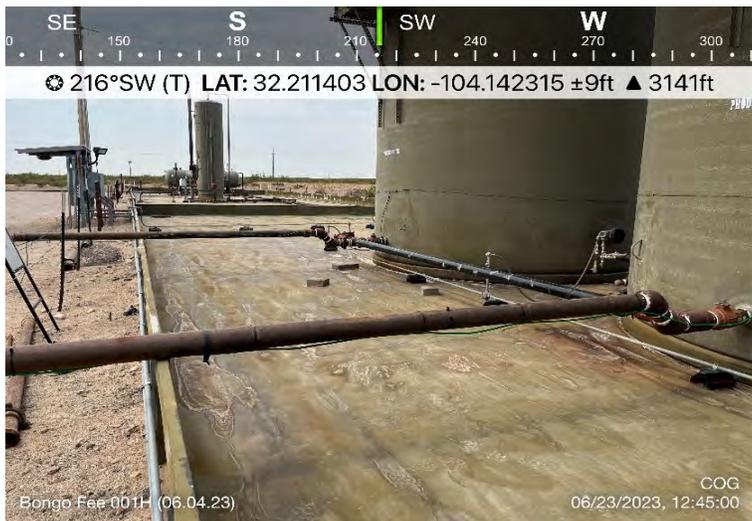
### Photograph No. 14

**Description:**  
View Southwest, area of the lined facility.

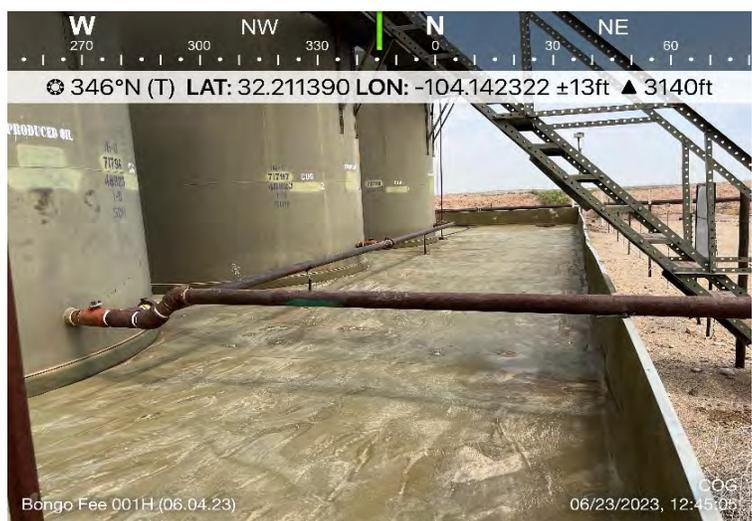
### Photograph No. 15

**Description:**  
View North, area of the lined facility.
