Incident ID	nAPP2331719355
District RP	
Facility ID	
Application ID

## Release Notification

Site Name L C Kelly 3G	Site Type Well
Date Release Discovered: 11/2/2023 @ 03:00 pm (MT)	API# 30-045-33237

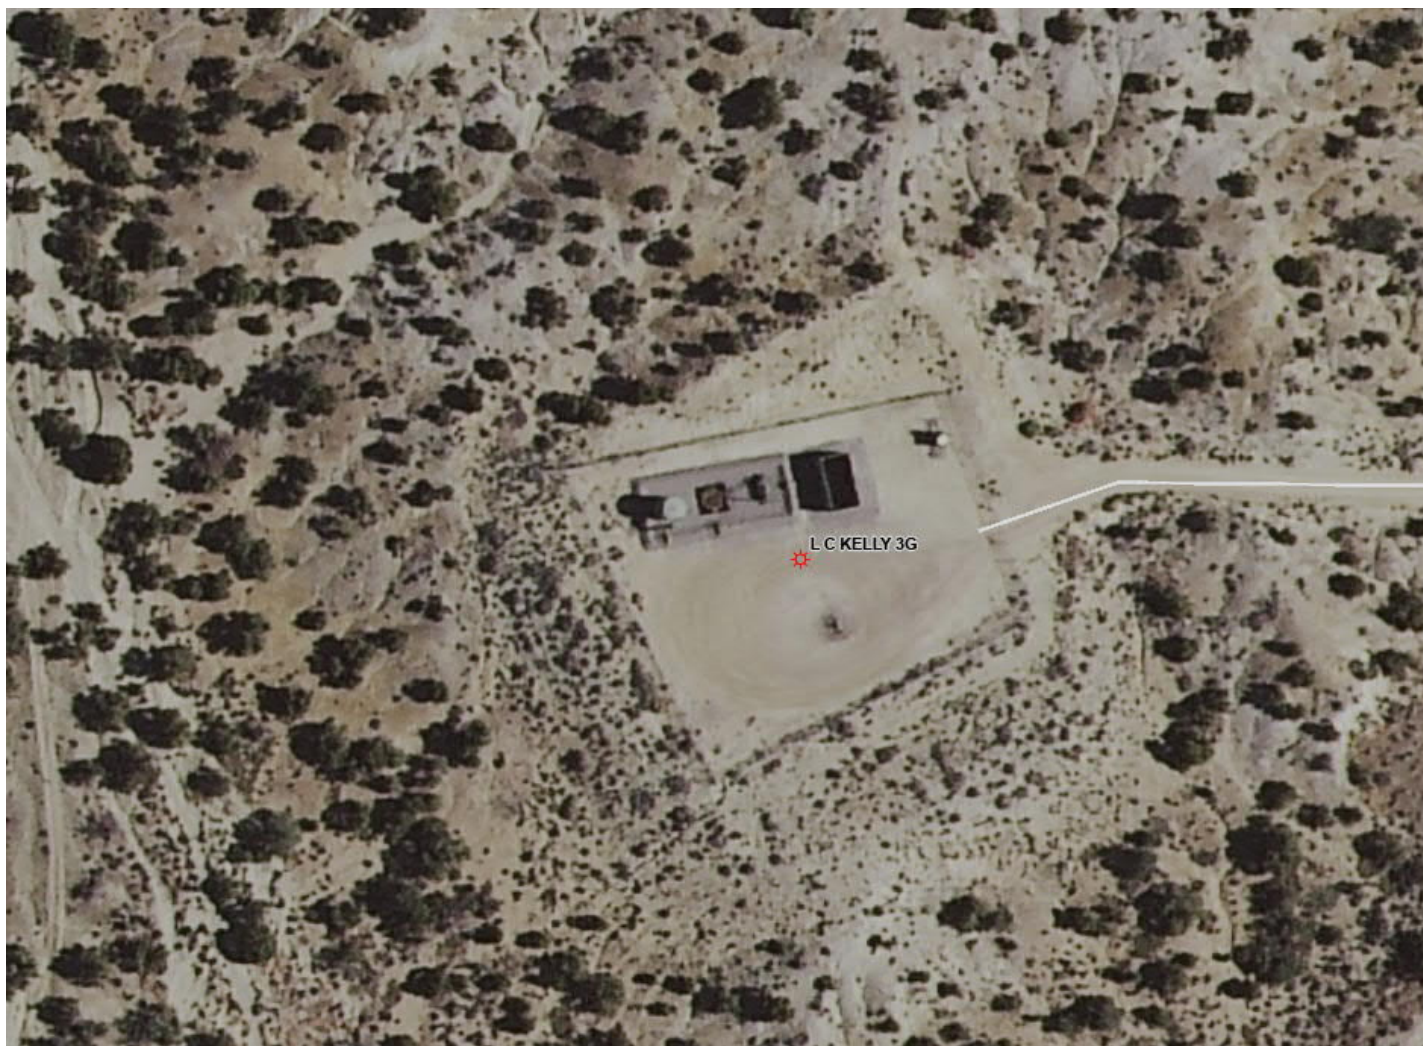
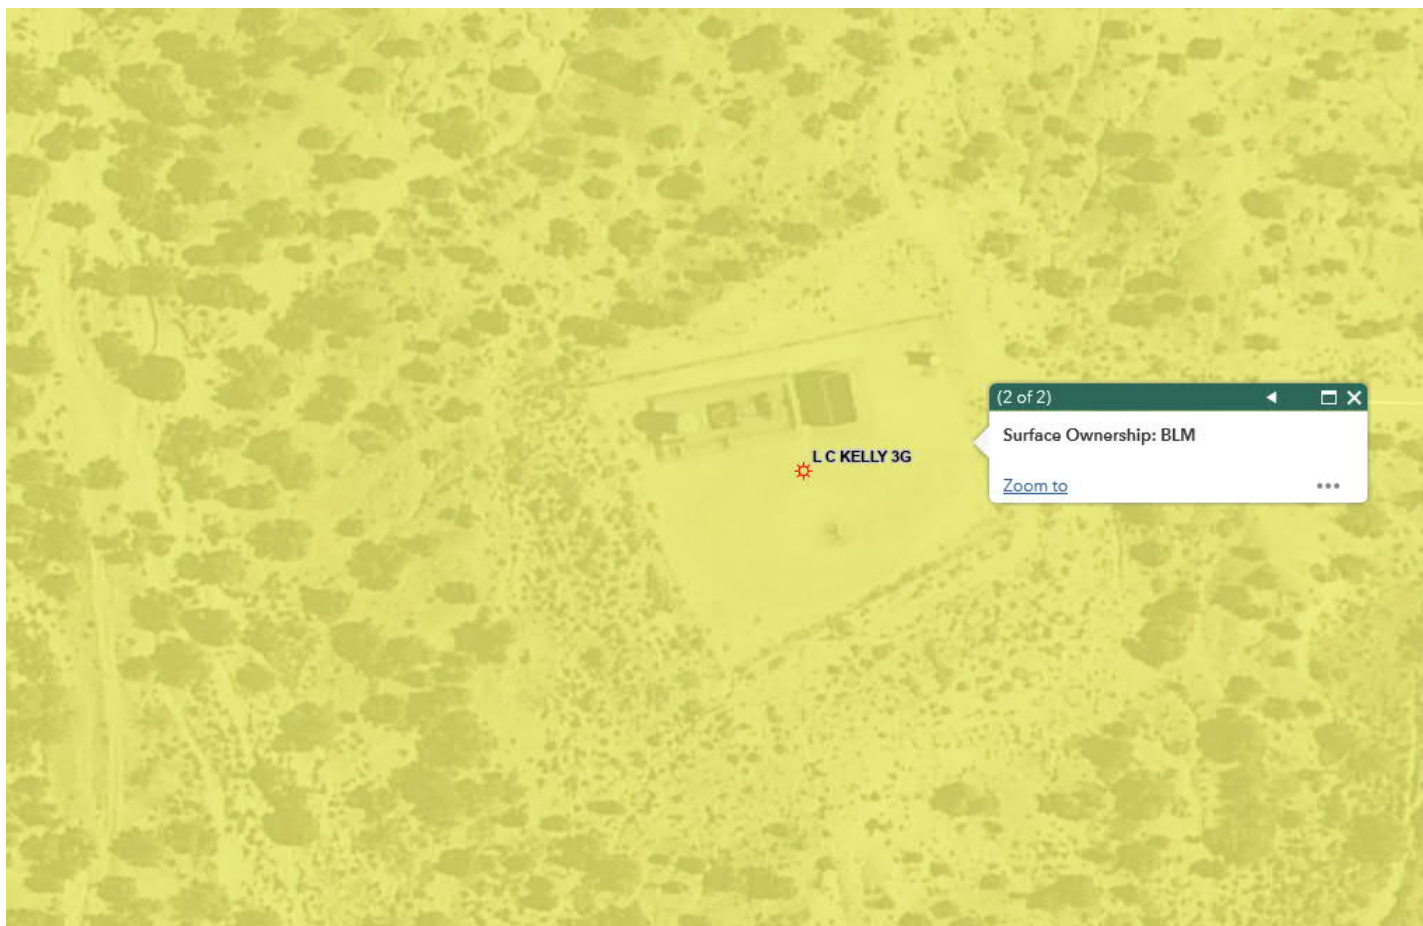
On 11/2/2023 at approx. 3:00 pm (MT), a Hilcorp operator discovered produced water fluid standing in the wooden cribbing surrounding the 120-bbl BGT at the L C Kelly 3G (API: 30-045-33237) in San Juan County, NM (36.846566, -108.101757). Upon discovery, the well was shut-in. The operator called in a water truck to remove all standing fluid from within the cribbing. Spill volume was determined to be 40 bbls produced water (also equals the volume recovered from the cribbing). After further investigation, it was determined that a hole had formed at the bottom of the BGT, most likely from corrosion. Next steps are ensuring that all agency notifications are in and a sundry request has been submitted to the BLM-FFO for moving the BGT. No spilled fluids migrated horizontally off the pad.
