## Release Notification

Site Name: Red Hills 32 Federal Com	Site Type: Battery
Date Release Discovered: 9/14/2023	API# (if applicable)

# Liner Integrity Certification

## Daily Site Visit Report

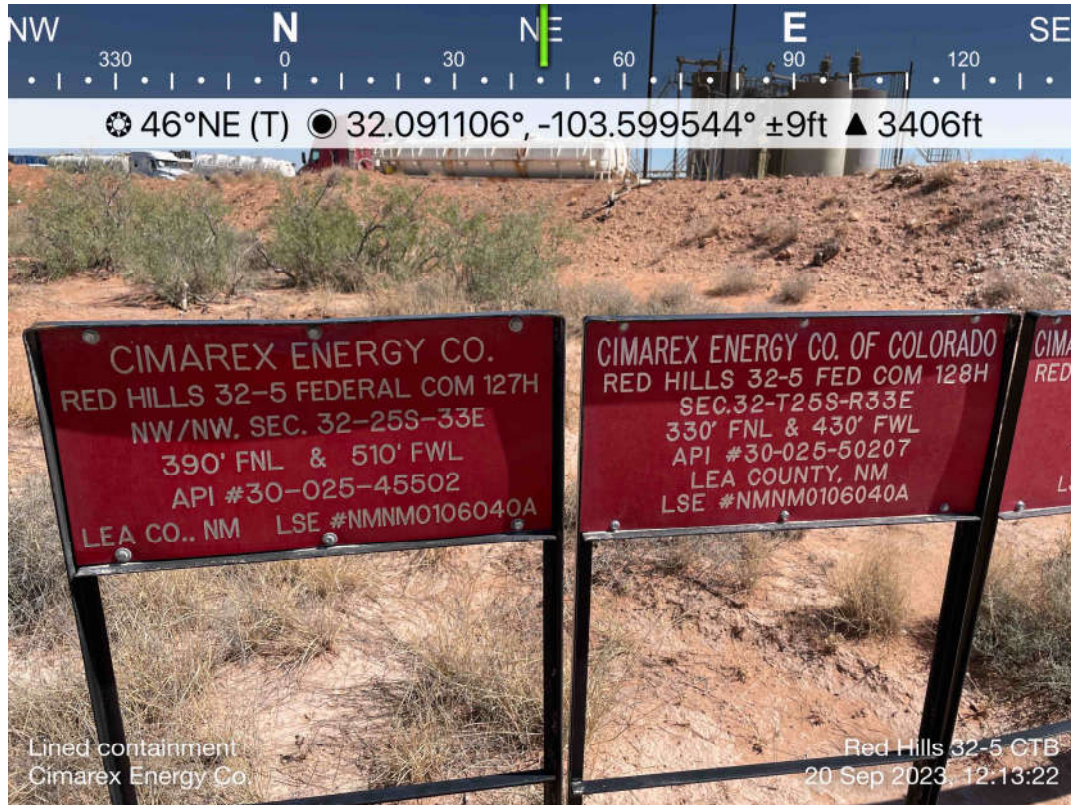
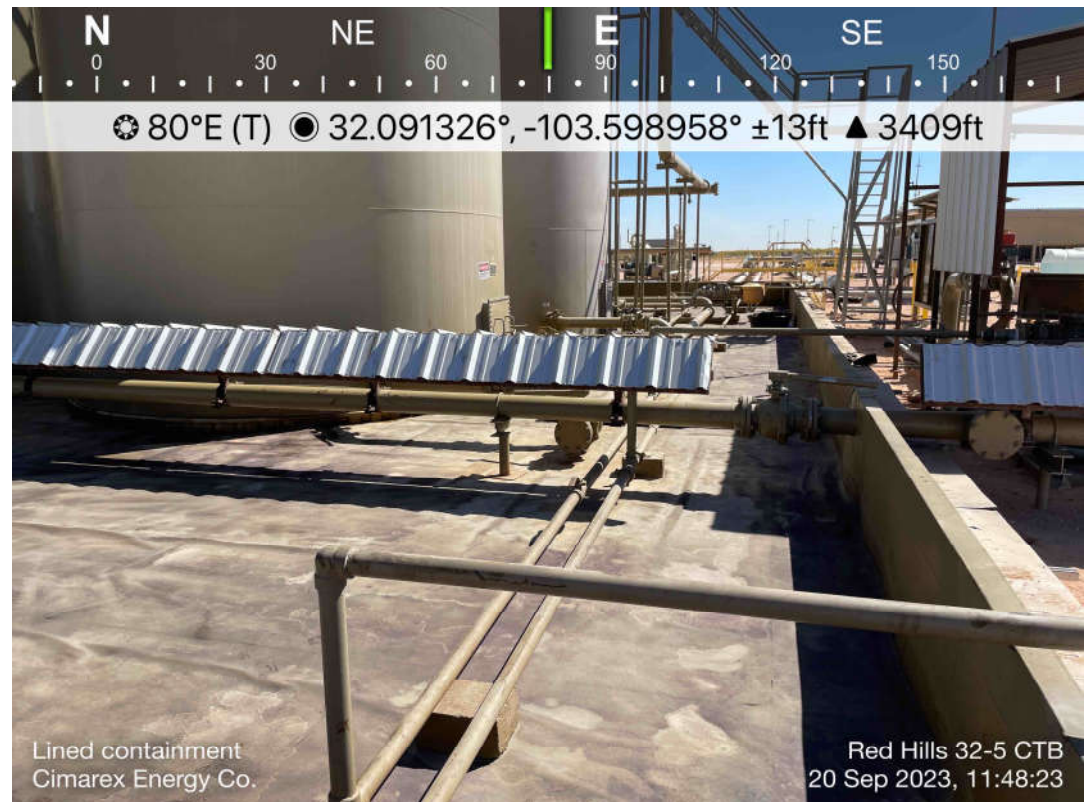
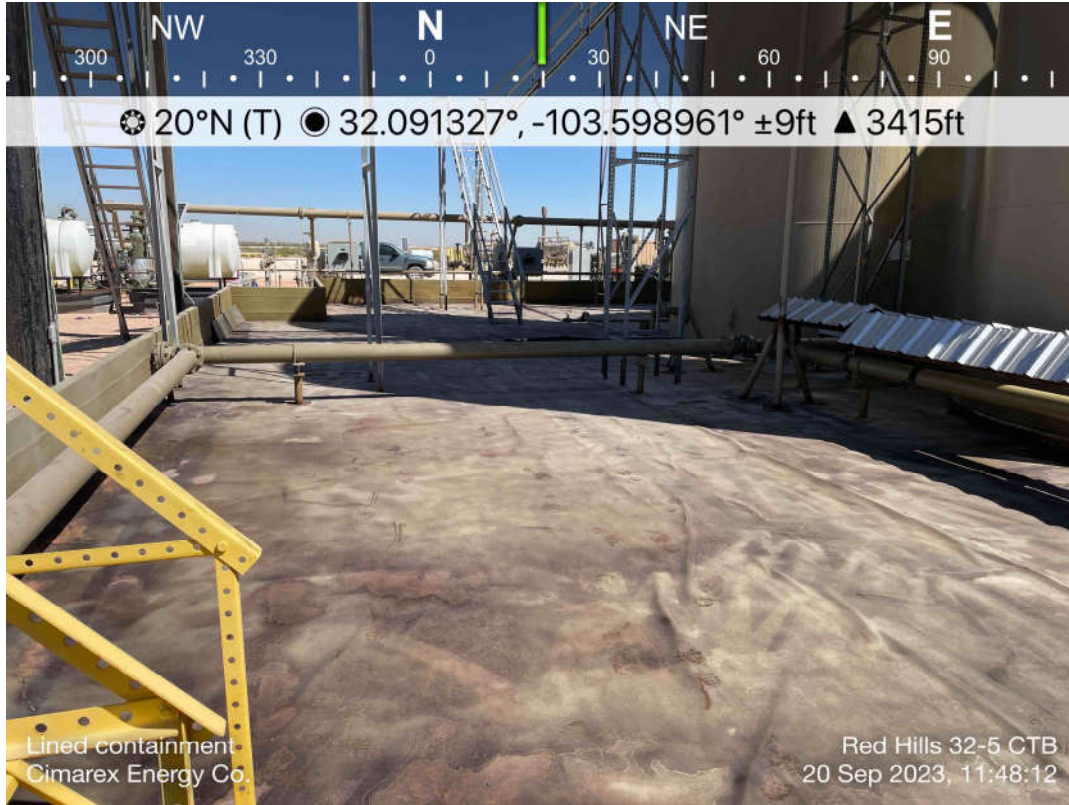
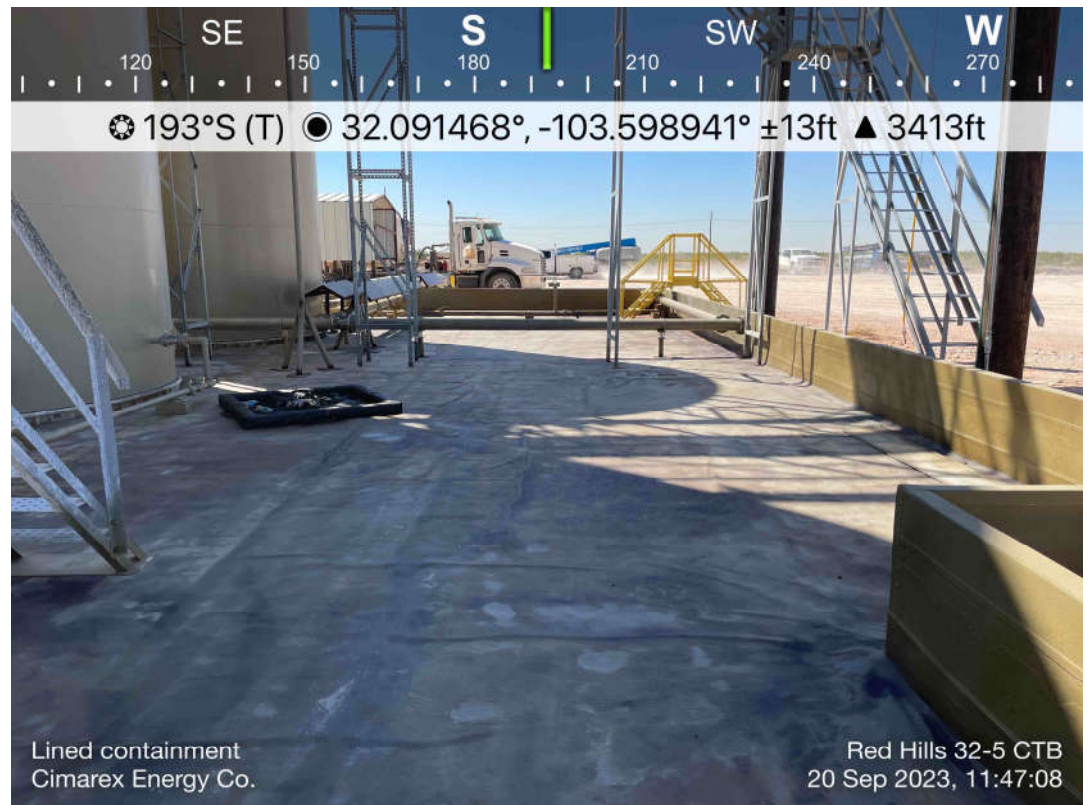
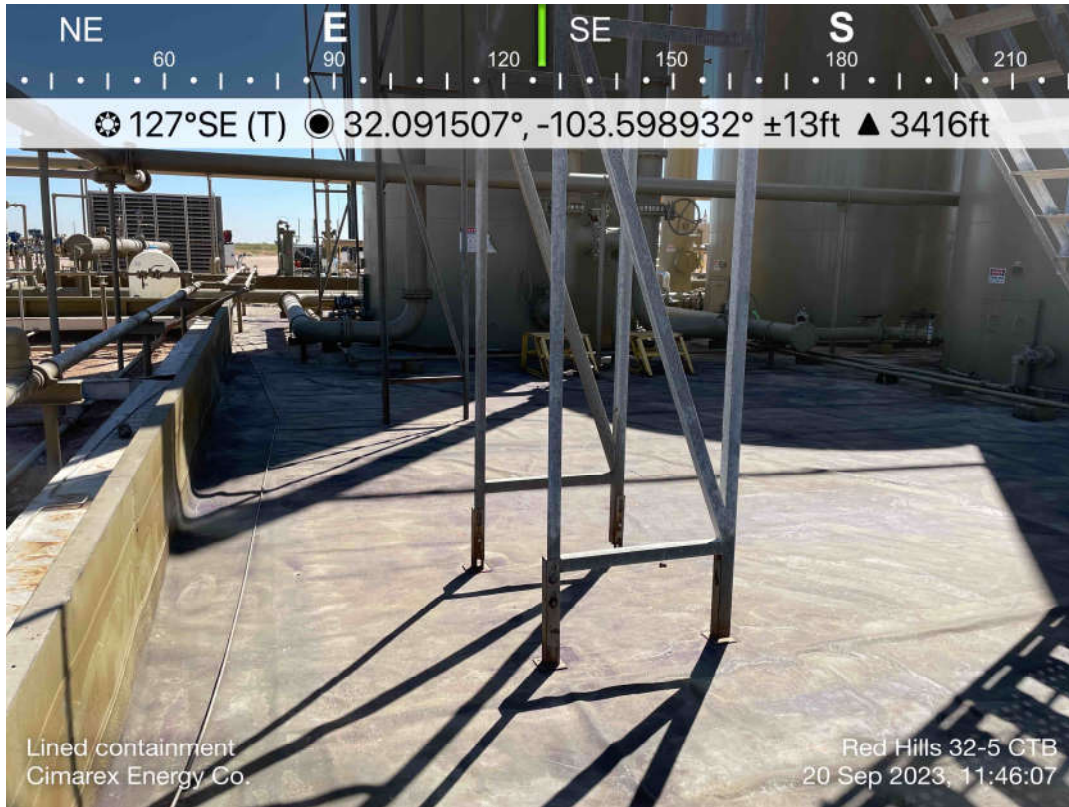
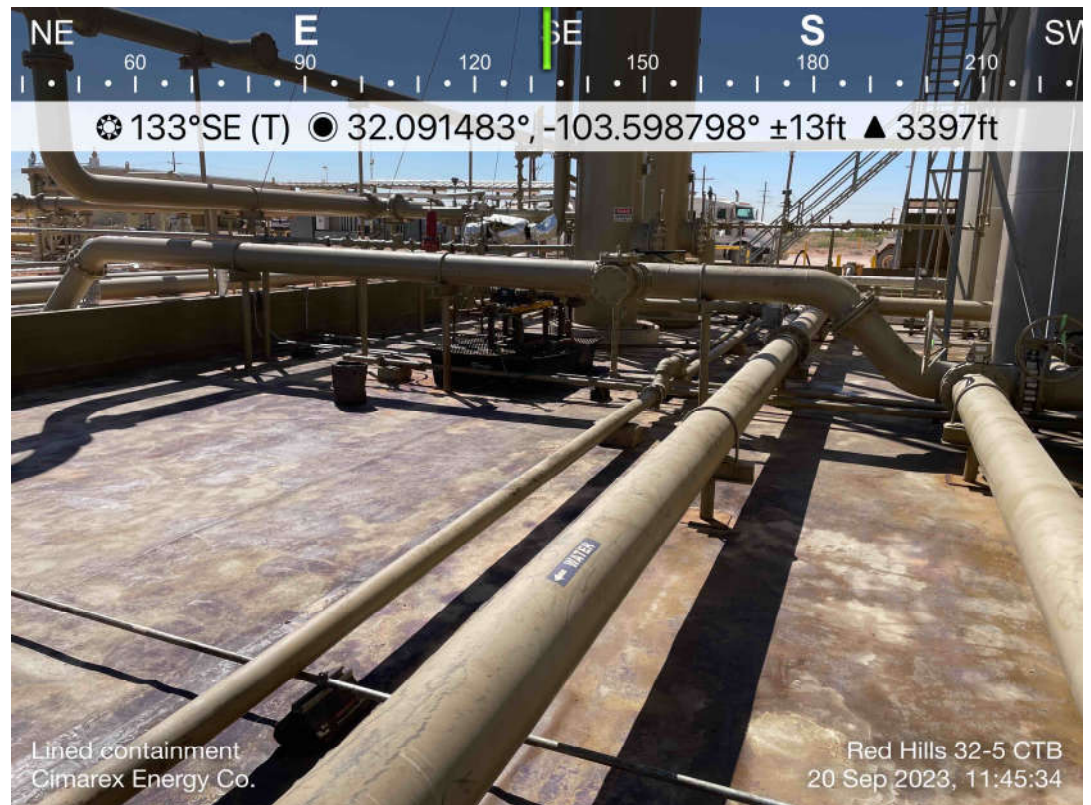
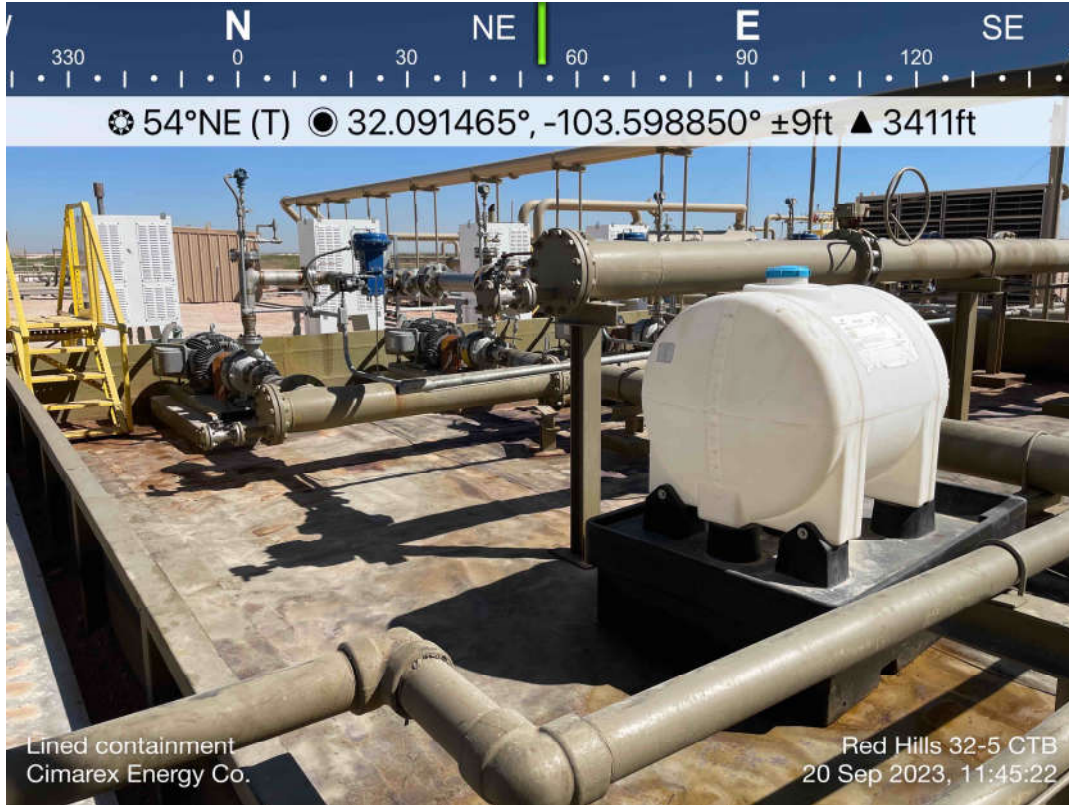
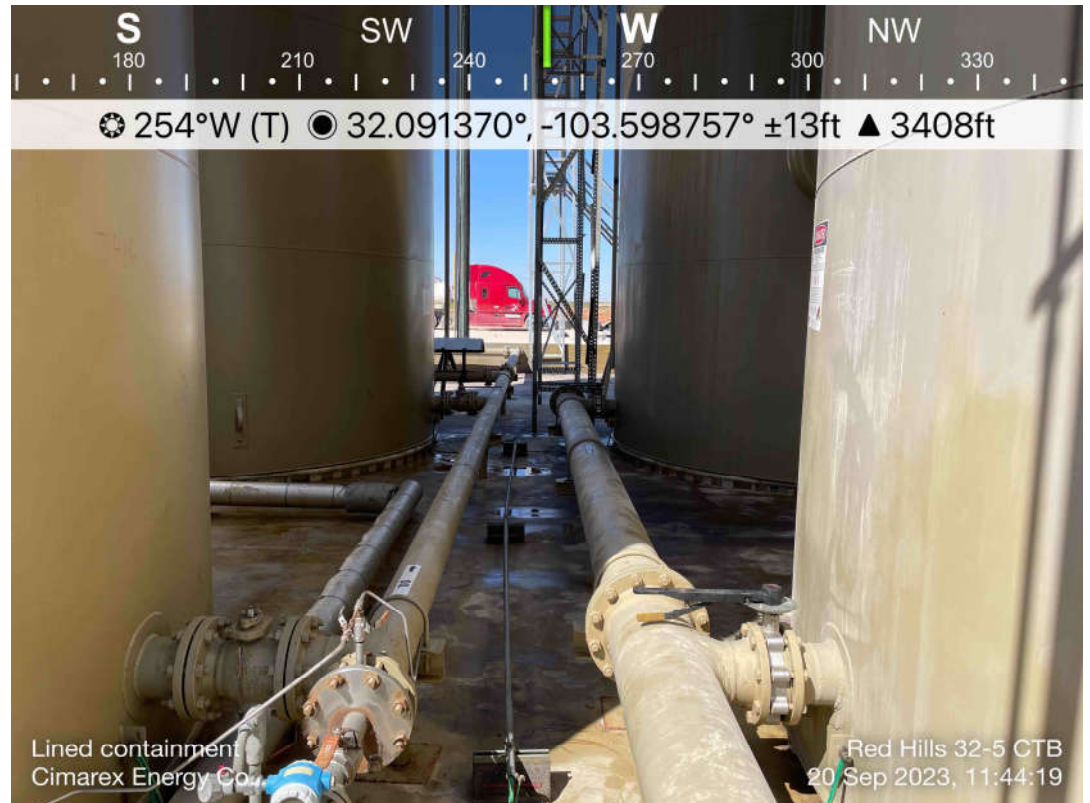
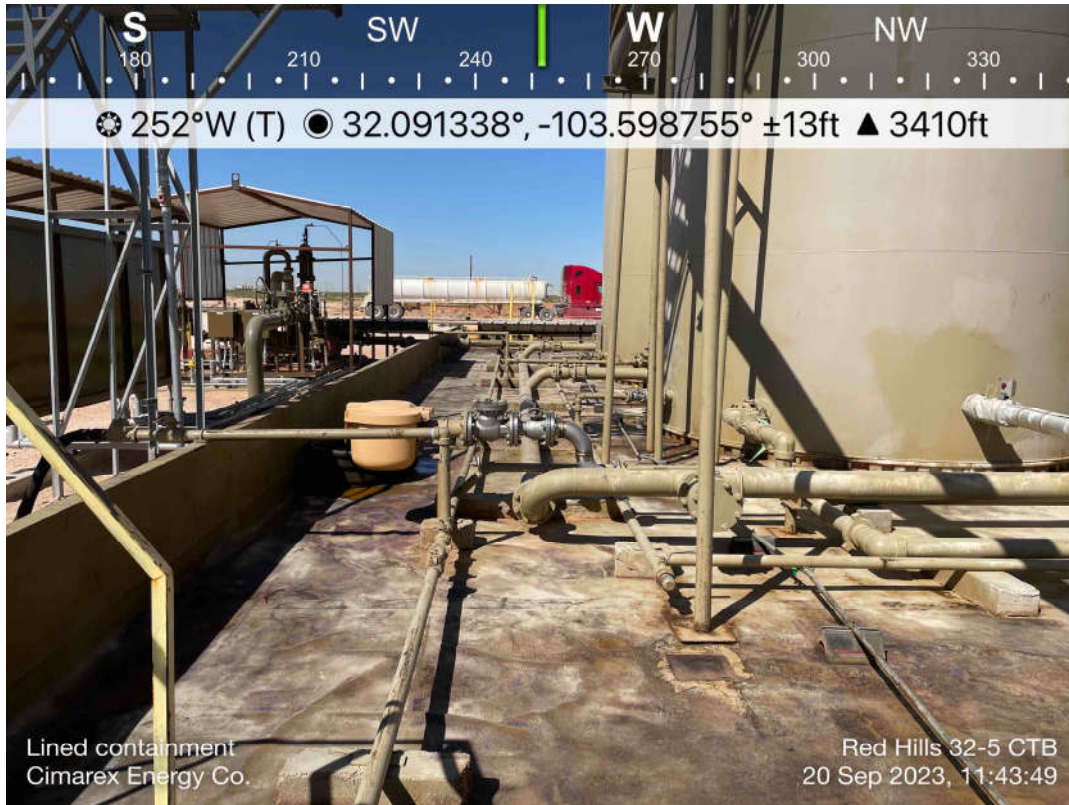
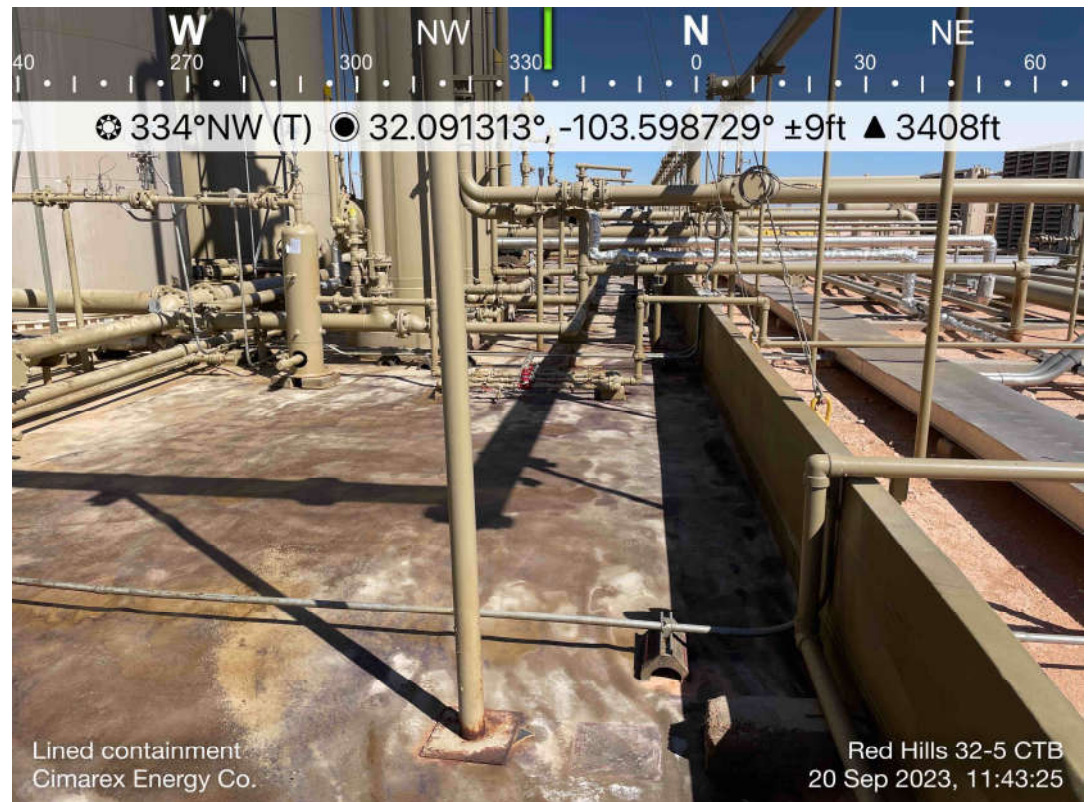
The following serves to verify that the affected liner has been inspected and found to be in serviceable condition in accordance with 19.15.29.11 A.(5)(a)(i-ii) of the New Mexico Administrative Code.

- ☒ Responsible Party has visually inspected the liner.
- ☒ Liner remains intact and was able to contain the leak in question.
- ☒ At least two business days' notice was given to the appropriate division district office before conducting the liner inspection.
- ☒ Photographs illustrating liner integrity are included.

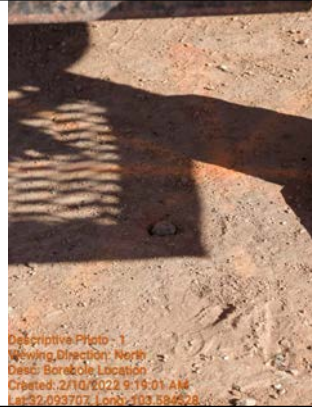
Borehole Location

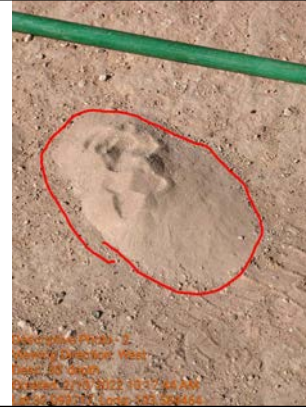
30' depth

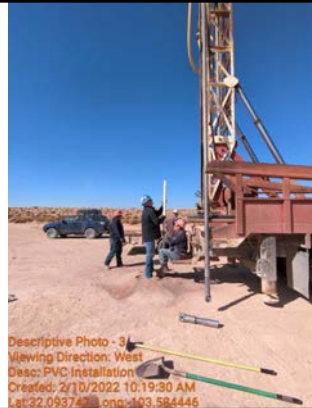
PVC Installation

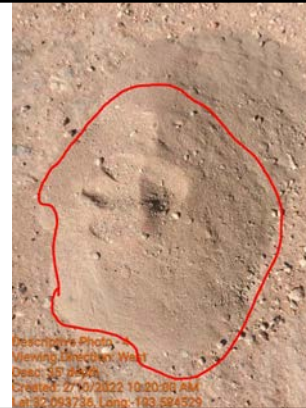
35' depth

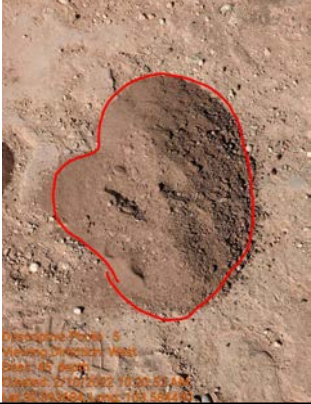
<p>45' depth</p>	<p><b>Viewing Direction: West</b></p>

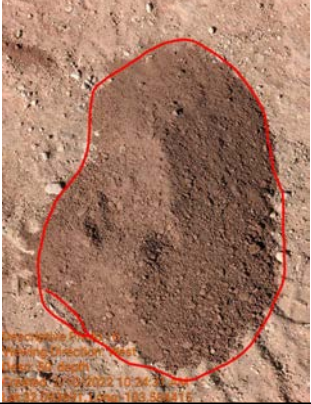
<p>50' depth</p>
<p><b>Viewing Direction: West</b></p>

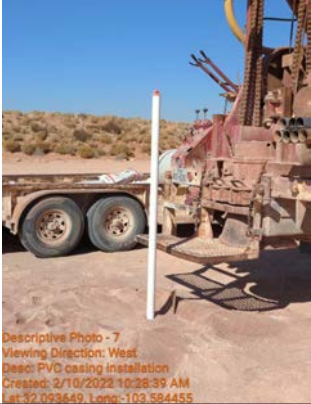
<p>PVC casing installation</p>	<p><b>Viewing Direction: North</b></p>

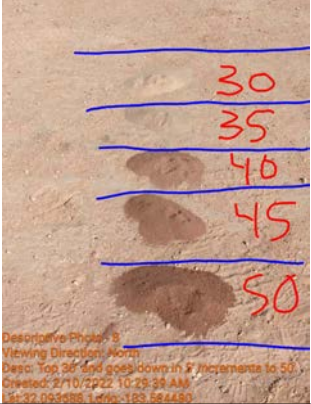
<p>Top 30' and goes down in 5' increments to 50'</p>

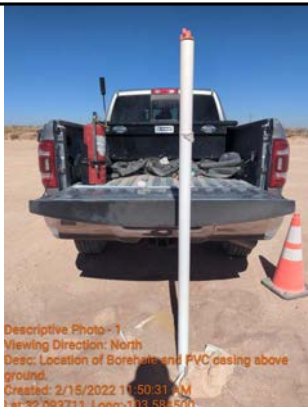
Location of Borehole and PVC casing above ground.

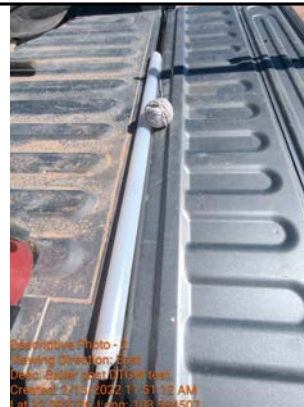
- 1 Water was not present at the bottom of the borehole as evidenced by the results of trying to bail the well. This location is ready for P & A. No further testing will be required. GW is not present at 55' feet BGS.

Bailer post DTGW test.
