Liberty Lift was in the process of pumping out of the jet nozzle when the jet pump pressured up causing the PRV to relieve. The operation was shut down and fluid was immediately removed. 15 bbls. of fluid was released to the lined secondary containment.

# Daily Site Visit Report

Client:	<u>BTA Oil Producers LLC</u>	Inspection Date:	<u>11/22/2023</u>
Site Location Name:	<u>Chiso State 14 Battery</u>	Report Run Date:	<u>11/27/2023 10:19 AM</u>
Client Contact Name:	<u>Kelton Baird</u>	API #:	<u></u>
Client Contact Phone #:	<u>432-312-2203</u>		
Unique Project ID	<u></u>	Project Owner:	<u></u>
Project Reference #	<u></u>	Project Manager:	<u></u>

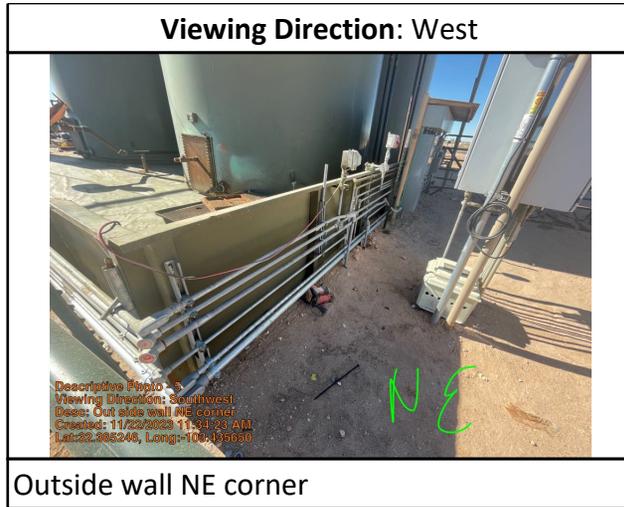
Outside wall NE corner

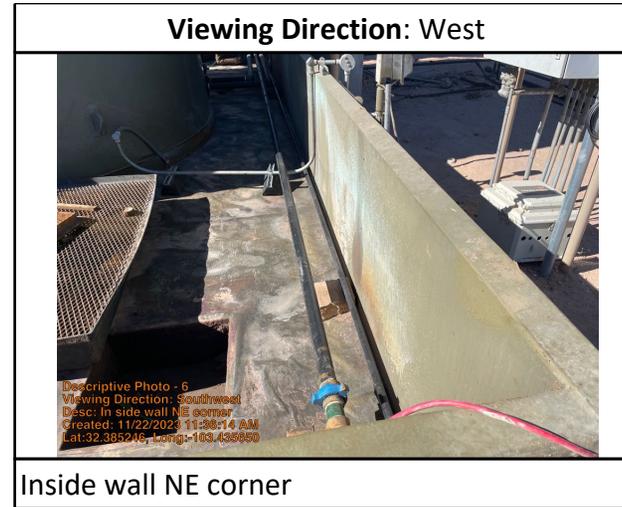
Inside wall NE corner

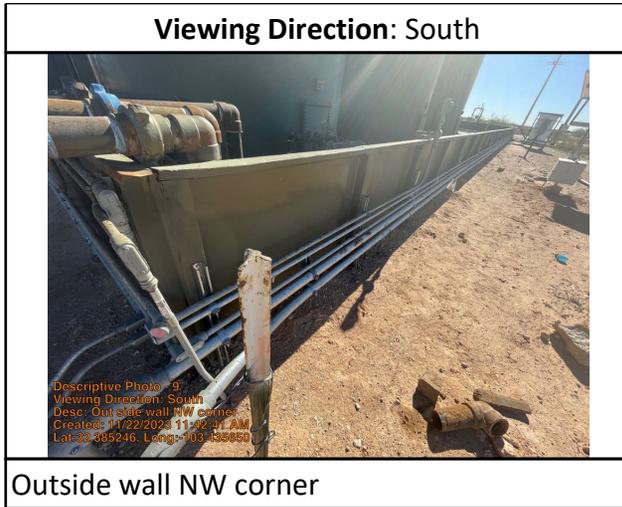
Outside wall NW corner

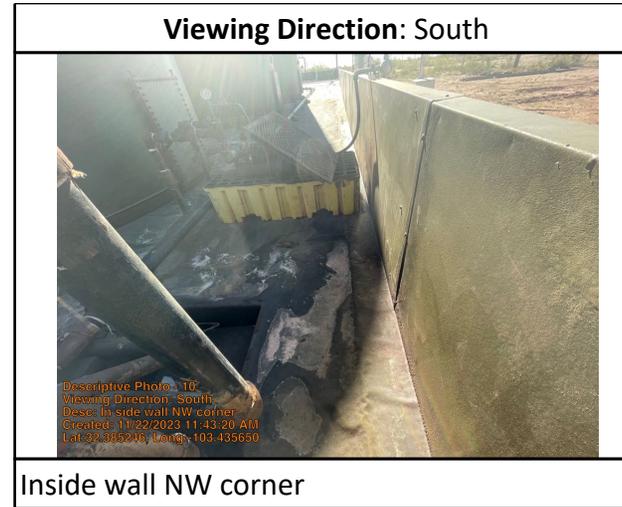
Inside wall NW corner

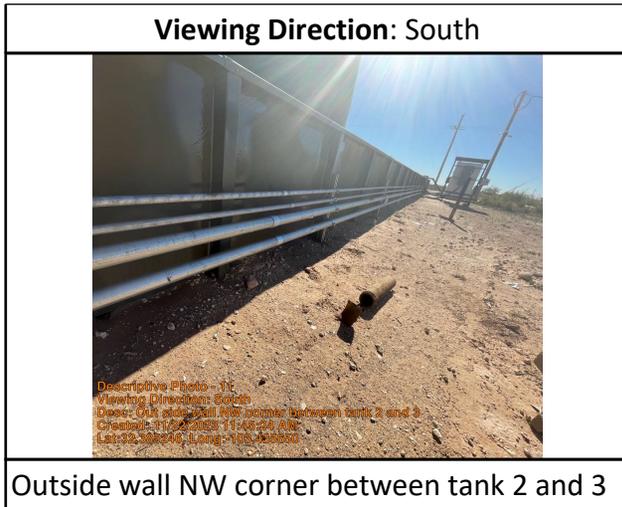
Outside wall NW corner between tank 2 and 3

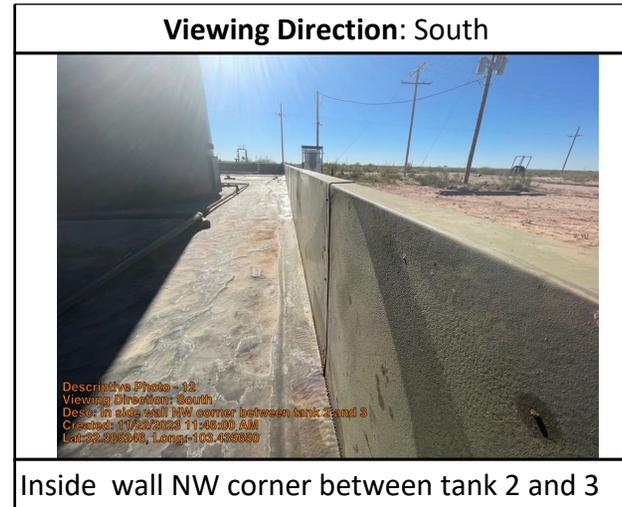
Inside wall NW corner between tank 2 and 3

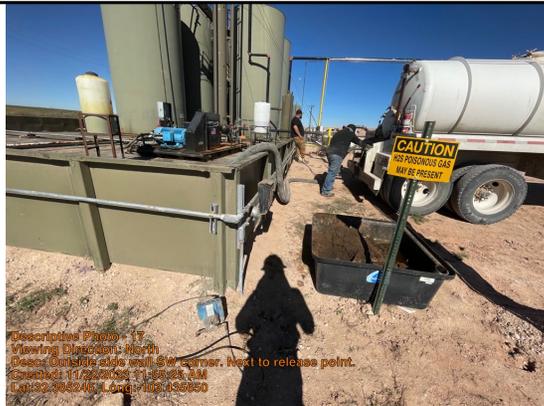
Descriptive Photo - 17  
Viewing Direction: North  
Desc: Outside side wall SW corner. Next to release point.  
Created: 11/22/2023 11:55:31 AM  
Lat:32.385246, Long:-103.433650

Outside side wall SW corner. Next to release point.

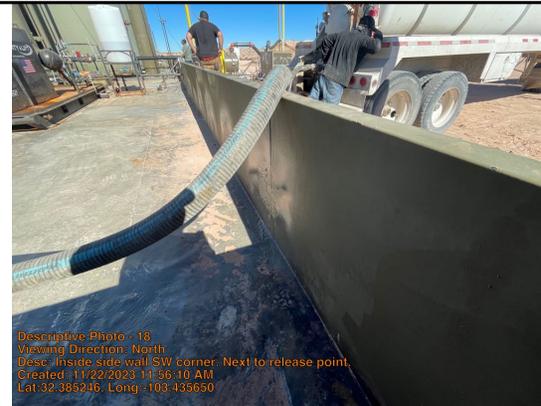
Descriptive Photo - 18  
Viewing Direction: North  
Desc: Inside side wall SW corner. Next to release point.  
Created: 11/22/2023 11:56:10 AM  
Lat:32.385246, Long:-103.433650

Inside side wall SW corner. Next to release point.

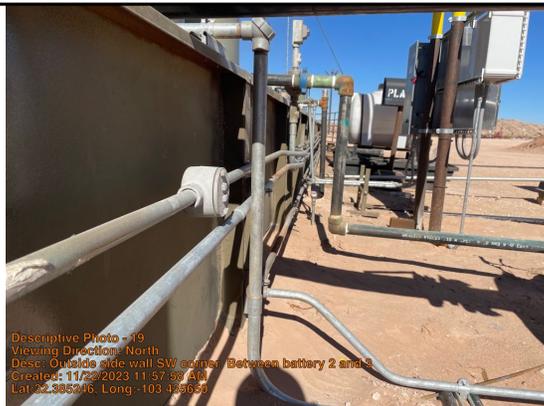
Descriptive Photo - 19  
Viewing Direction: North  
Desc: Outside side wall SW corner. Between battery 2 and 3.  
Created: 11/22/2023 11:57:57 AM  
Lat:32.385246, Long:-103.433650

Outside side wall SW corner. Between battery 2 and 3

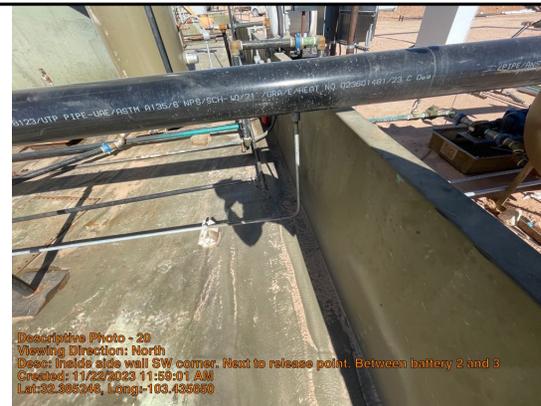
Descriptive Photo - 20  
Viewing Direction: North  
Desc: Inside side wall SW corner. Next to release point. Between battery 2 and 3.  
Created: 11/22/2023 11:59:01 AM  
Lat:32.385246, Long:-103.433650

Inside side wall SW corner. Next to release point. Between battery 2 and 3

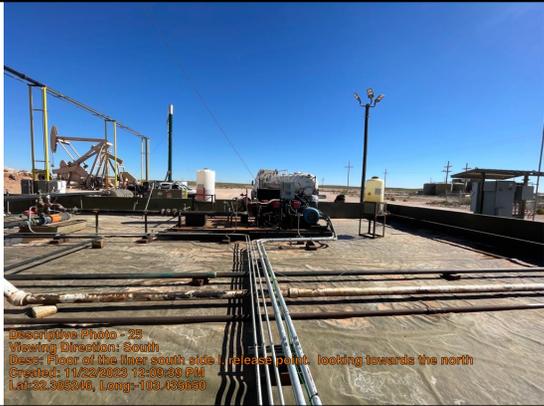
**12:20** The floor of the liner does not appear to have any significant damage. There is only a oil standing inside of the south corner, close to the release point. No damage on the wall for any side.

Descriptive Photo - 25  
Viewing Direction: South  
Desc: Floor of the liner south side I, release point. looking towards the north  
Created: 11/22/2023 12:00:30 PM  
Lat:32.505306, Long:-103.436650

Floor of the liner south side I, release point.  
looking towards the north edge

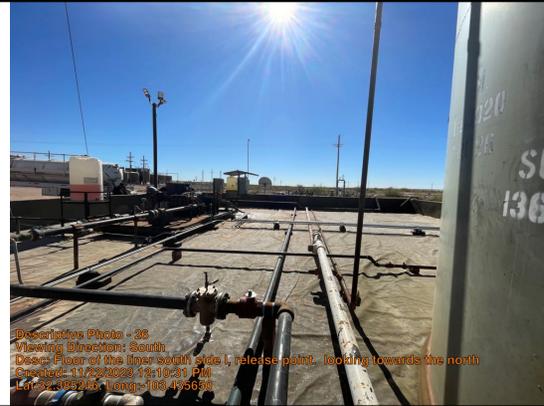
Descriptive Photo - 26  
Viewing Direction: South  
Desc: Floor of the liner south side I, release point. looking towards the north  
Created: 11/22/2023 12:10:31 PM  
Lat:32.505206, Long:-103.436650

Floor of the liner south side I, release point.  
looking towards the north edge #2
