LINER INSPECTION AND CLOSURE REPORT

Spur Energy Partners
Hobgoblin 7 Fed Com #4H TB
Incident ID: nAPP2402351357
Eddy County, NM

Paragon Environmental LLC
1601 N. TURNER ST. STE.500
Hobbs, NM 88240
575-631-6977

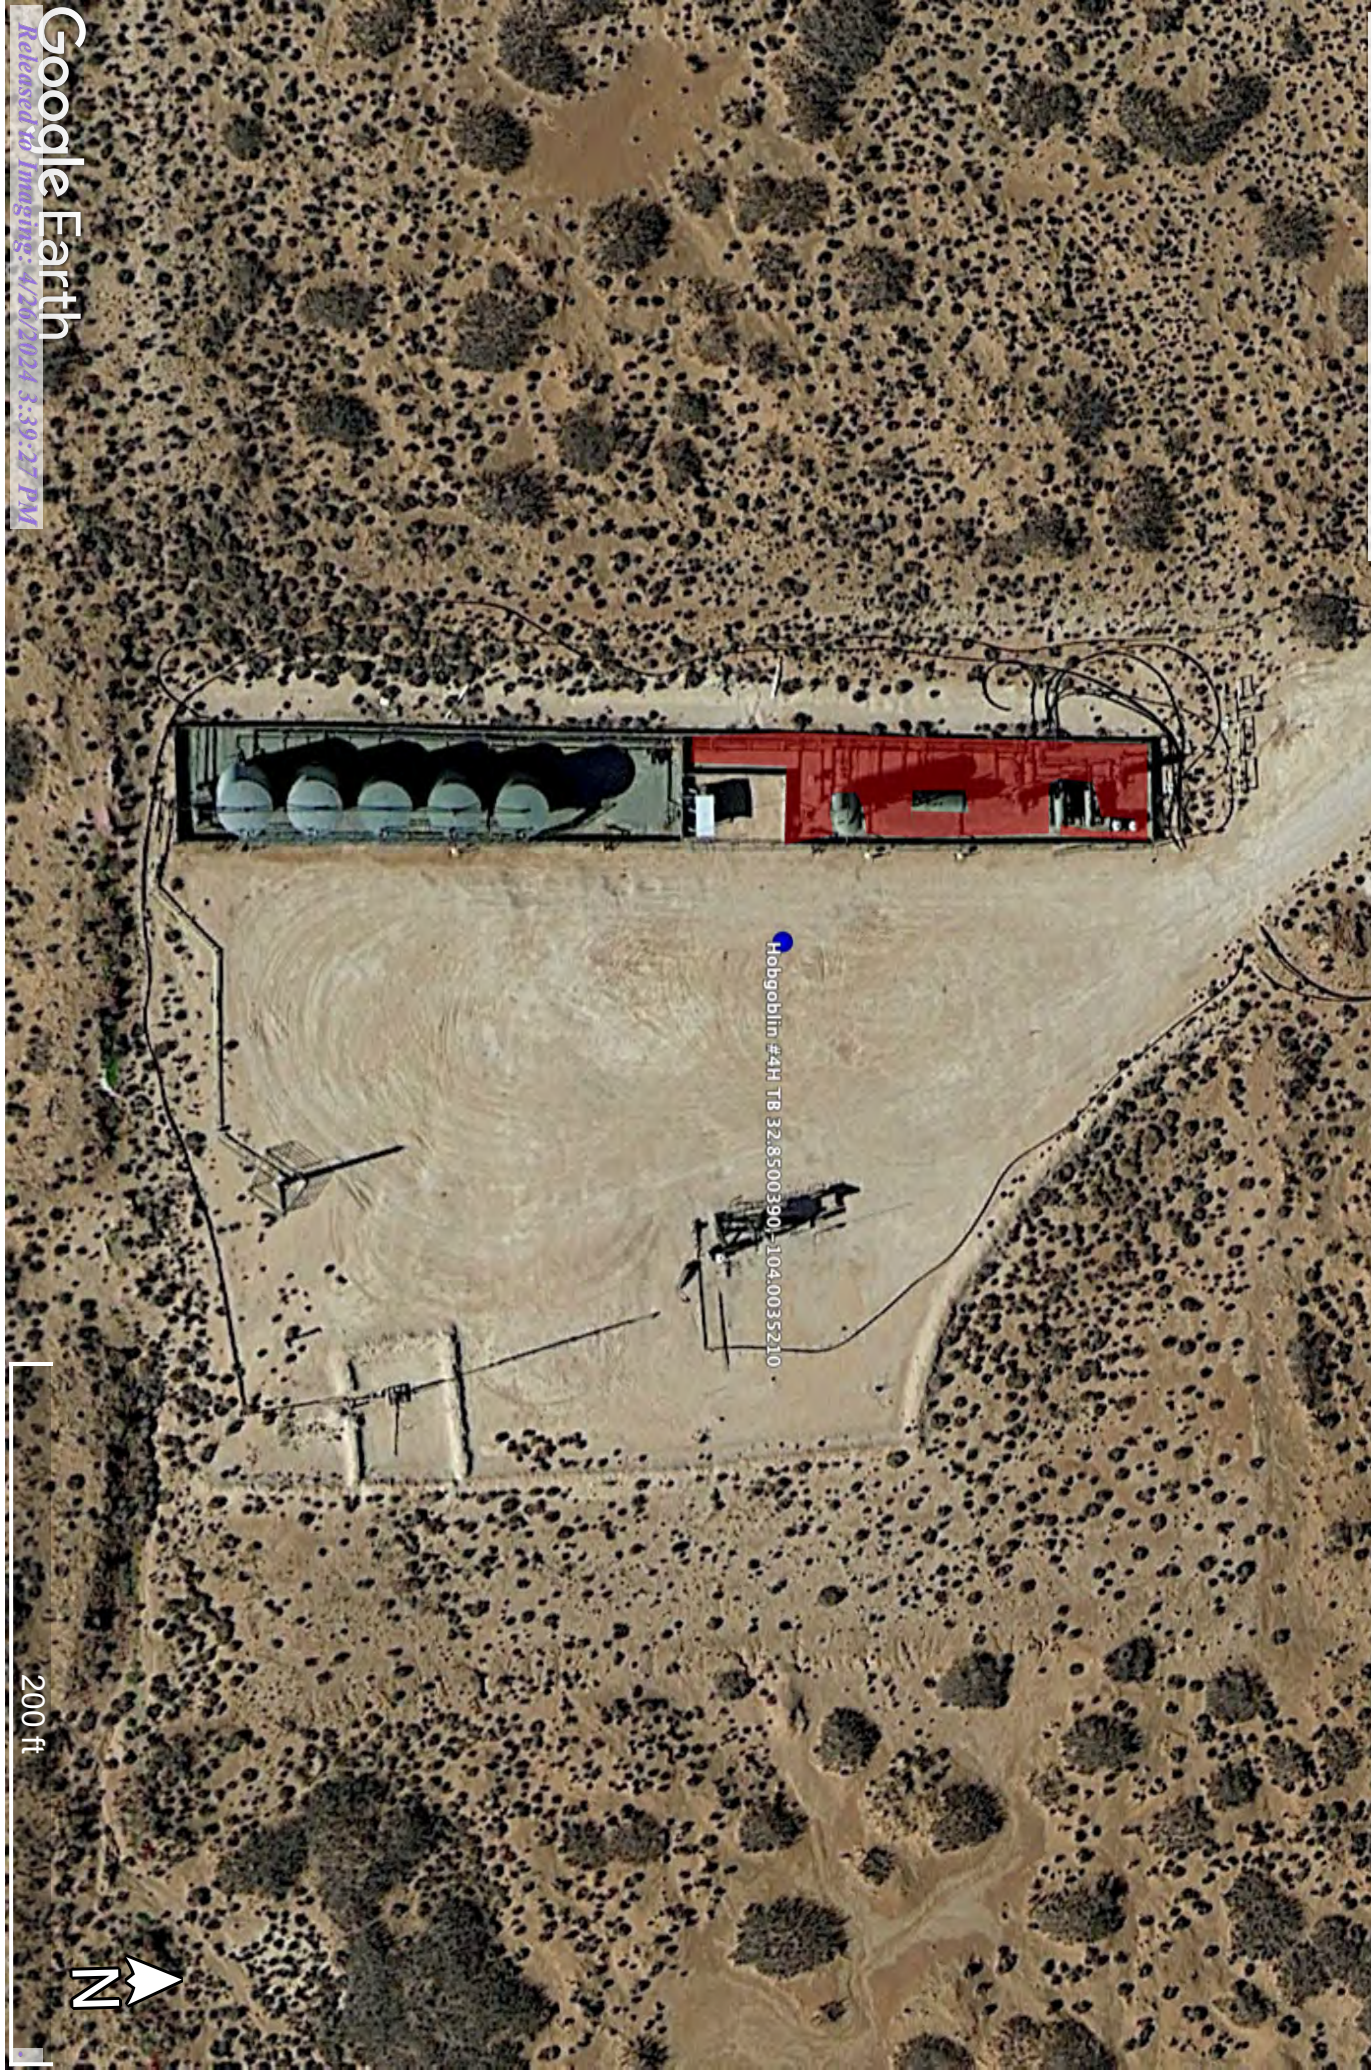
Spur Energy Partners
Hobgoblin 7 Fed Com #4H TB
Eddy County, NM
Site Map

Spill Area 3000 S/F

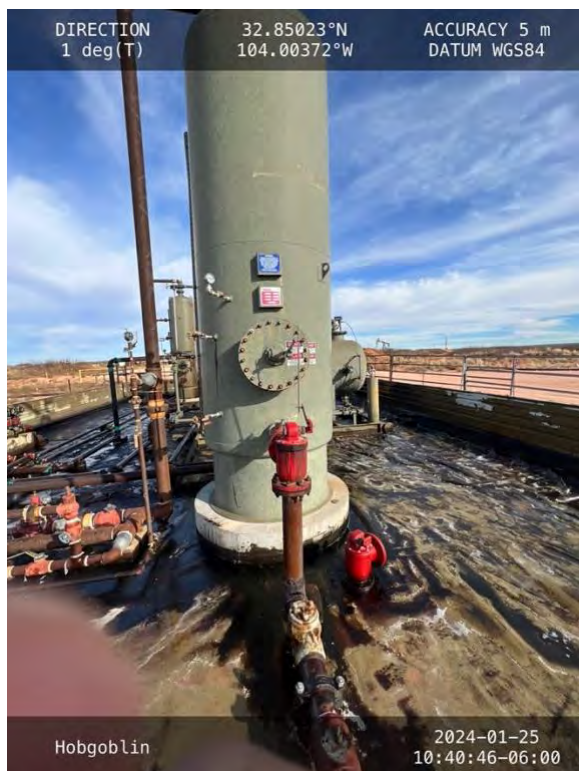
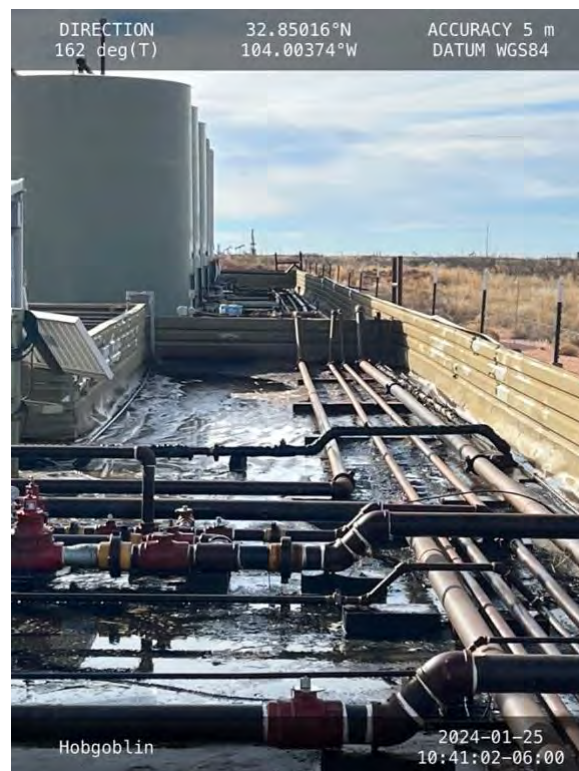
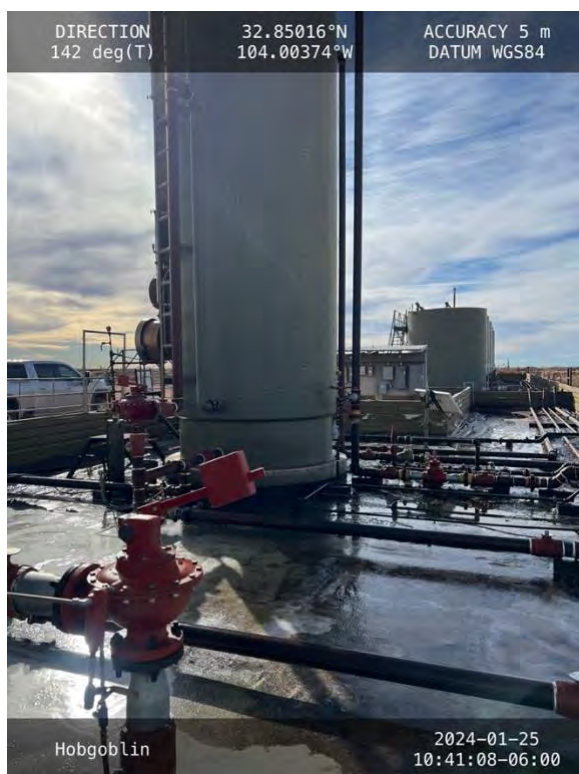
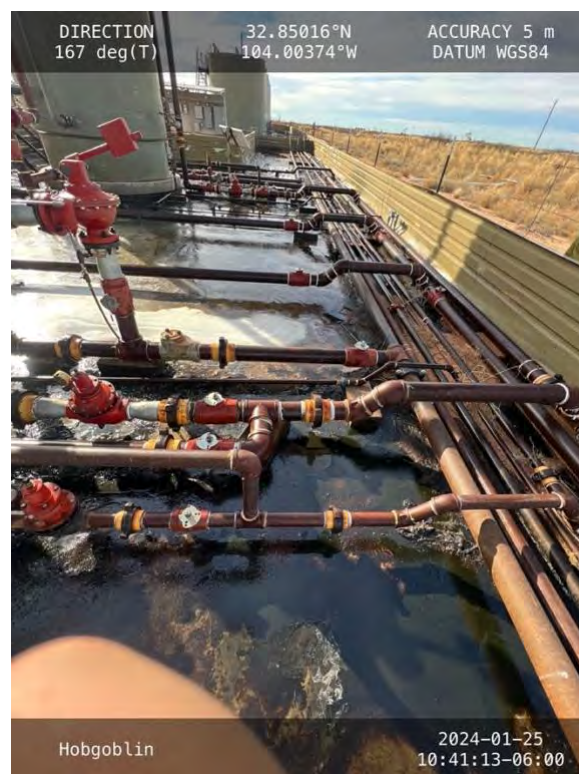
Photographic Documentation After Incident

On January 22, 2024, Paragon went to the Hobgoblin and conducted an initial assessment. There was obvious staining on the liner from the spill. The surface area affected was approximately 3000 s/f. There were no signs outside the containment that the liner had been breached. Therefore, no samples were taken.

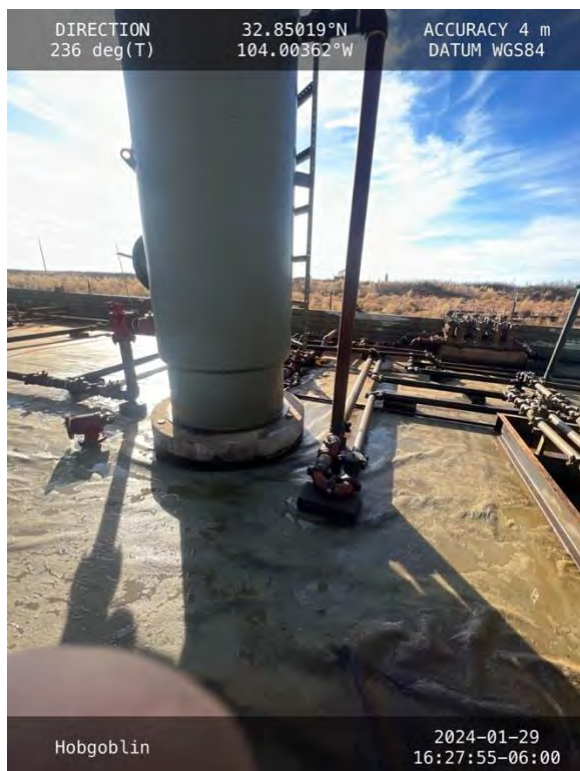
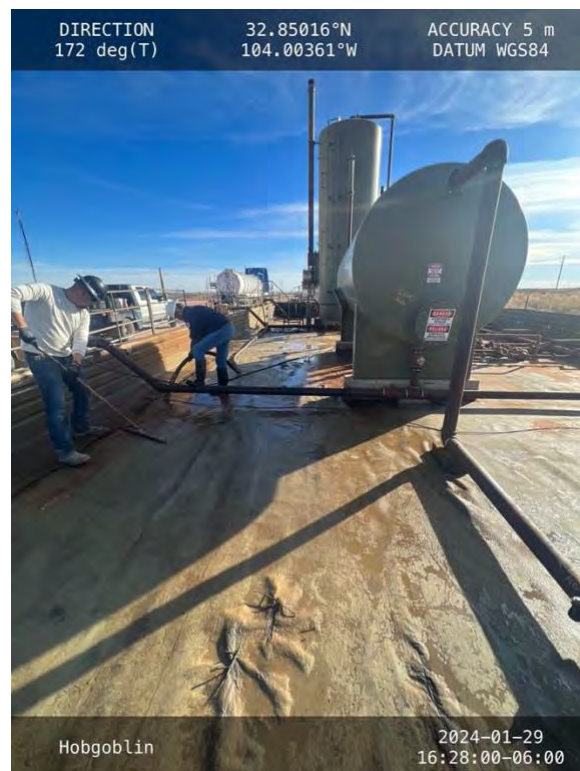
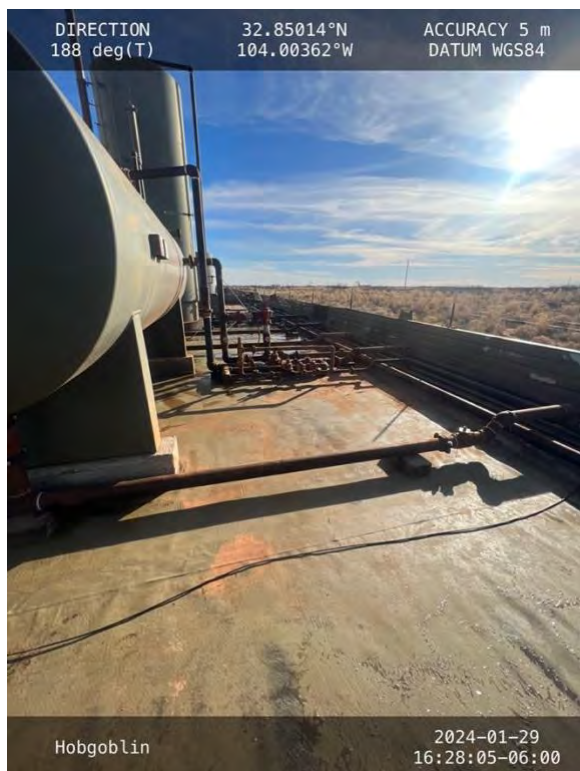
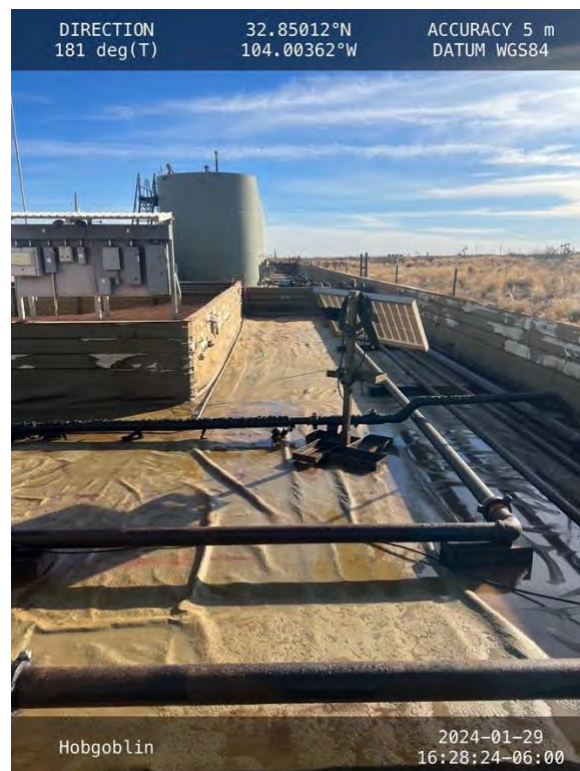
After Clean

On February 7, 2024, Paragon returned to the site to conduct the liner cleaning. No further remediation tasks were needed for this site. On February 2, 2024, a liner inspection notification was submitted to the OCD to conduct a liner inspection on 2-7-24, Appendix C. Pictures and a liner inspection report are also attached in Appendix C.

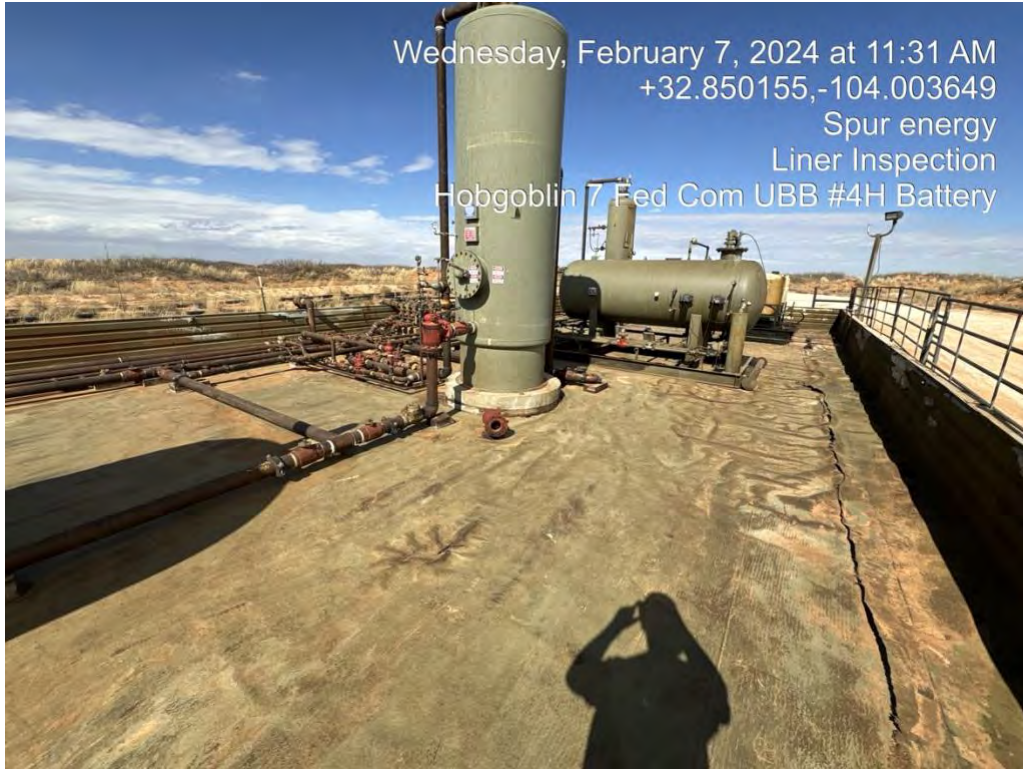
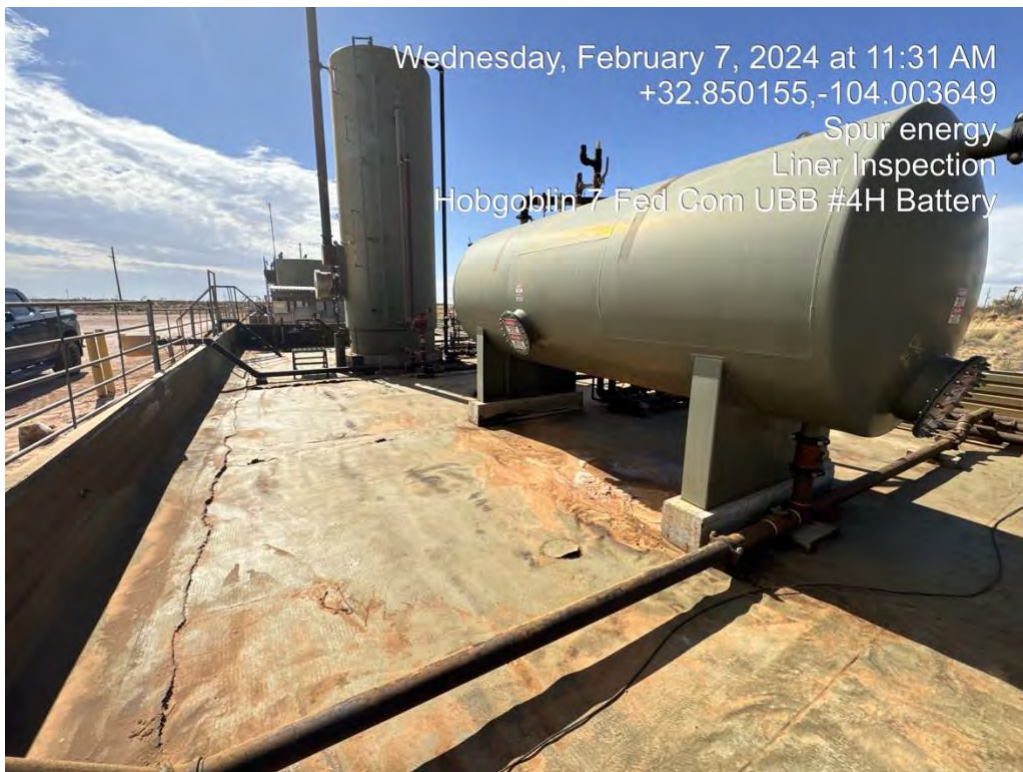
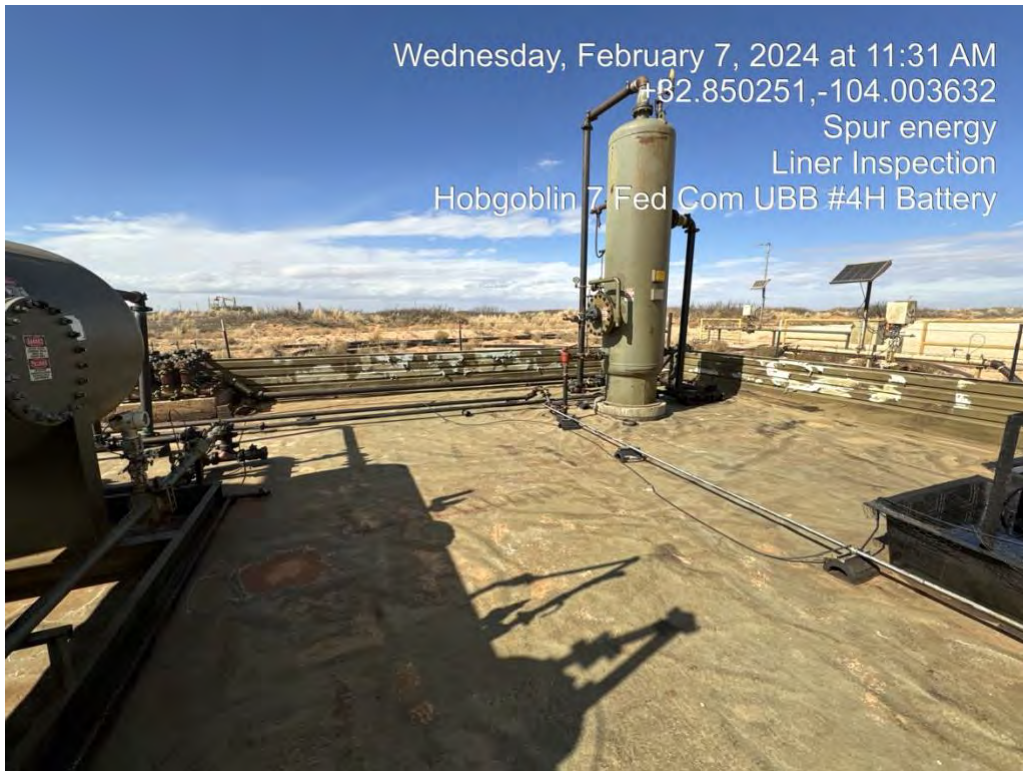
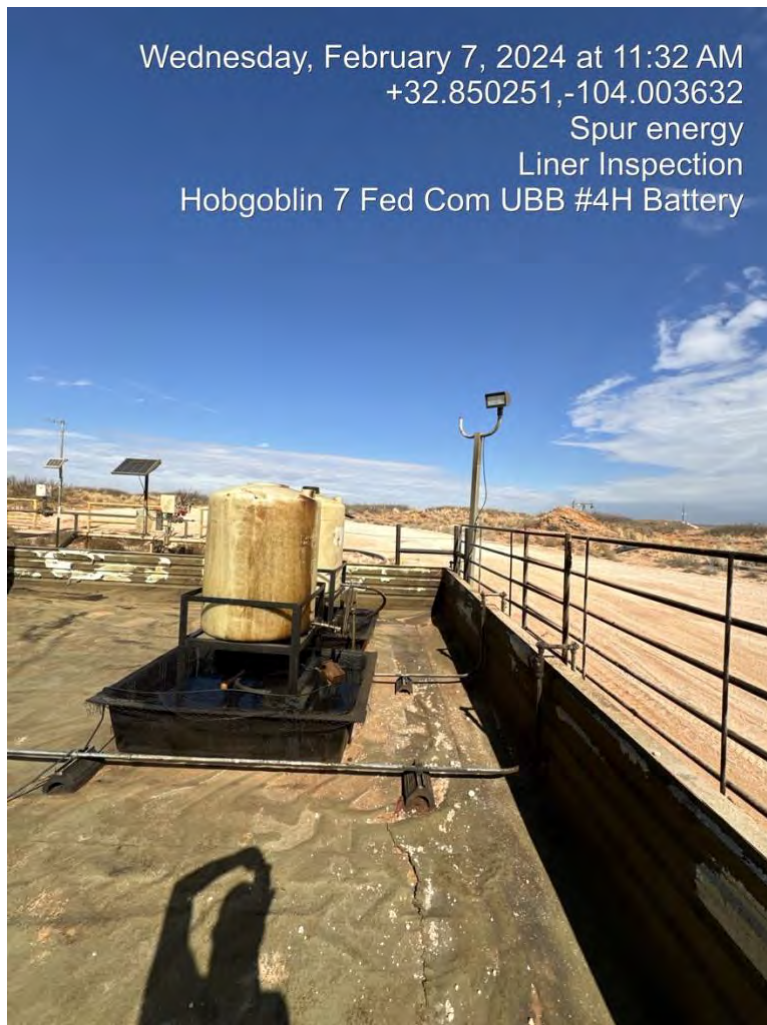
Liner Inspection

Visualization	Yes	No	Comments
Is there a tear in the liner?		✓	
Are there holes in the liner?		✓	
Is the liner retaining any fluids?		✓	
Does the liner have integrity to contain a leak?	✓

Comments: liner looks good
