SEAWOLF 1-12-CTB 1

**RE: Liner Inspection and Closure Report  
Seawolf 1-12 CTB 1  
API No. N/A  
GPS : Latitude 32.07693371 Longitude -103.5266281  
UL- C, Section 01, Township 26S, Range 33E  
Lea County, NM  
NMOCD Reference No. NAPP2402659188**

## SITE PHOTOGRAPHS

#### Liner Inspection

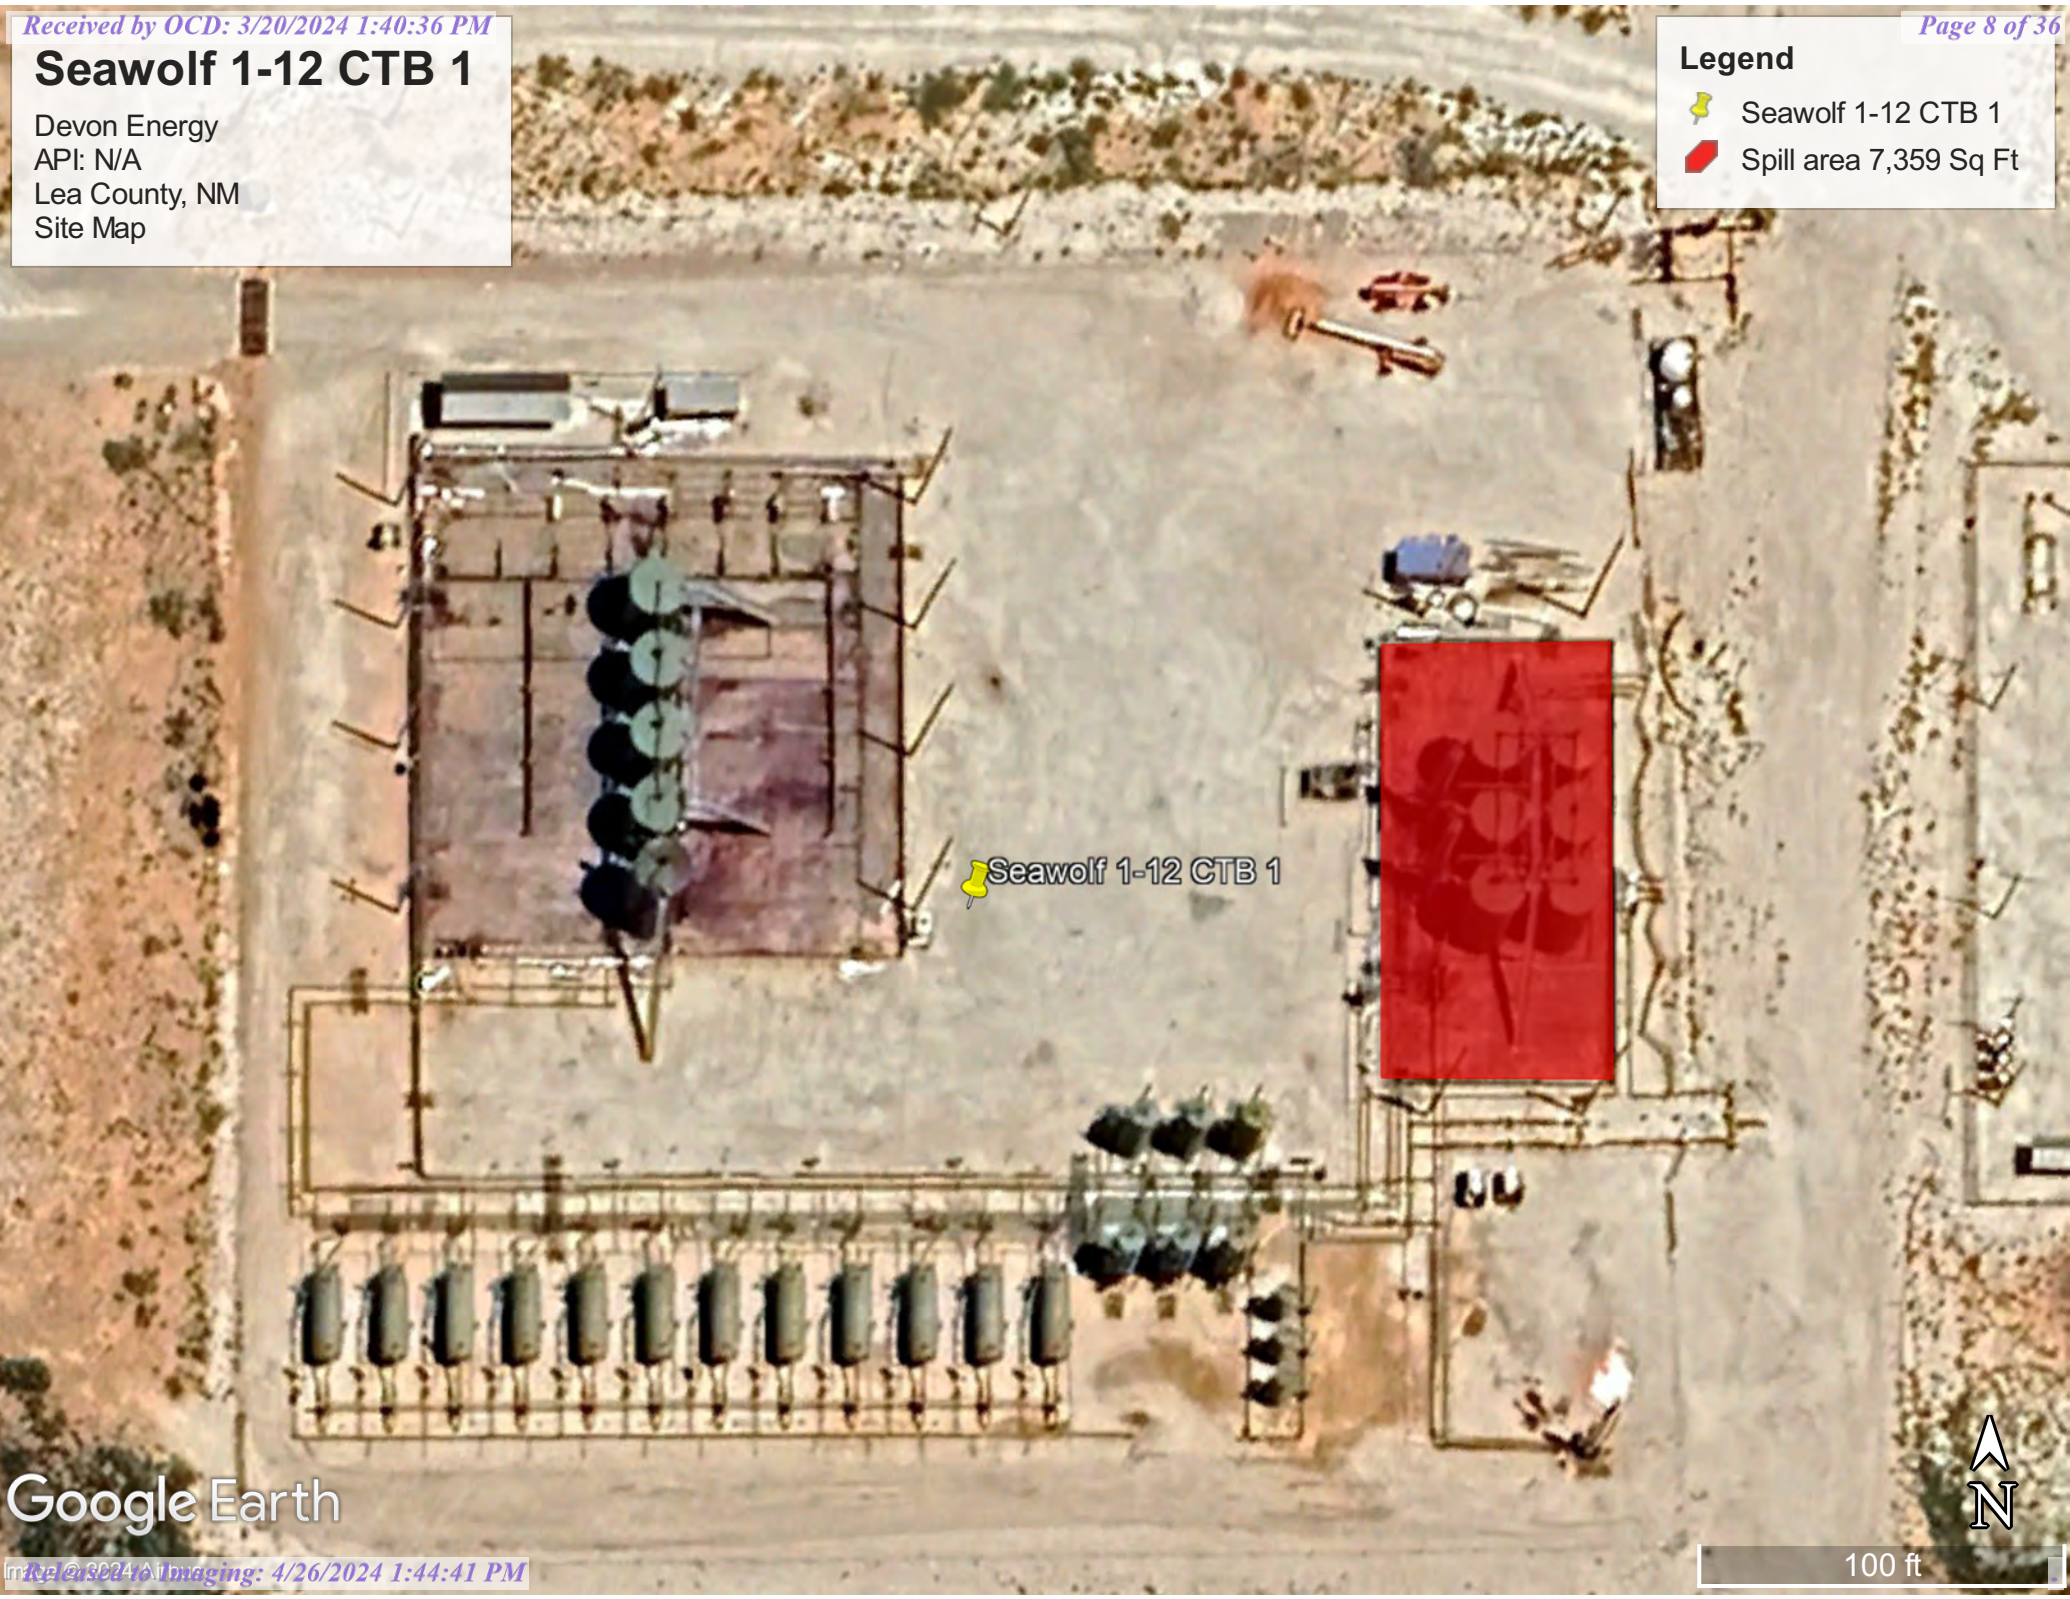
Devon Energy  
API: N/A  
Lea County, NM  
Site Map

**NAPP2402659188:** On January 26, 2024, LO found a ½ ball valve cracked open on ULPS. The valve was shut and plugged to stop the leak. Approximately 21 barrels (bbls) of produced water was released from the valve, into the lined, secondary containment. A vacuum truck was dispatched and recovered approximately 20 bbls of fluid from the lined SPCC containment ring. Once standing fluids were removed, the liner was visually inspected by Devon field staff for any pinholes or punctures; none were found. Based on this inspection there is no evidence that the spilled fluids left containment.

Spill area 7,359 Sq Ft

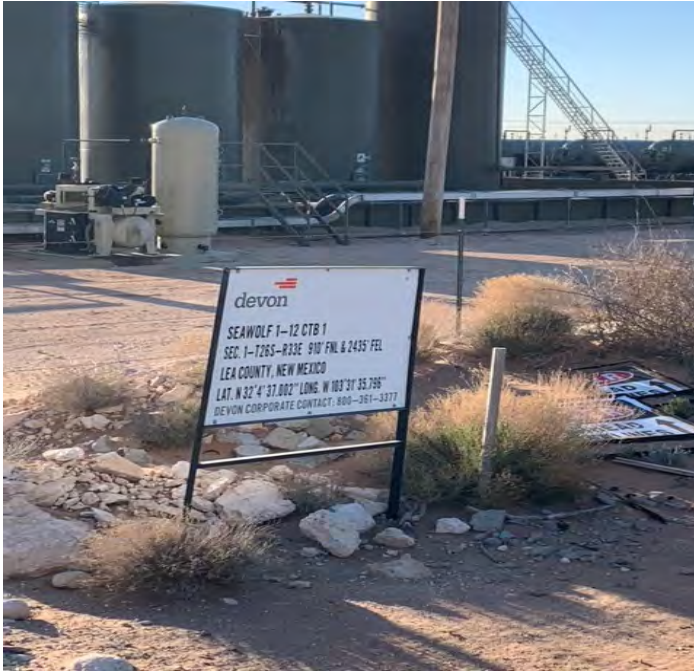
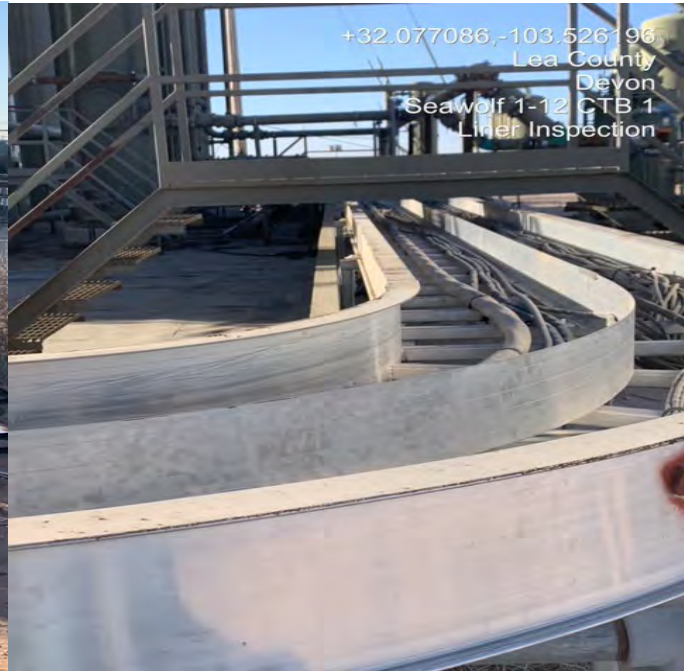
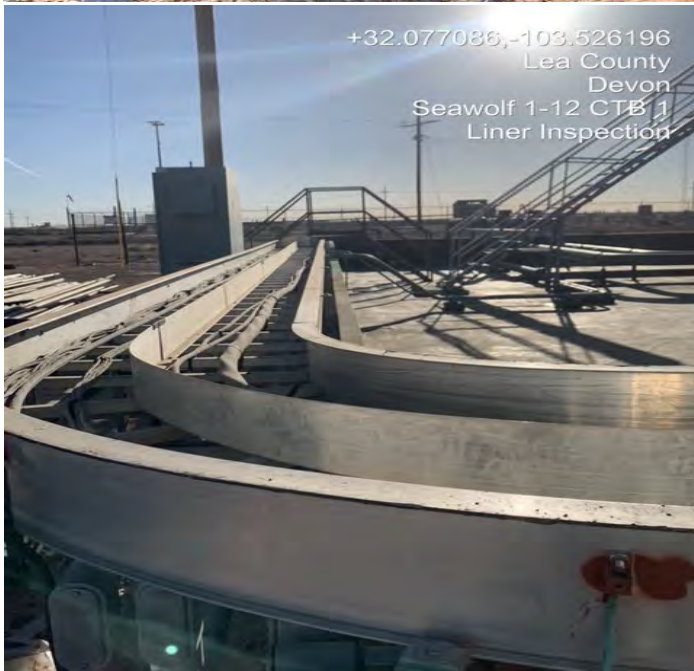
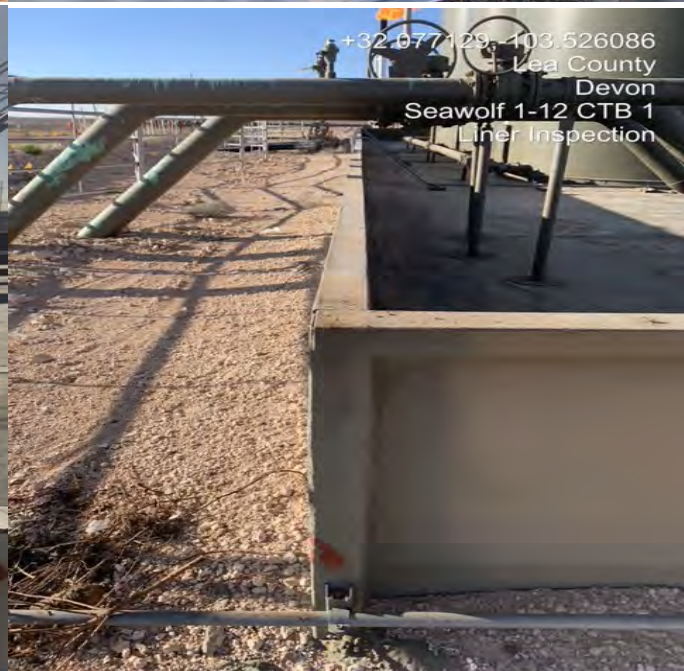
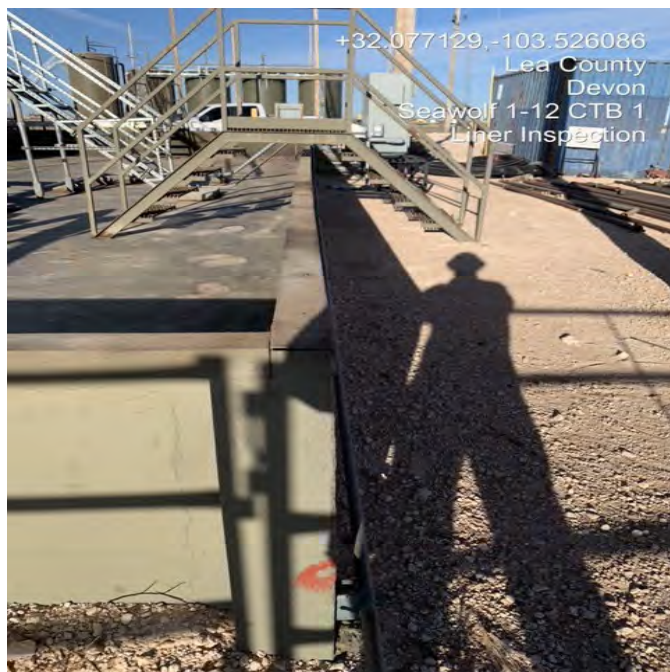
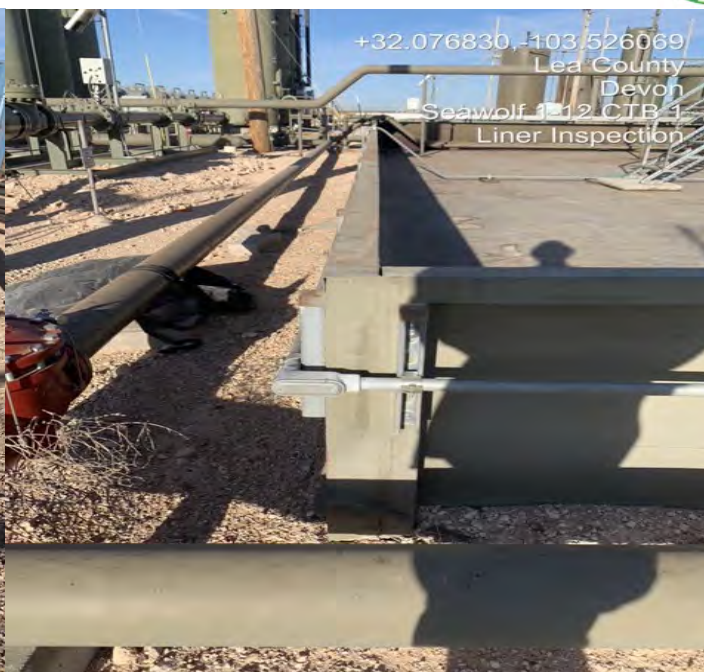
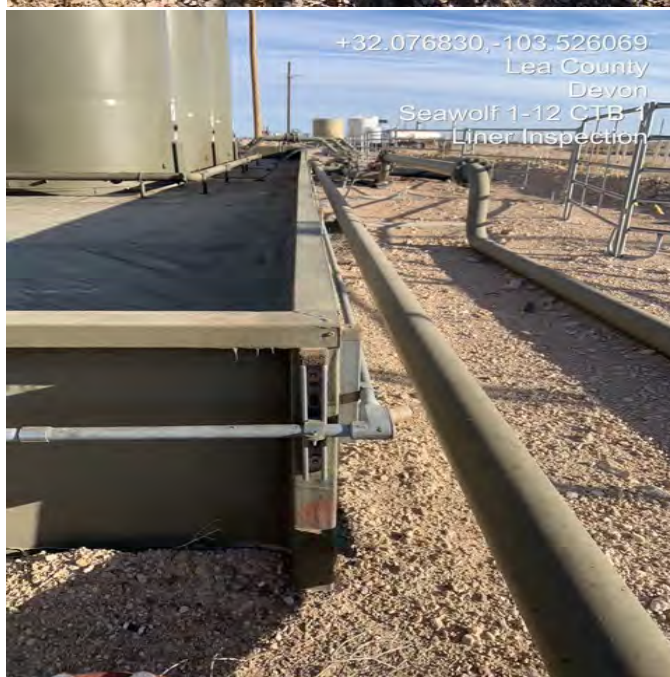
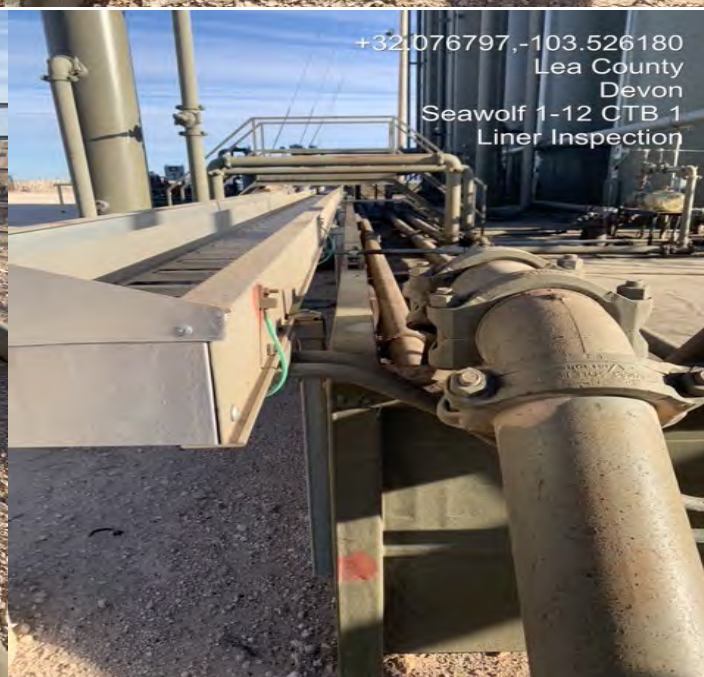
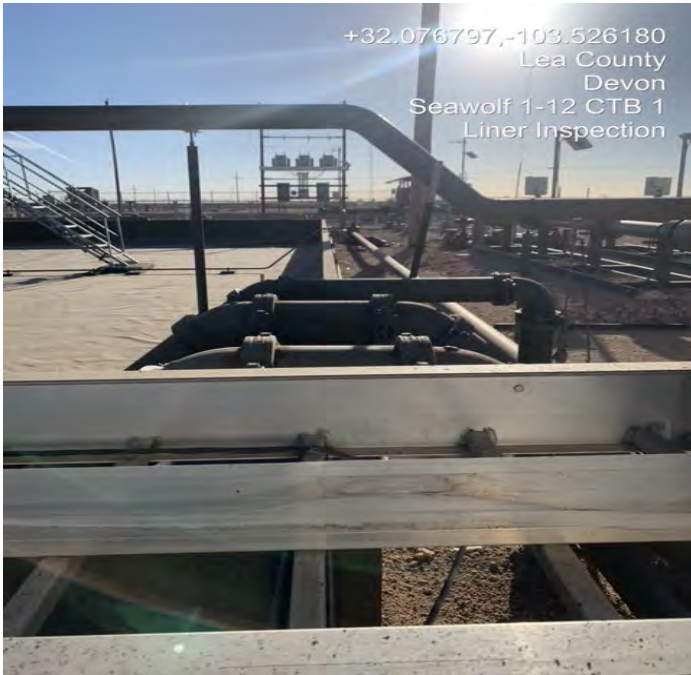
On March 18, 2024, after submitting the 48-hour notification application ID:323658 to the OCD, Pima Environmental conducted a liner inspection at this location. Pima concluded that this liner and containment maintained its integrity and was able to retain the fluids. The liner inspection form and photographic documentation can be found in Appendix C.

Visualization	Yes	No	Comments
Is there a tear in the liner?		X	
Are there holes in the liner?		X	
Is the liner retaining any fluids?		X	
Does the liner have integrity to contain a leak?	X
