**RE: Liner Inspection and Closure Report  
Thoroughbred 10 CTB 3  
API No. N/A  
GPS : Latitude 32.052615 Longitude -103.761754  
UL- O, Section 10, Township 26S, Range 31E  
Eddy County, NM  
NMOCD Reference No. NAPP2320157819**

**SITE PHOTOGRAPHS**  
**DEVON ENERGY – LINER INSPECTION**  
**THOROUGHbred 10 CTB 3**

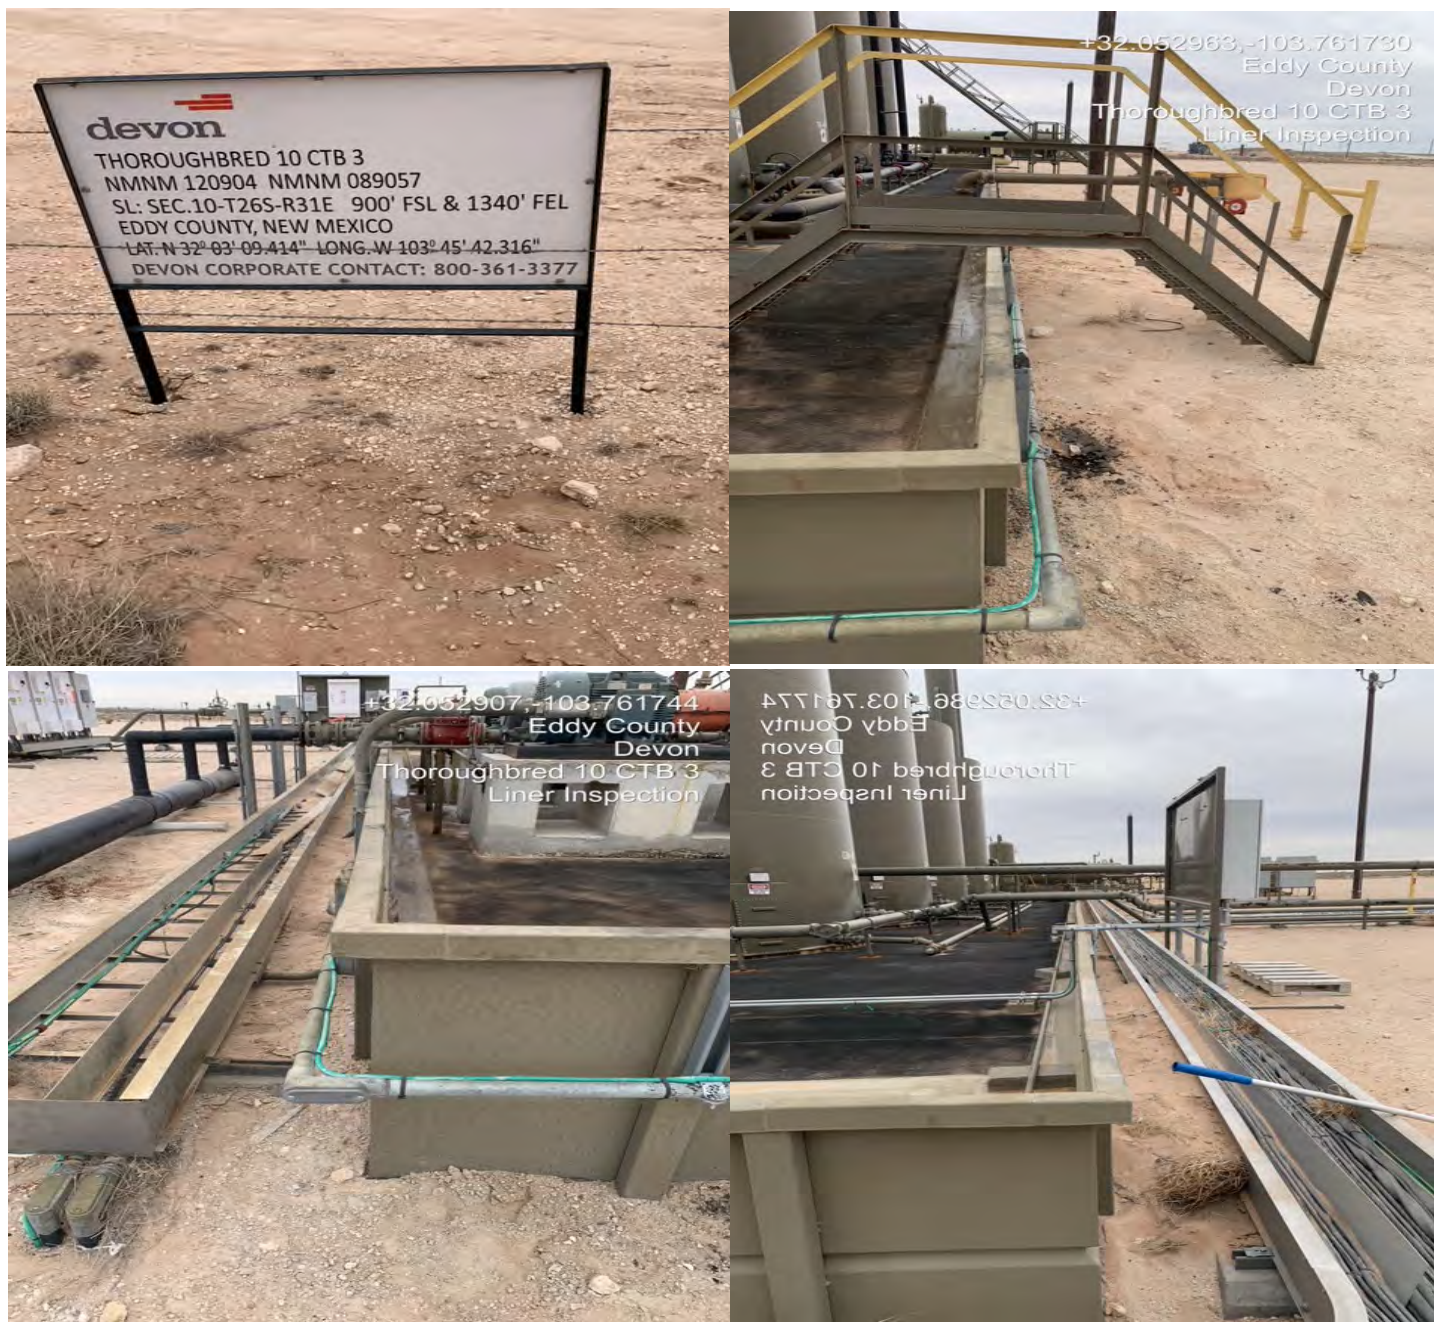
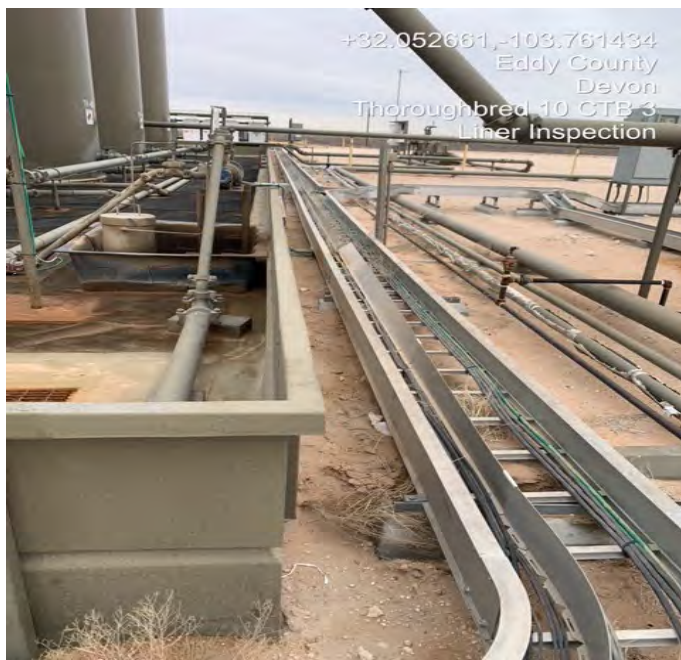
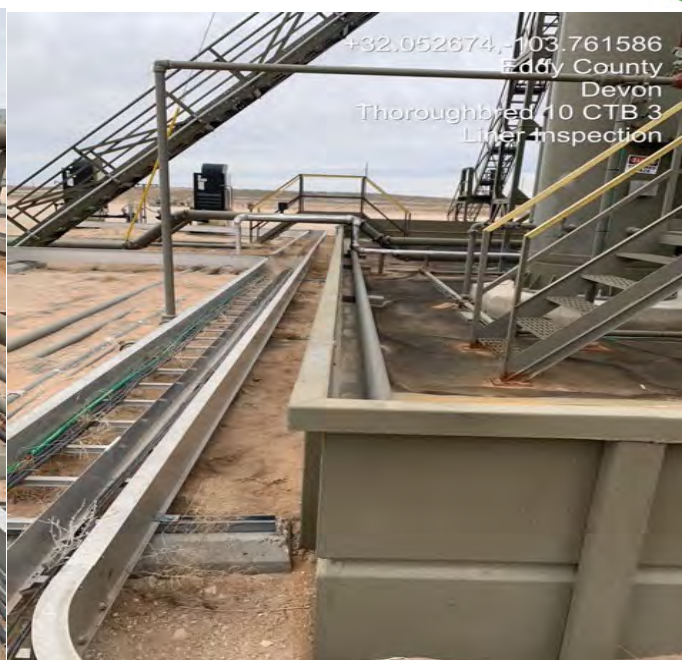
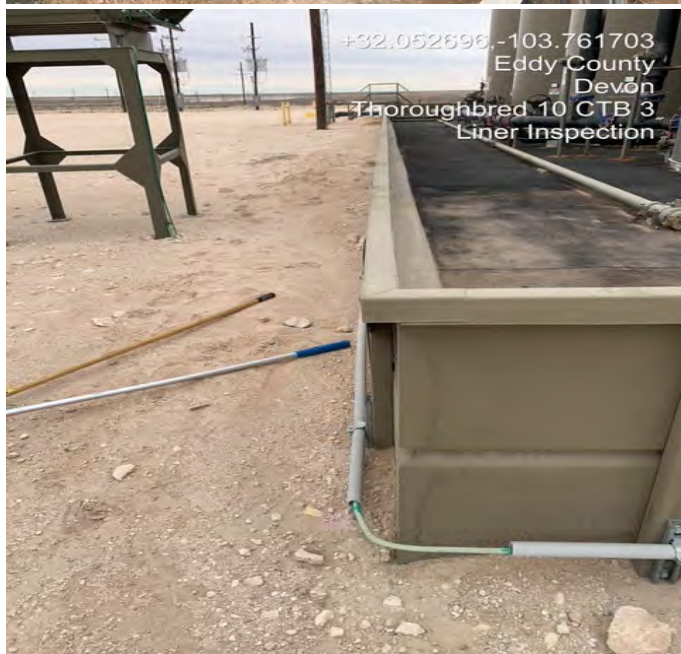
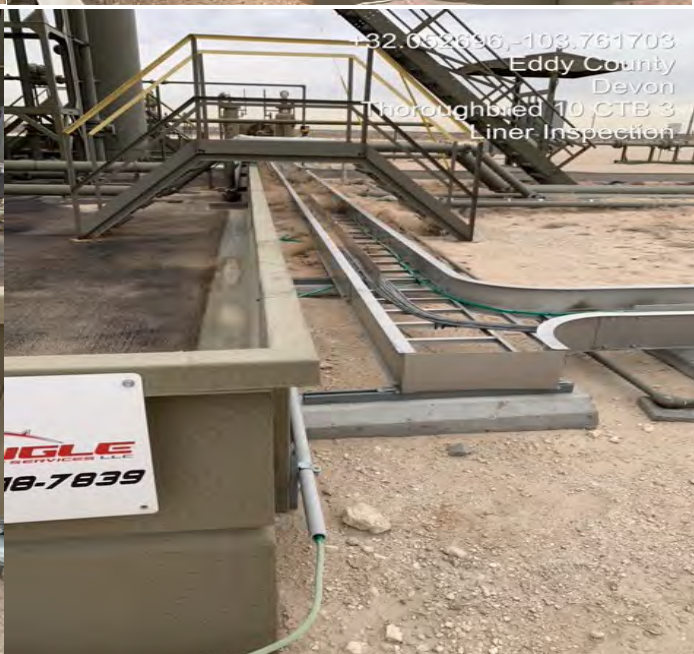
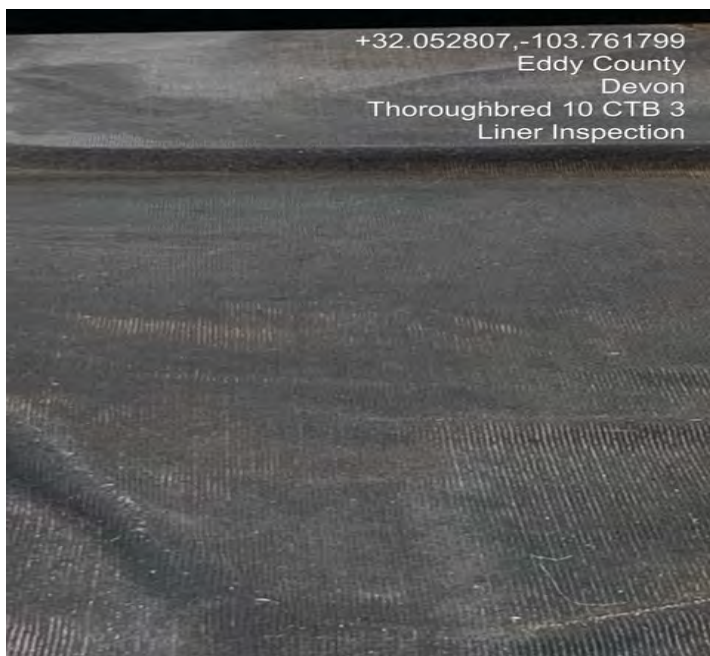
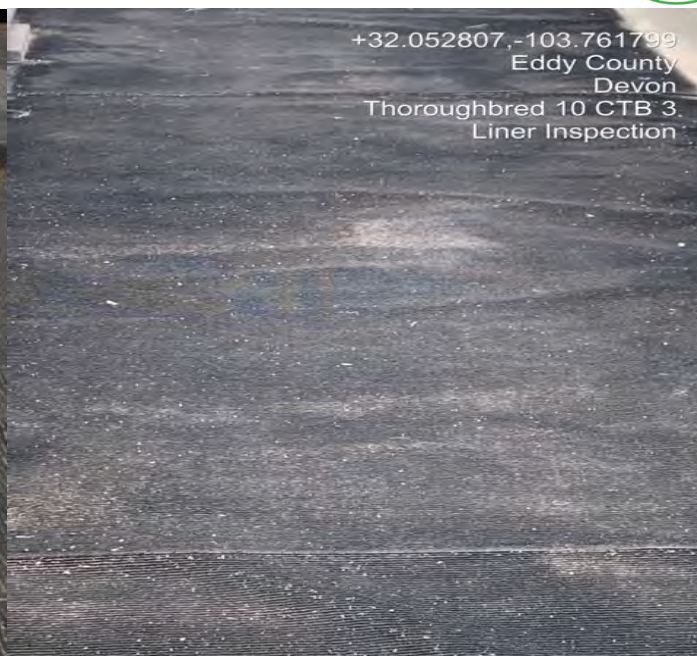
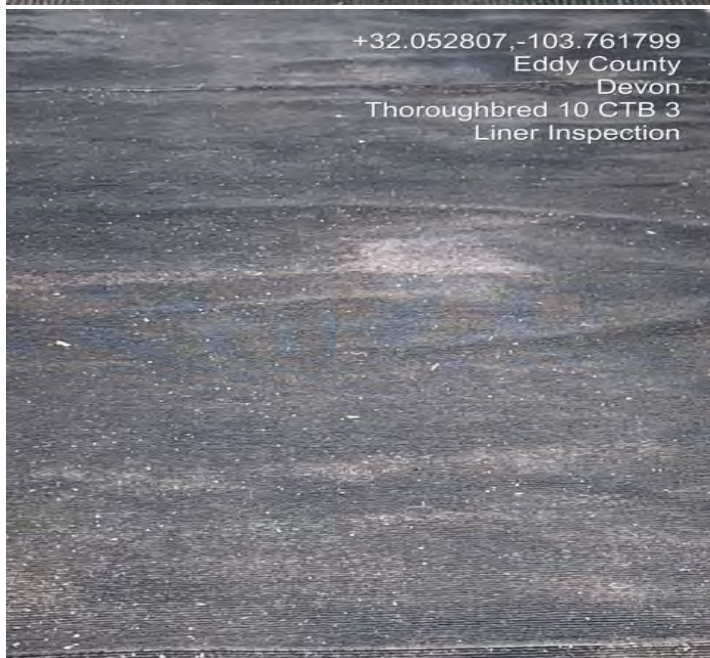
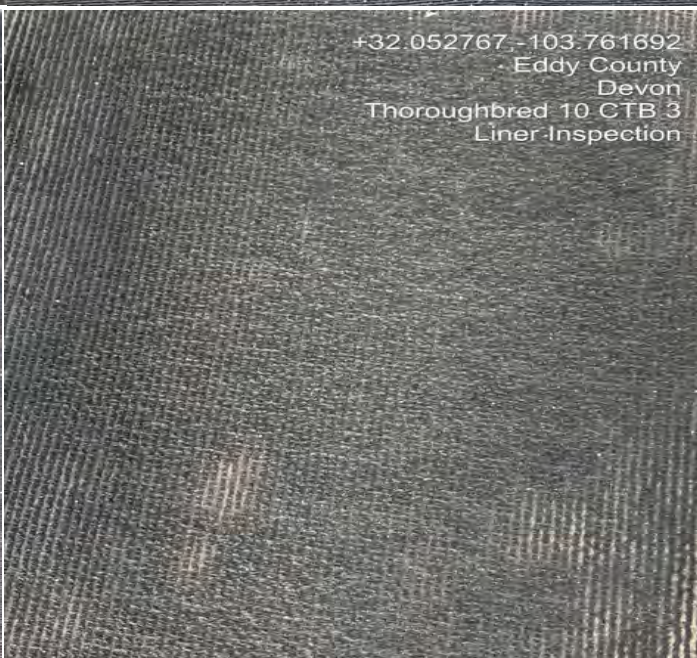
**Liner Inspection**

On February 16, 2024, after submitting the 48-hour notification application ID:314395 to the OCD, Pima Environmental conducted a liner inspection at this location. Pima concluded that this liner and containment maintained its integrity and was able to retain the fluids. The liner inspection form and photographic documentation can be found in Appendix C.

| Visualization | Yes | No | Comments |
|--|---|---|---|
| Is there a tear in the liner? | | X | |
| Are there holes in the liner? | | X | |
| Is the liner retaining any fluids? | | X | |
| Does the liner have integrity to contain a leak? | X | | |
