LINER INSPECTION AND CLOSURE REPORT

REPORTABLE RELEASE

Spur Energy Partners
Vermijo Fed 1 SWD
Incident ID: nAPP2403355380
Eddy County, NM

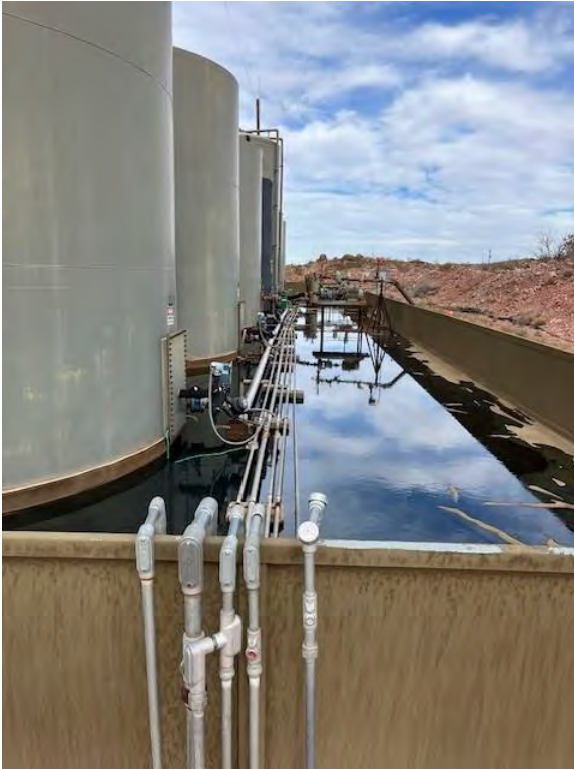
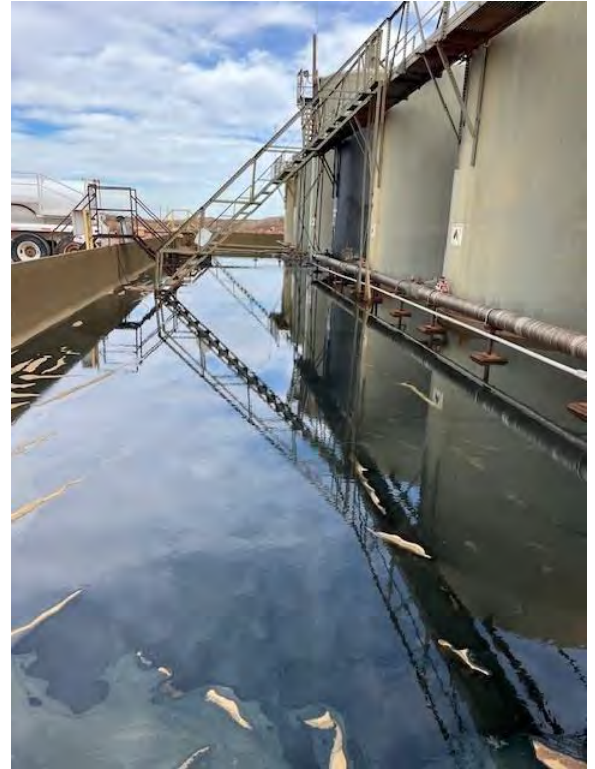
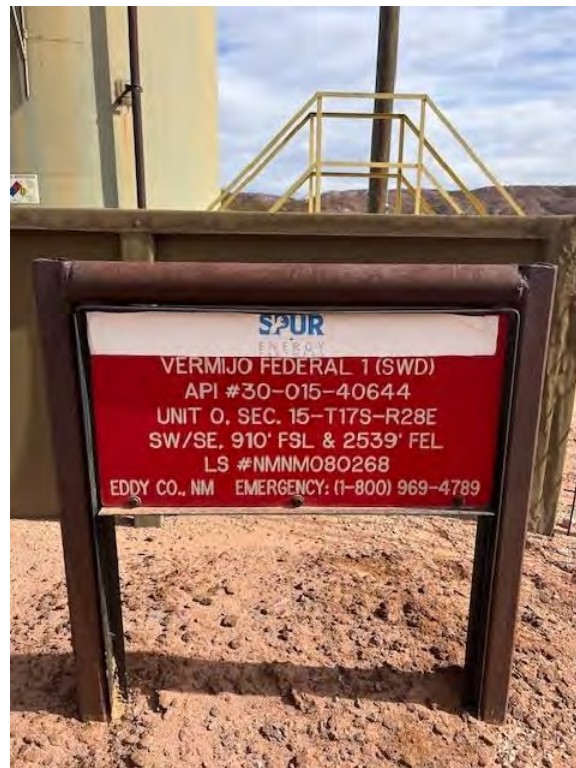
**Photographic Documentation
Incident Pics**

This release was due to equipment failure. A faulty level indicator resulted in the tank overflowing. A vacuum truck was dispatched and recovered 54 bbls of the fluids.

On February 2, 2024, Paragon went to the Vermijo and conducted an initial assessment. There was obvious staining on the liner from the spill. The surface area affected was approximately 3975 s/f. There were no signs outside the containment that the liner had been breached. Therefore, no samples were taken.

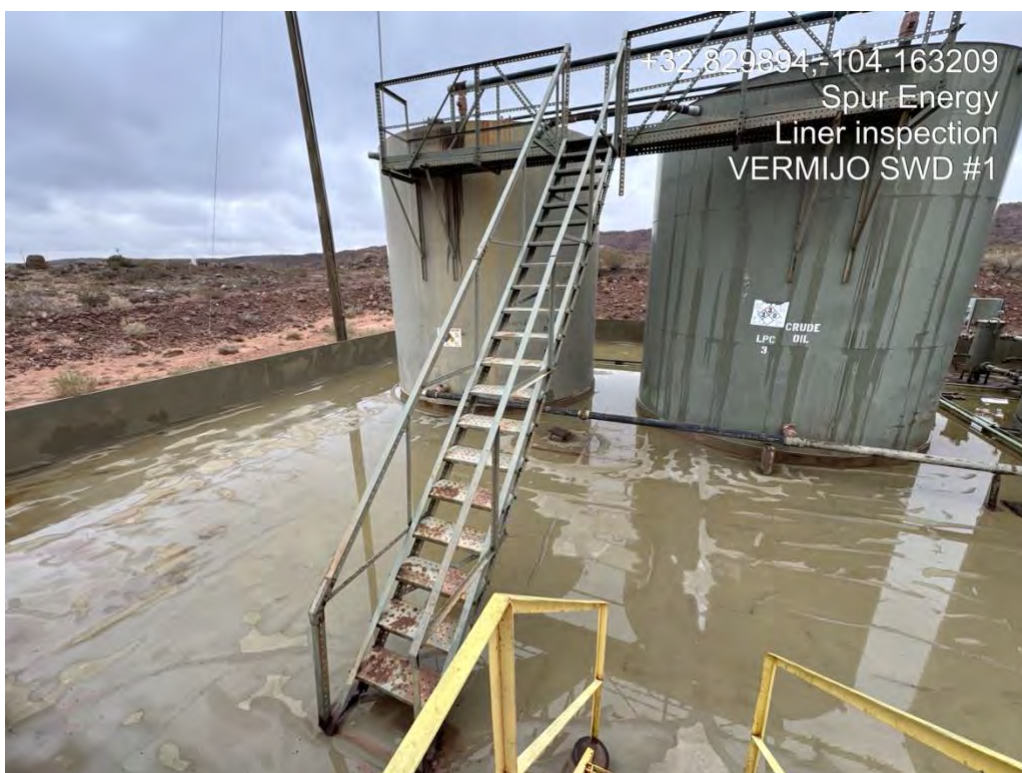
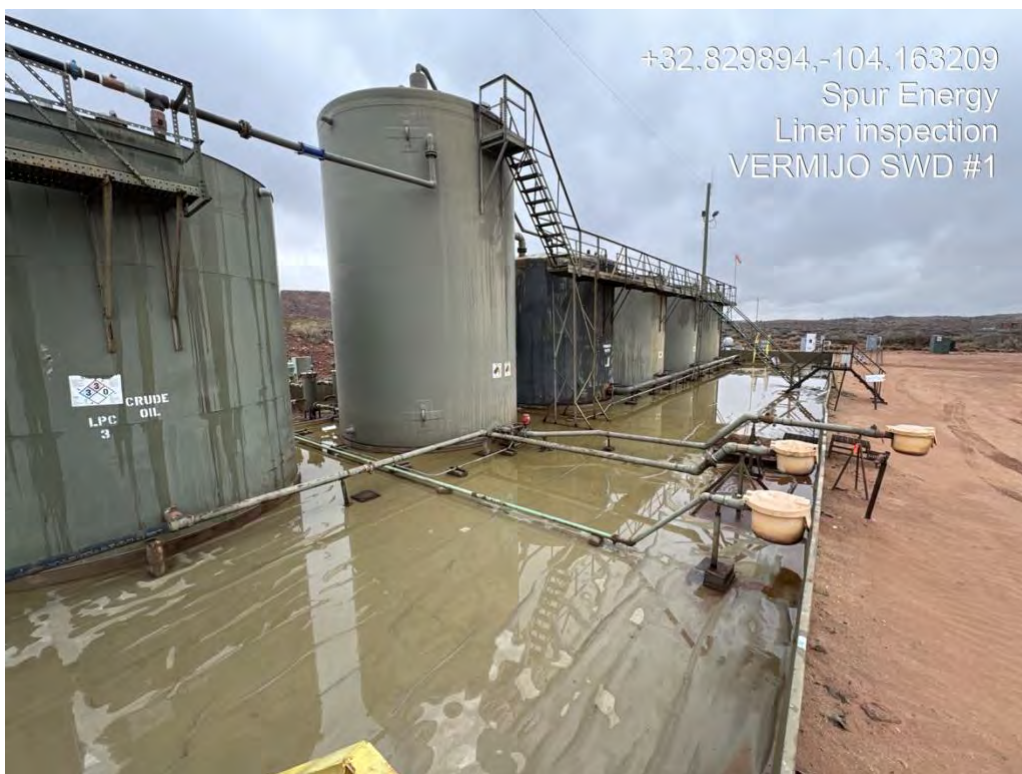
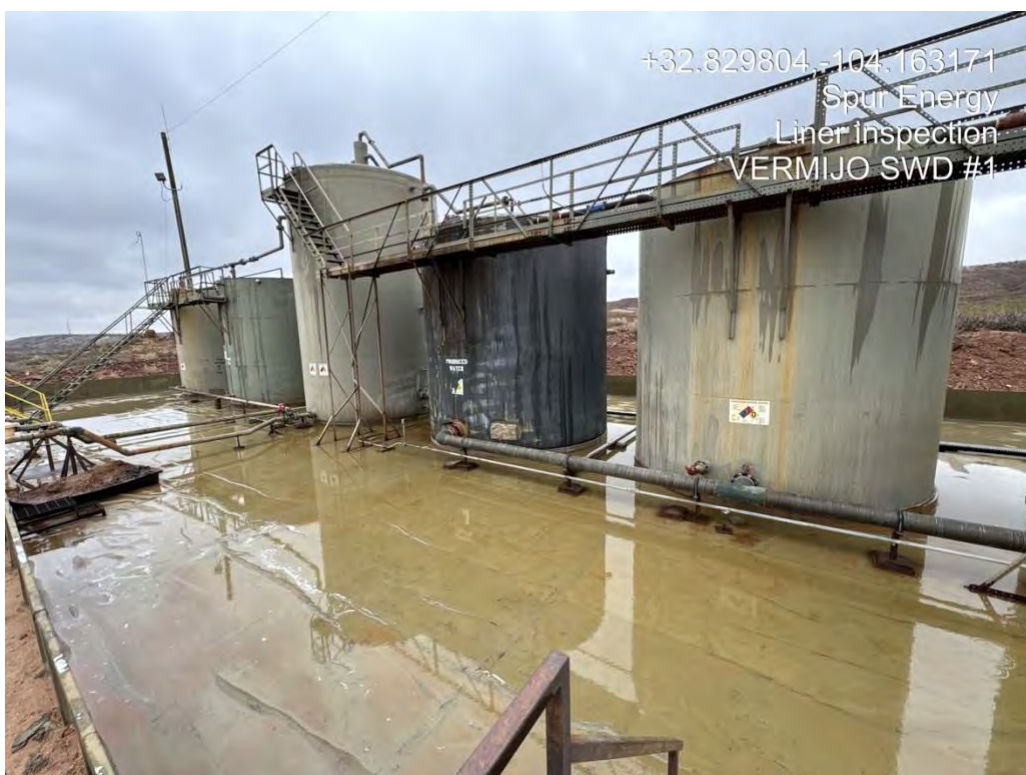
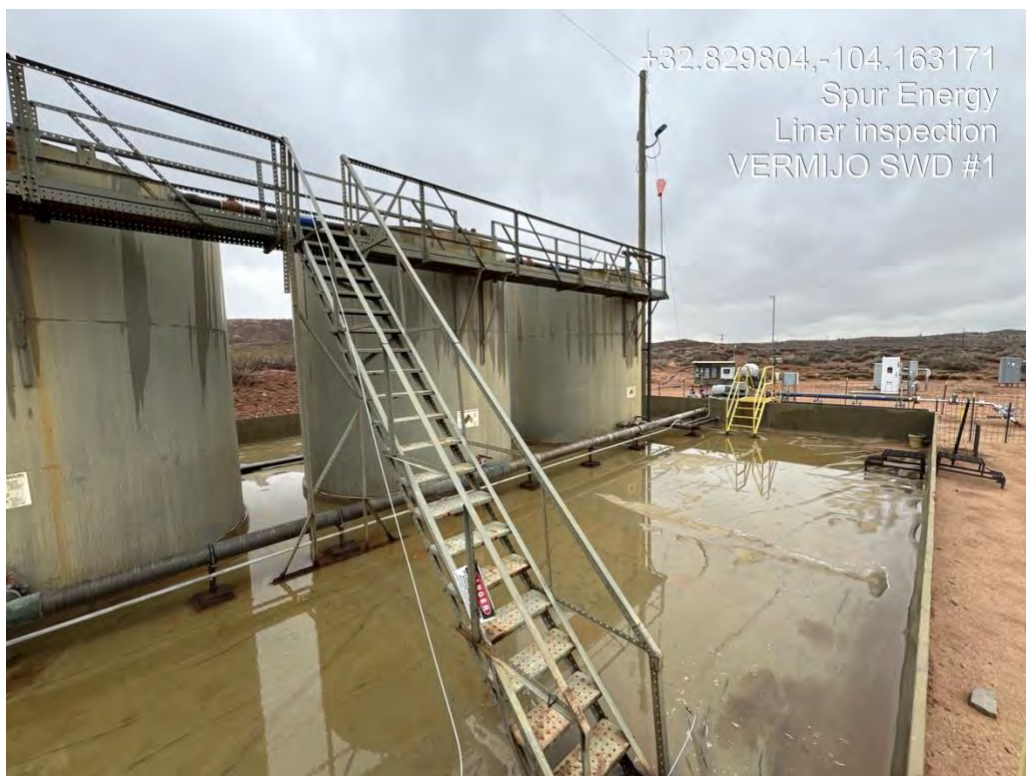
Liner Inspection

Visualization	Yes	No	Comments
Is there a tear in the liner?		x	
Are there holes in the liner?		x	
Is the liner retaining any fluids?	x		Rain Water
Does the liner have integrity to contain a leak?	x
