Pima Environmental Services
5614 N. Lovington Highway
Hobbs, NM 88240
575-964-7740

April 12, 2024

RE: Liner Inspection and Closure Report
Lusitano 27 CTB 3
API No. N/A
GPS : Latitude 32.106037 Longitude -103.769429
UL- C, Section 27, Township 25S, Range 31E
Eddy County, NM
NMOCD Reference No. NAPP2102651517

Liner Inspection

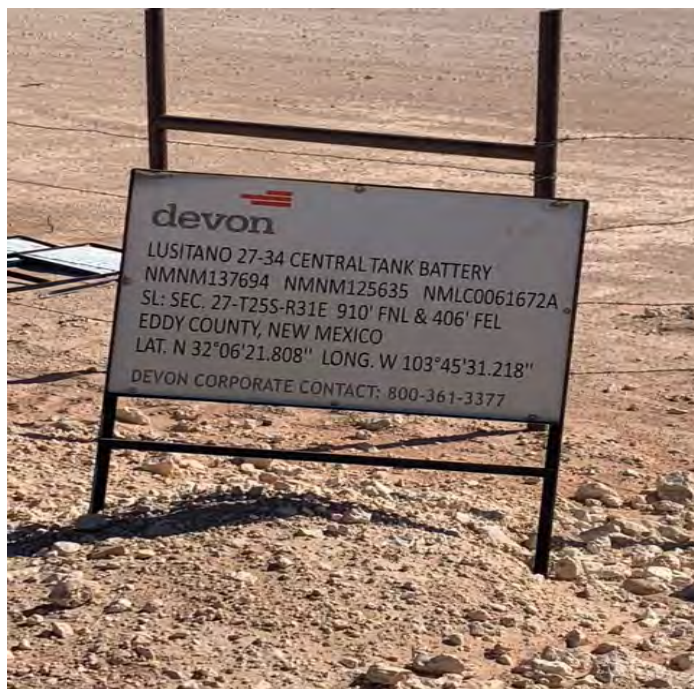
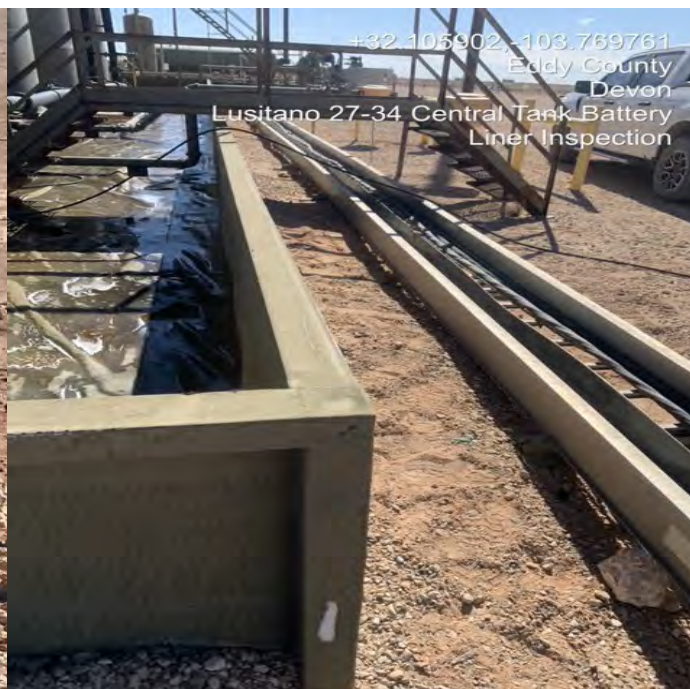
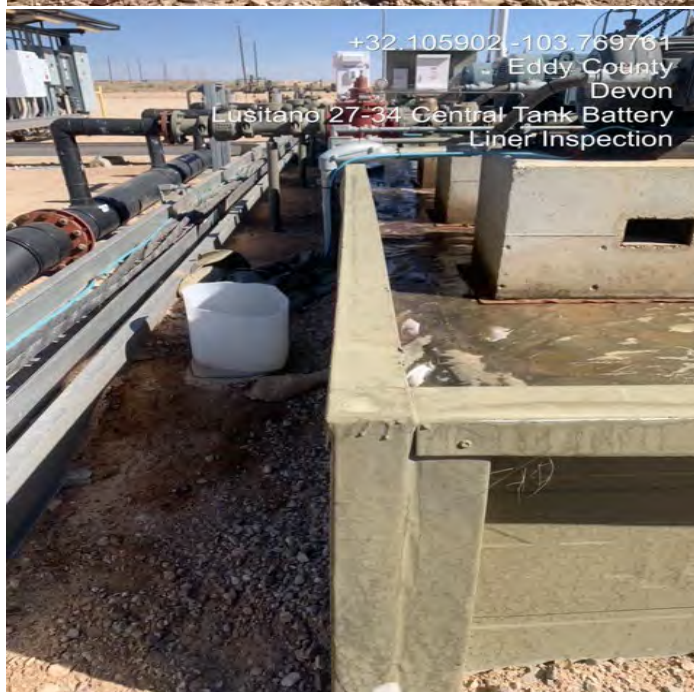
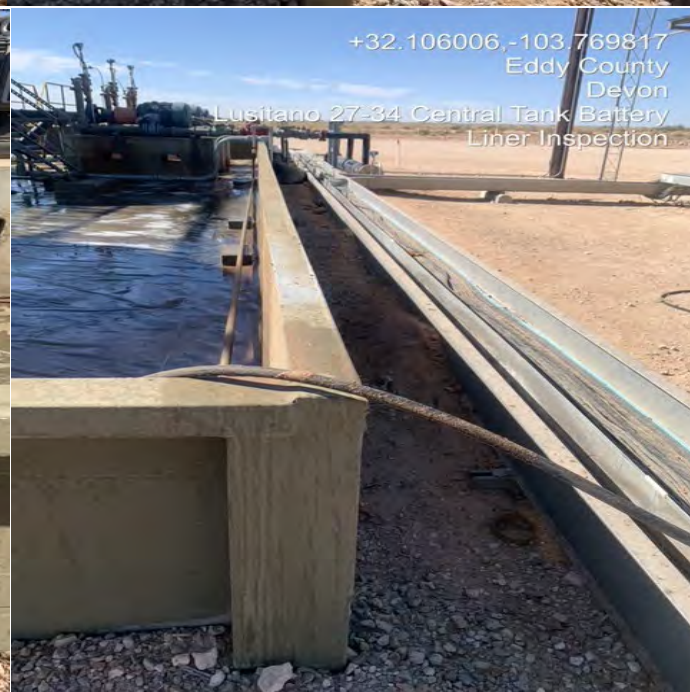
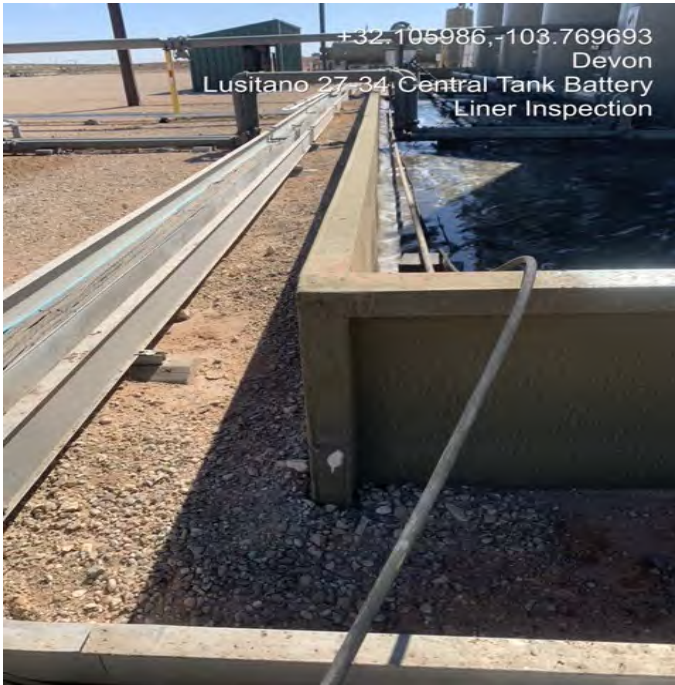
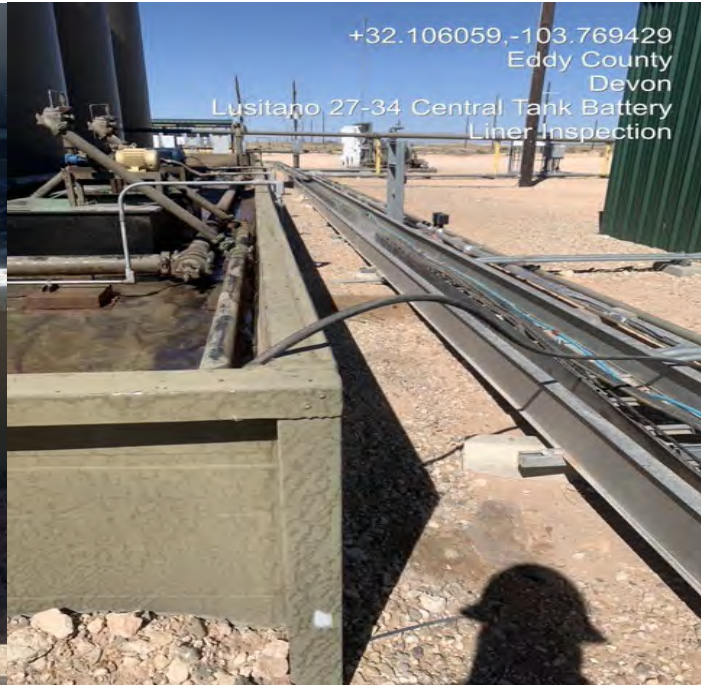
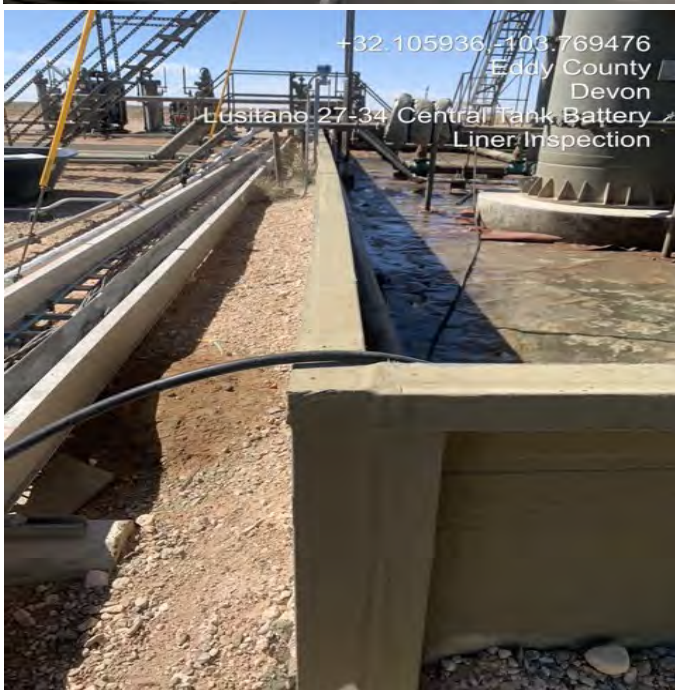
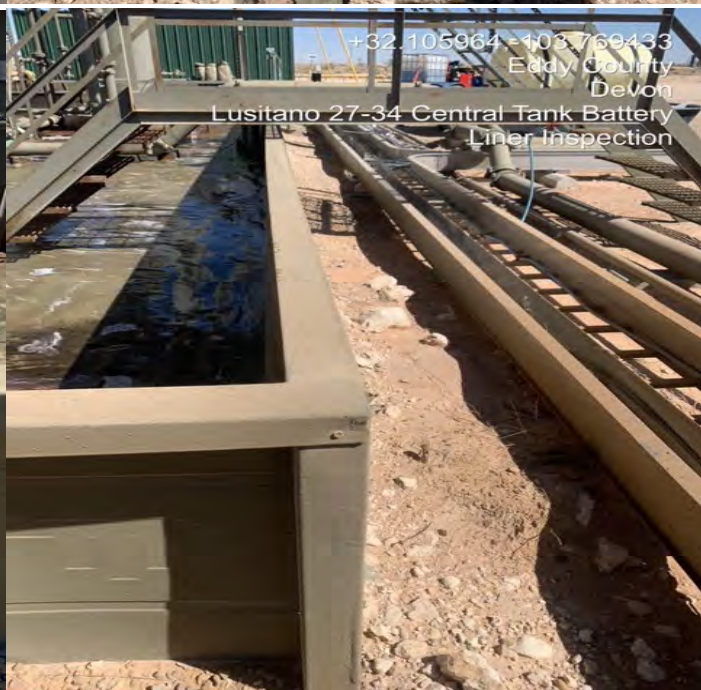
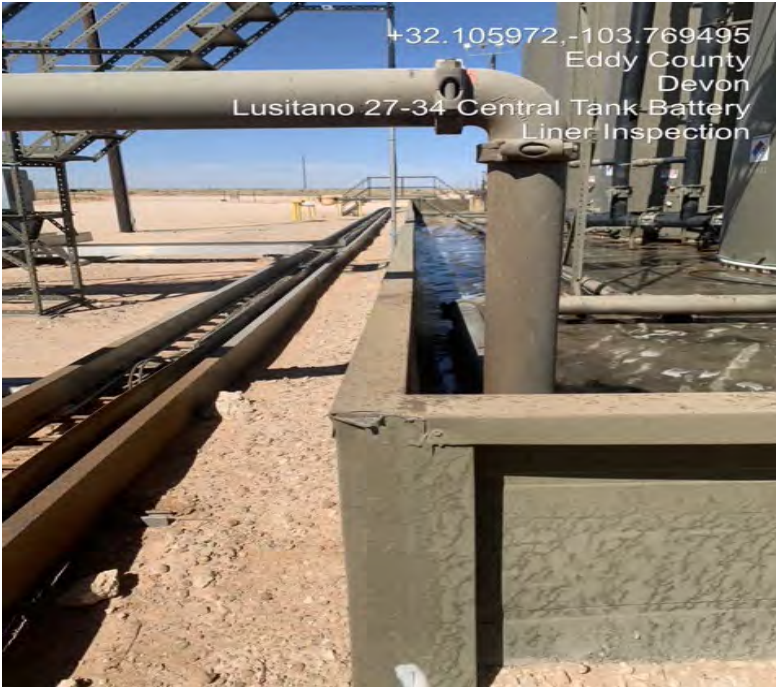
On April 11, 2024, after submitting the 48-hour notification application ID:331345 to the OCD, Pima Environmental conducted a liner inspection at this location. Pima concluded that this liner and containment maintained its integrity and was able to retain the fluids. The liner inspection form and photographic documentation can be found in Appendix C.

Visualization	Yes	No	Comments
Is there a tear in the liner?		X	
Are there holes in the liner?		X	
Is the liner retaining any fluids?	X		Fluid from power washing the Liner
Does the liner have integrity to contain a leak?	X
