LINER INSPECTION AND CLOSURE REPORT

REPORTABLE RELEASE

Spur Energy Partners
Halberd 27 St Com North TB
Incident ID: nAPP2317133379
Eddy County, NM

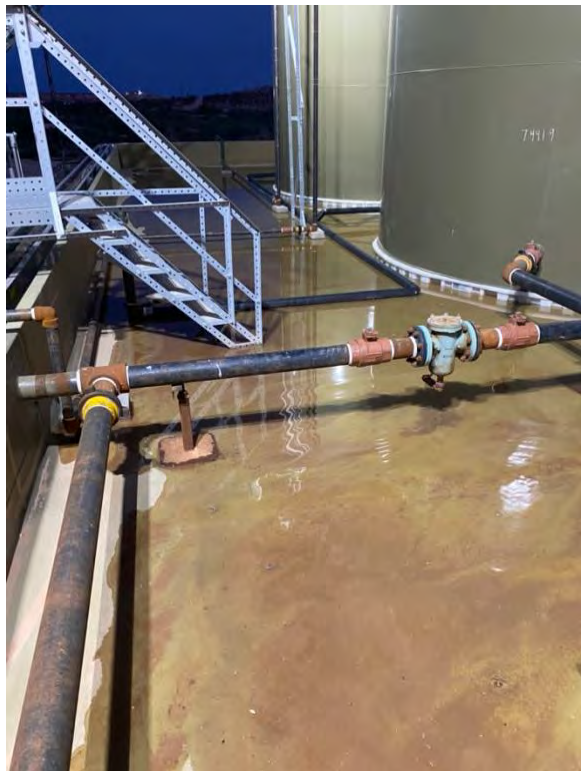
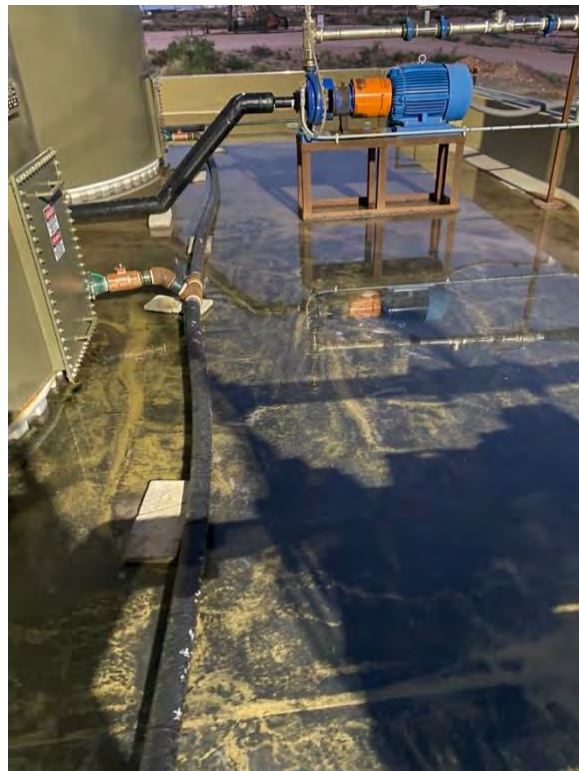
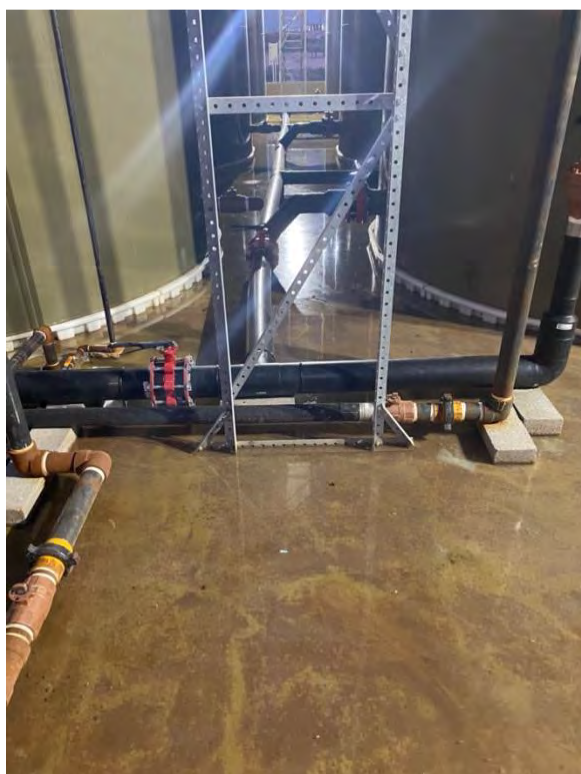
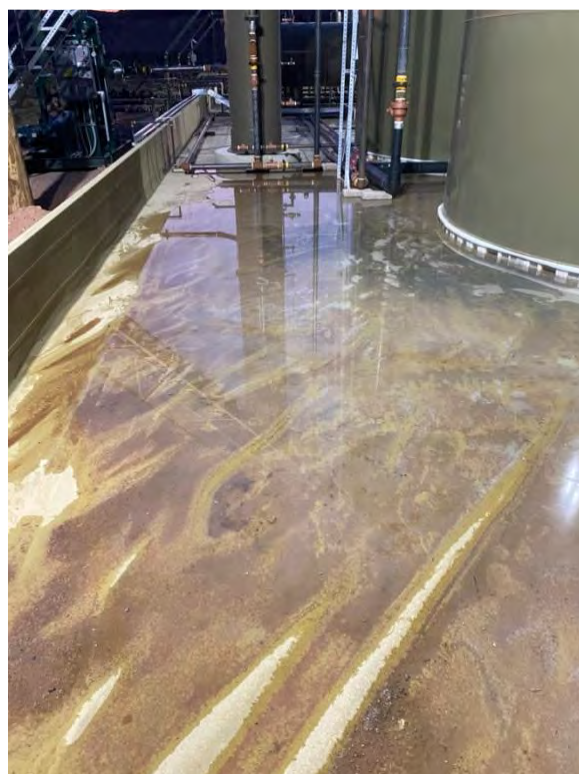
**Photographic Documentation
Initial Pictures**

On June 22, 2023, Paragon went to the Halberd and conducted an initial assessment. There was obvious staining on the liner from the spill. The surface area affected was approximately 1500 s/f. There were no signs outside the containment that the liner had been breached. Therefore, no samples were taken.

On June 23, 2023, Paragon returned to the site to conduct the liner cleaning. No further remediation tasks were needed for this site. On June 26, 2023, a liner inspection notification was emailed to the OCD to conduct a liner inspection on June 28, 2023, Appendix C. Pictures and a liner inspection report are also attached in Appendix C.

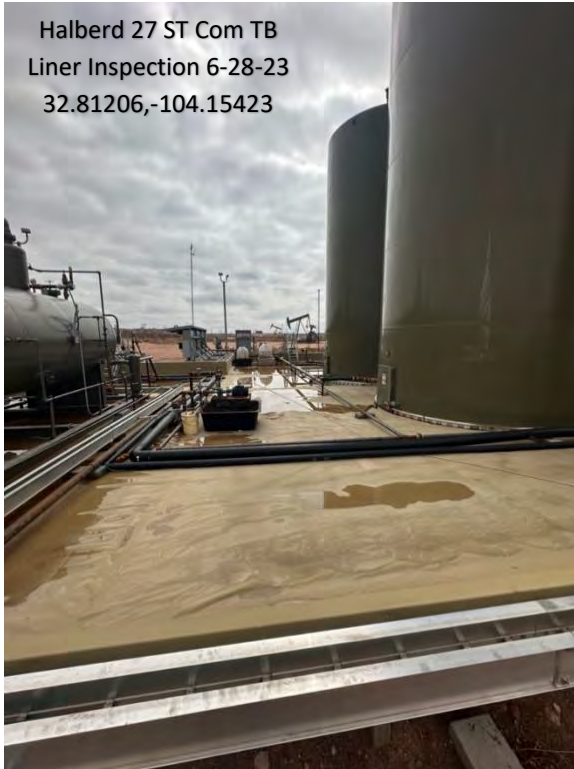
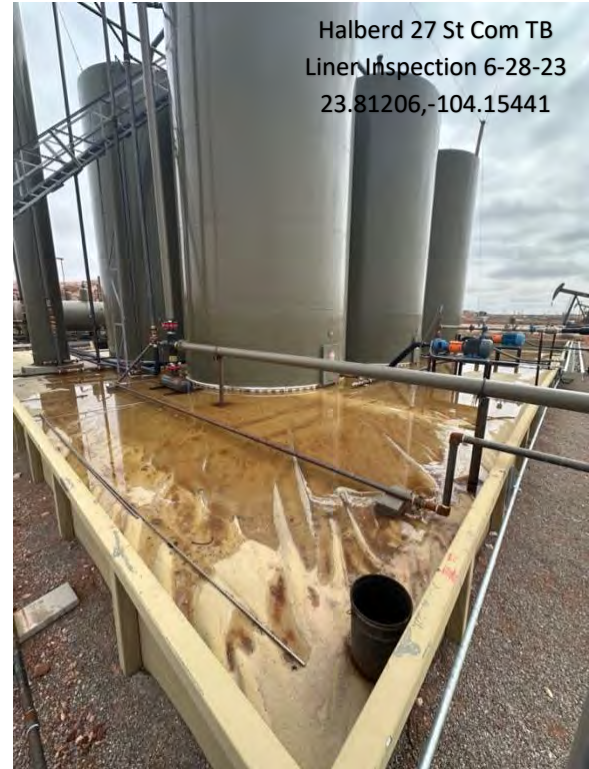
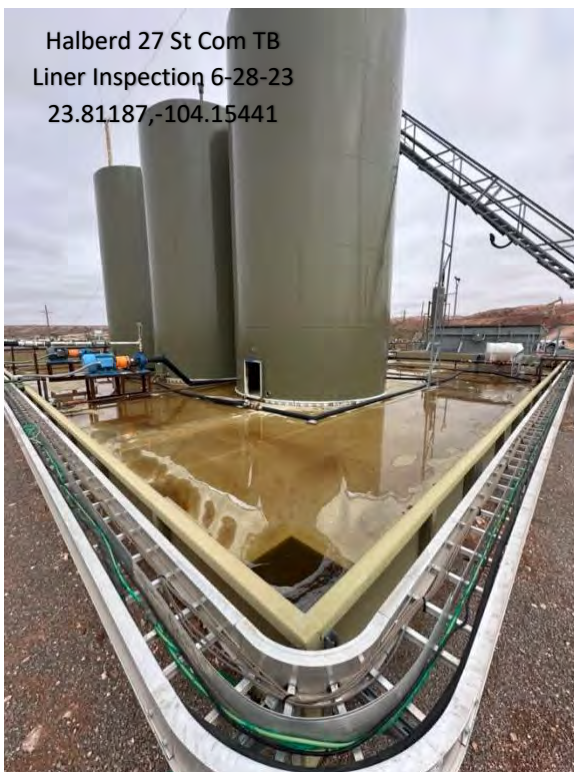
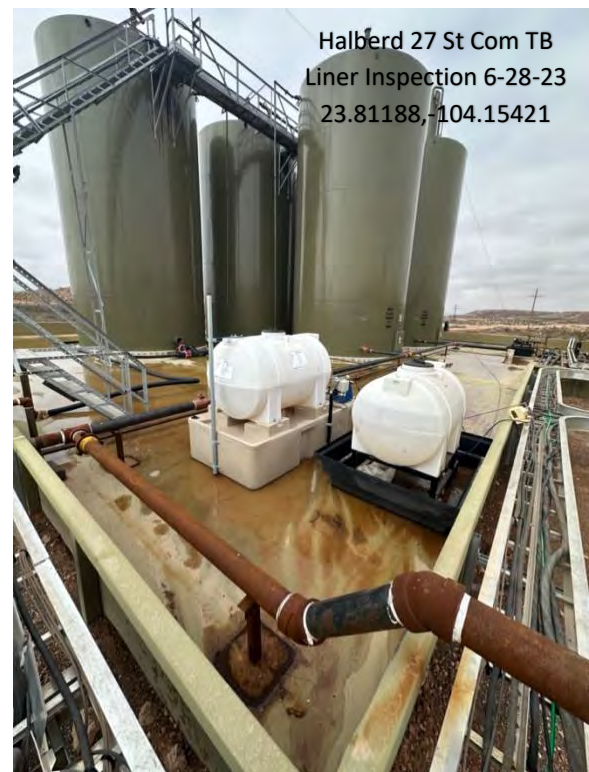
Liner Inspection

Visualization	Yes	No	Comments
Is there a tear in the liner?		x	
Are there holes in the liner?		x	
Is the liner retaining any fluids?	x		Rain Water
Does the liner have integrity to contain a leak?	x
