BELLOQ 11 CTB 1

napp2406225921

RE: Liner Inspection and Closure Report
Belloq 11 CTB 1
API No. N/A
GPS : Latitude 32.31470991 Longitude -103.7534005
UL- M, Section 11, Township 23S, Range 31E
Eddy County, NM
NMOCD Reference No. NAPP2406225921

Liner Inspection

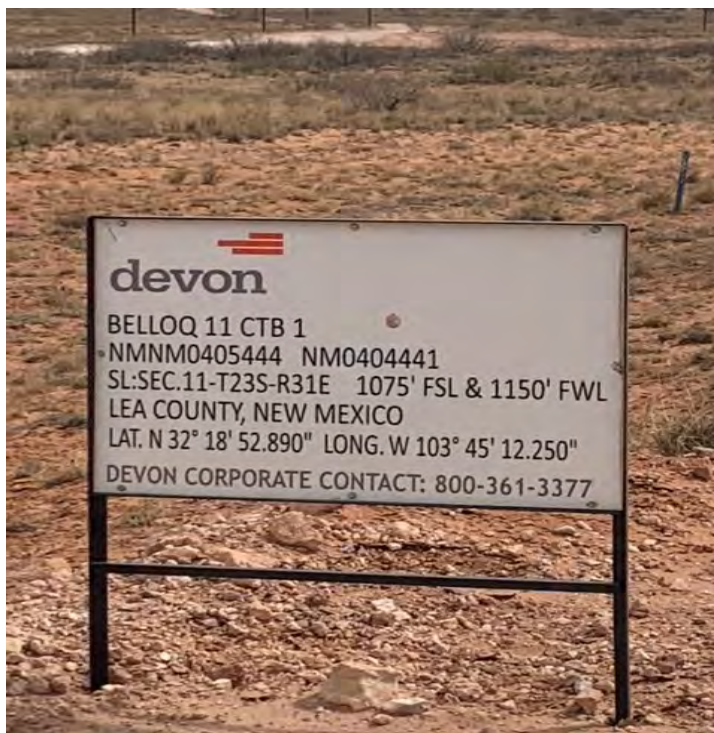
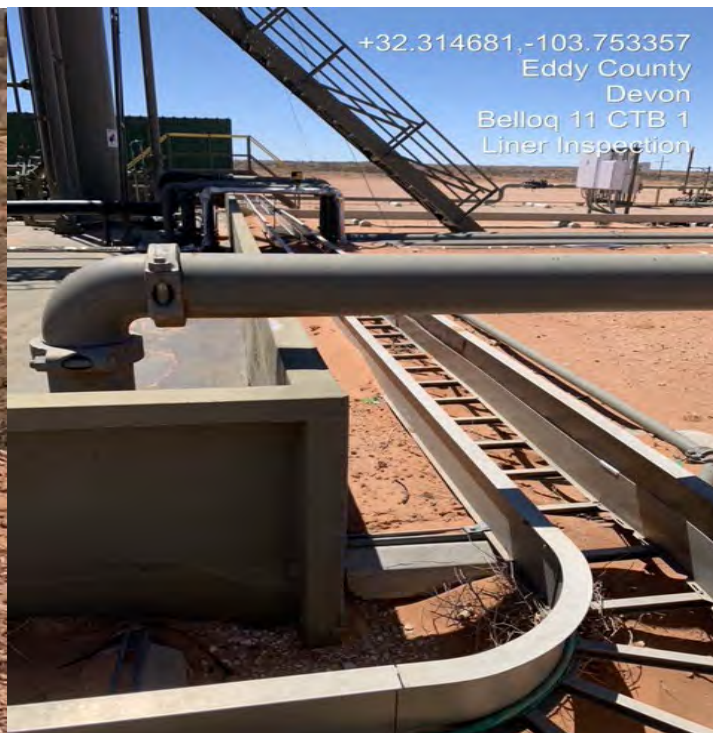
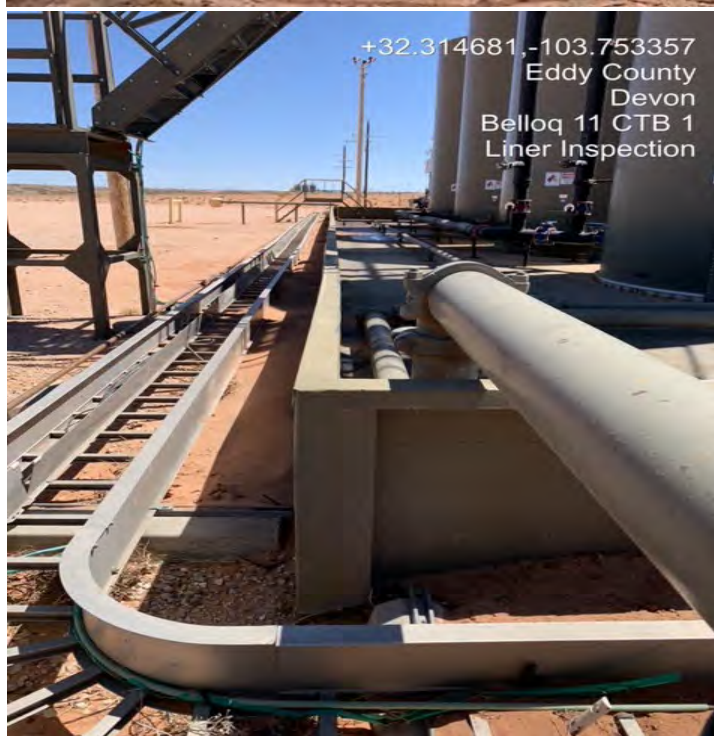
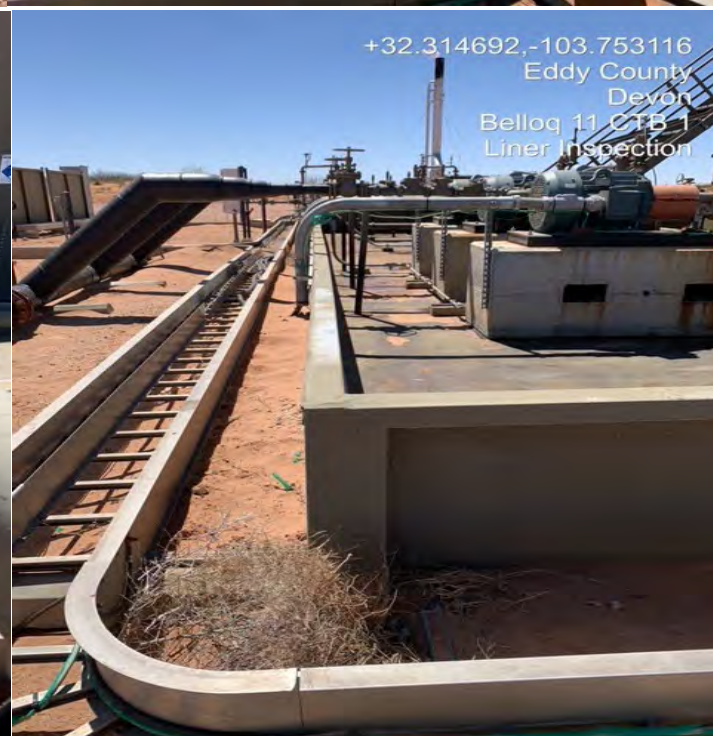
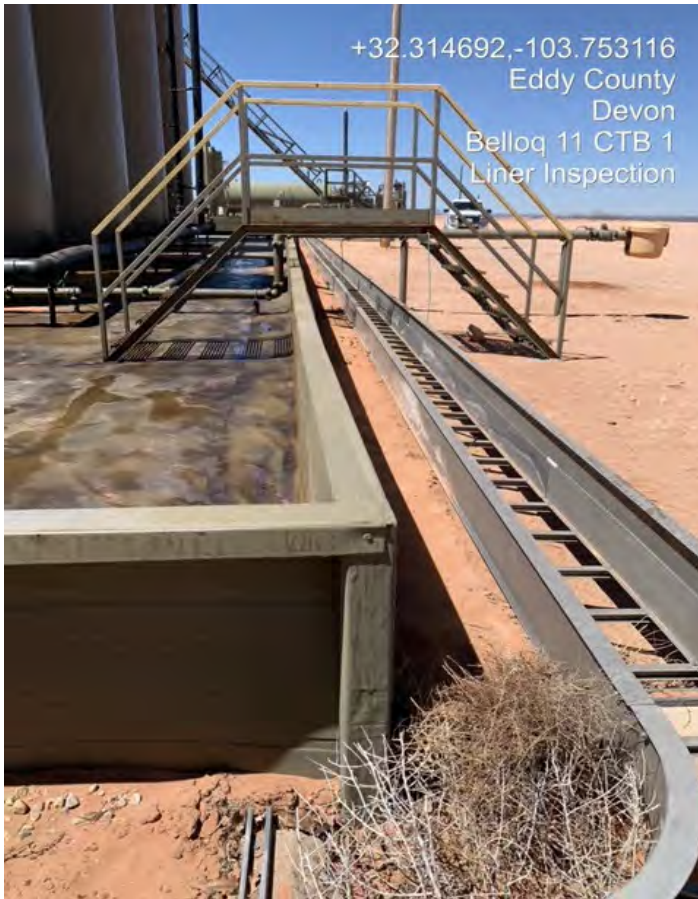
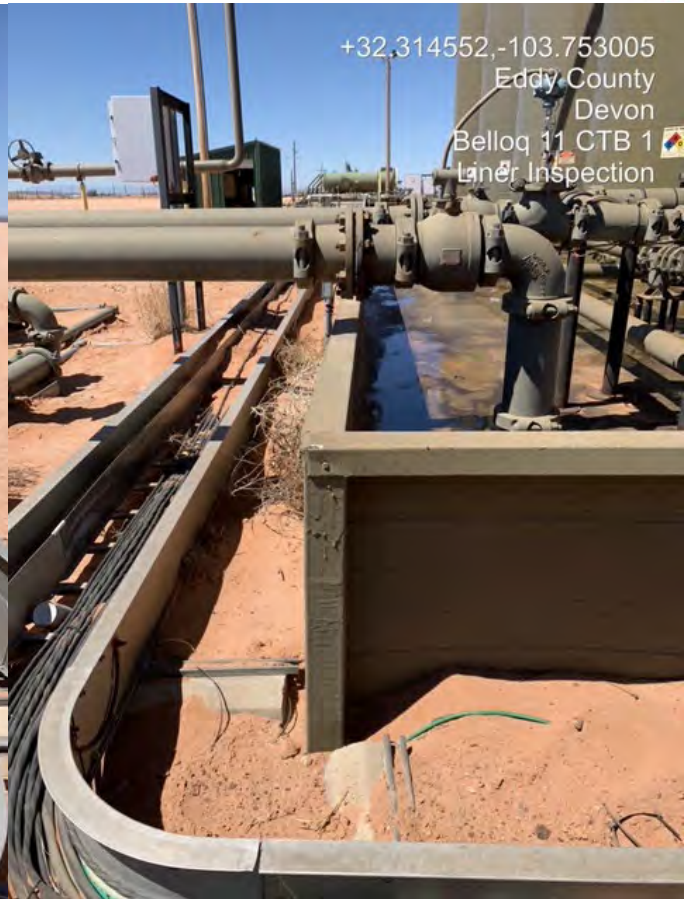
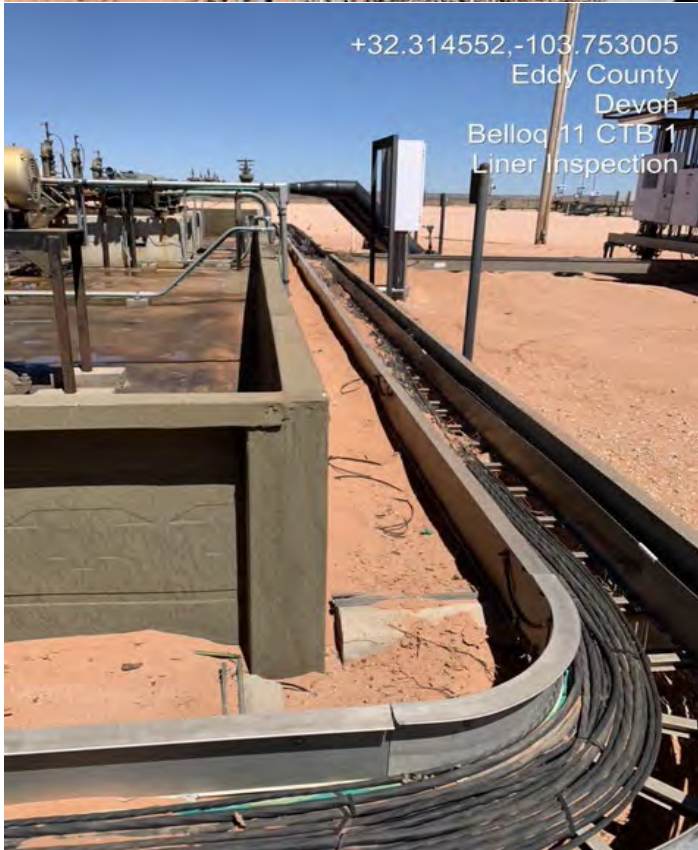
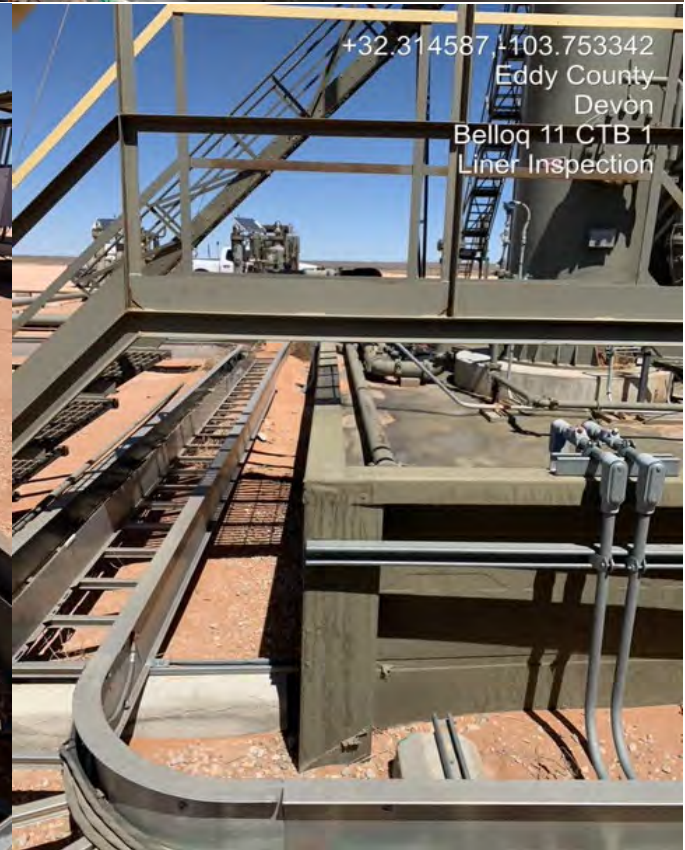
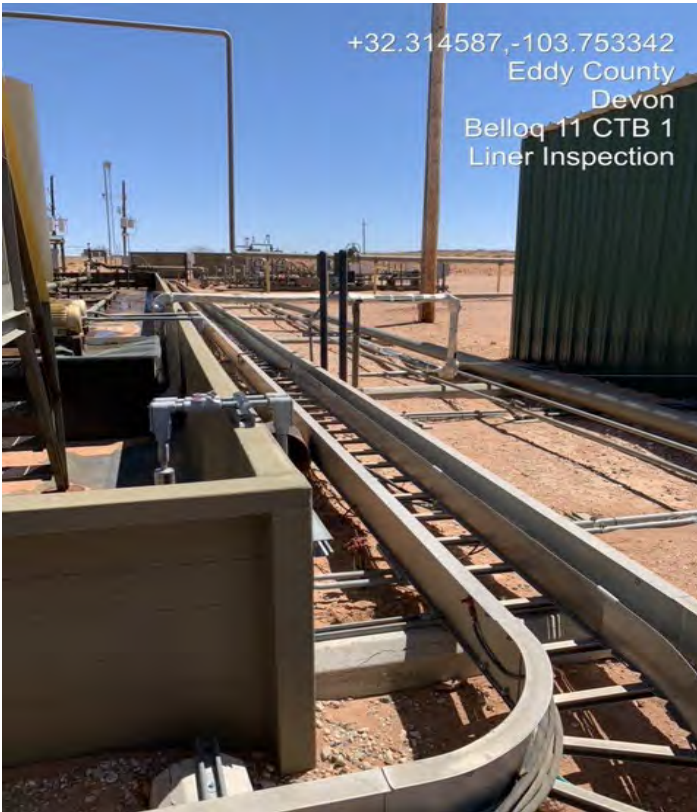
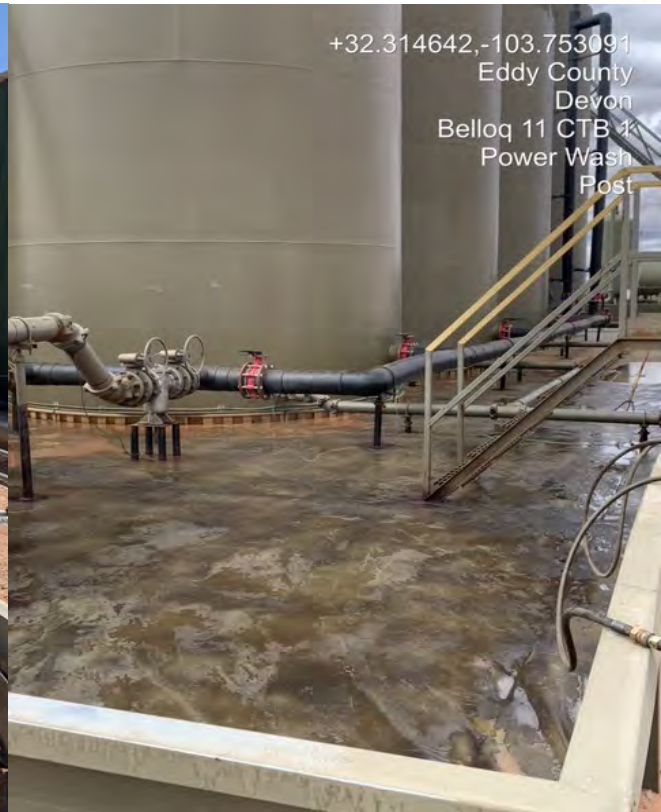
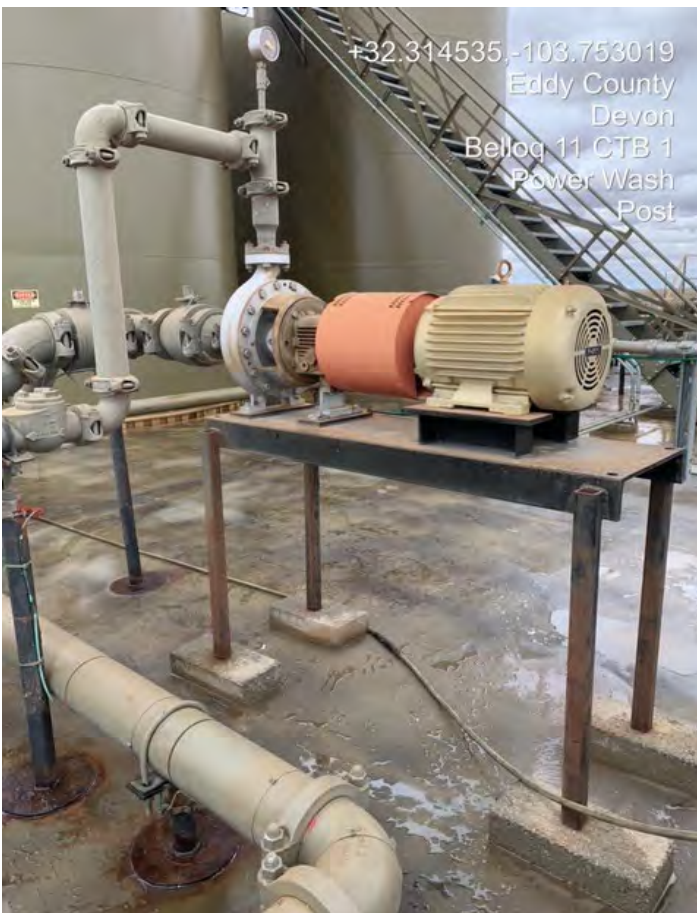
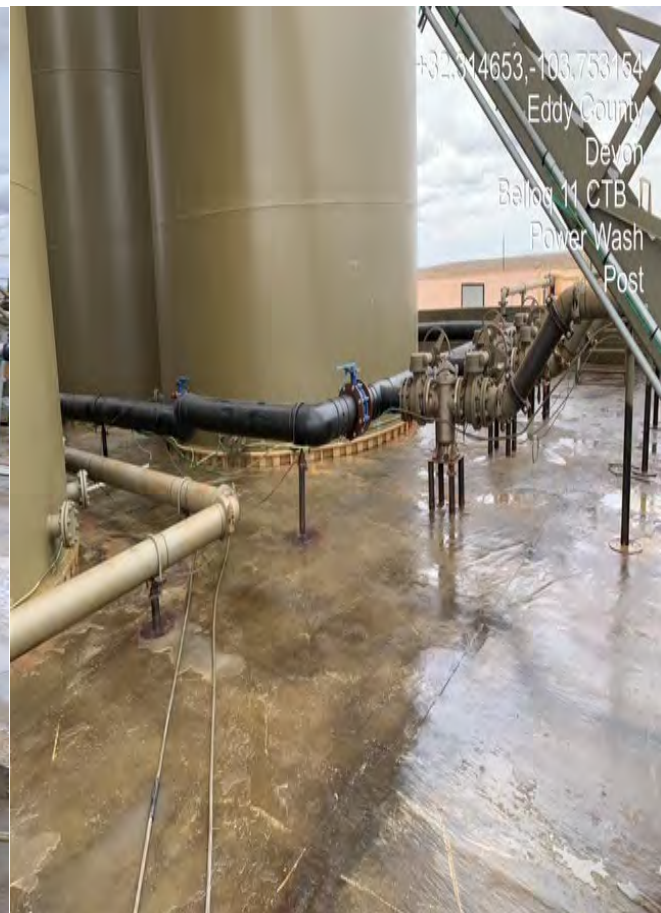
On April 11, 2024, after submitting the 48-hour notification application ID:331339 to the OCD, Pima Environmental conducted a liner inspection at this location. Pima concluded that this liner and containment maintained its integrity and was able to retain the fluids. The liner inspection form and photographic documentation can be found in Appendix C.

Visualization	Yes	No	Comments
Is there a tear in the liner?		X	
Are there holes in the liner?		X	
Is the liner retaining any fluids?	X		Fluid from power washing the Liner
Does the liner have integrity to contain a leak?	X
