**Pima Environmental Services**  
**5614 N. Lovington Highway**  
**Hobbs, NM 88240**  
**575-964-7740**

April 12, 2024

**RE: Liner Inspection and Closure Report**  
**Lusitano 27 CTB 3**  
**API No. N/A**  
**GPS : Latitude 32.106037 Longitude -103.769429**  
**UL- C, Section 27, Township 25S, Range 31E**  
**Eddy County, NM**  
**NMOCD Reference No. NAPP2313222791**

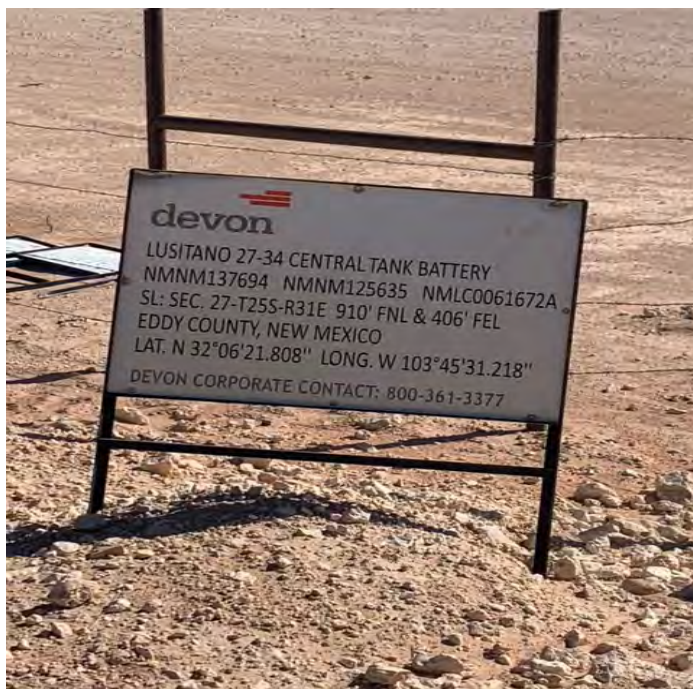
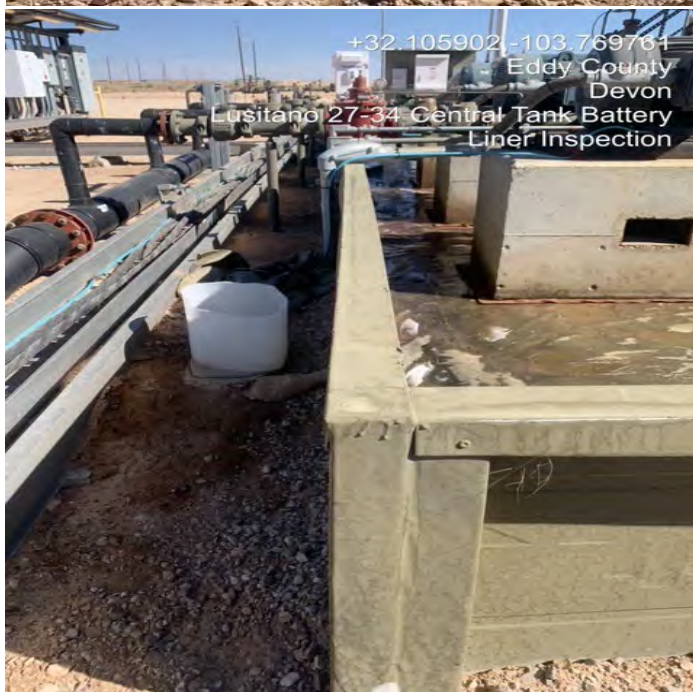
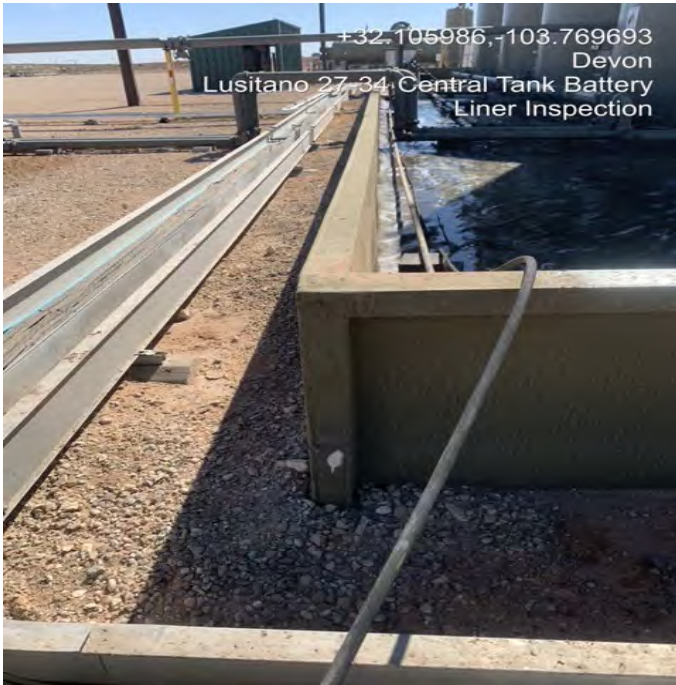
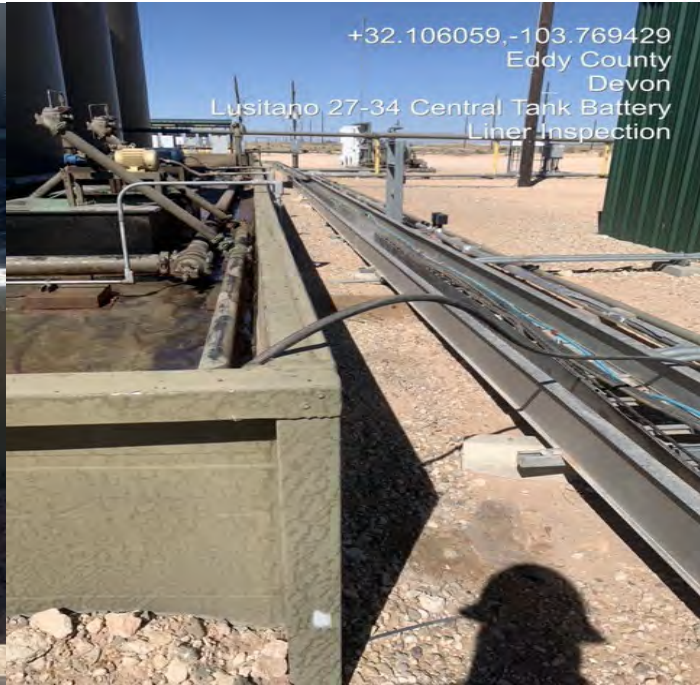
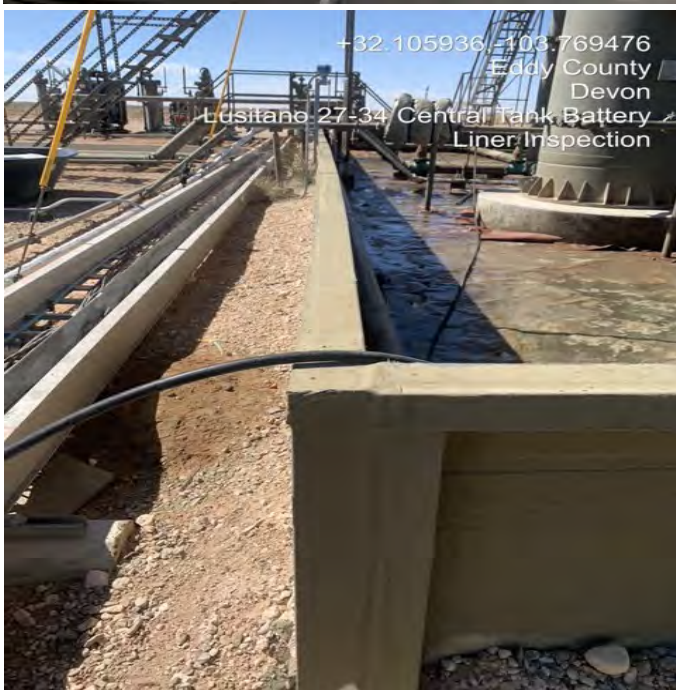
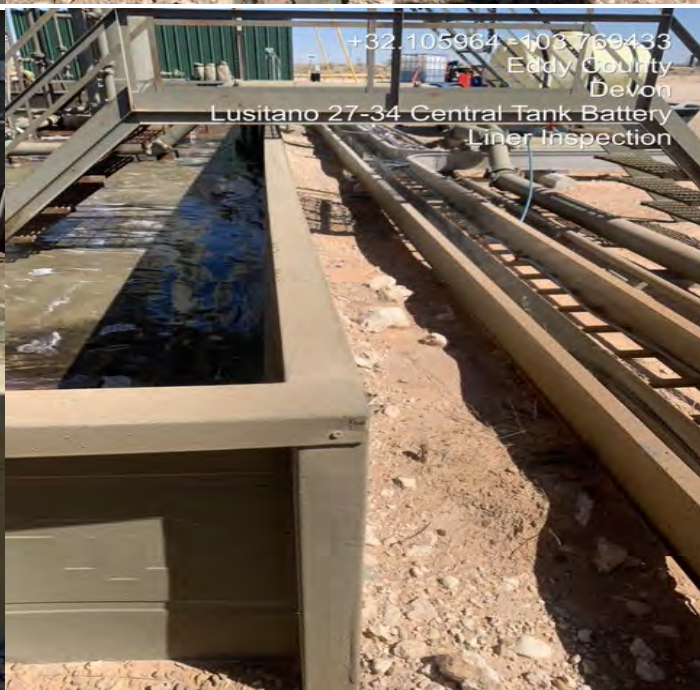
#### Liner Inspection

On April 11, 2024, after submitting the 48-hour notification application ID:331344 to the OCD, Pima Environmental conducted a liner inspection at this location. Pima concluded that this liner and containment maintained its integrity and was able to retain the fluids. The liner inspection form and photographic documentation can be found in Appendix C.

| Visualization | Yes | No | Comments |
|---|---|---|---|
| Is there a tear in the liner? | | X | |
| Are there holes in the liner? | | X | |
| Is the liner retaining any fluids? | X | | Fluid from power washing the Liner |
| Does the liner have integrity to contain a leak? | X | | |
