COTTON DRAW 14 BATTERY

April 25, 2024

RE: Liner Inspection and Closure Report
Cotton Draw 14 Battery
API No. N/A
GPS : Latitude 32.13675214 Longitude -103.7534162
UL- D, Section 14, Township 25S, Range 31E
Eddy County, NM
NMOCD Reference No. NAPP2410024170

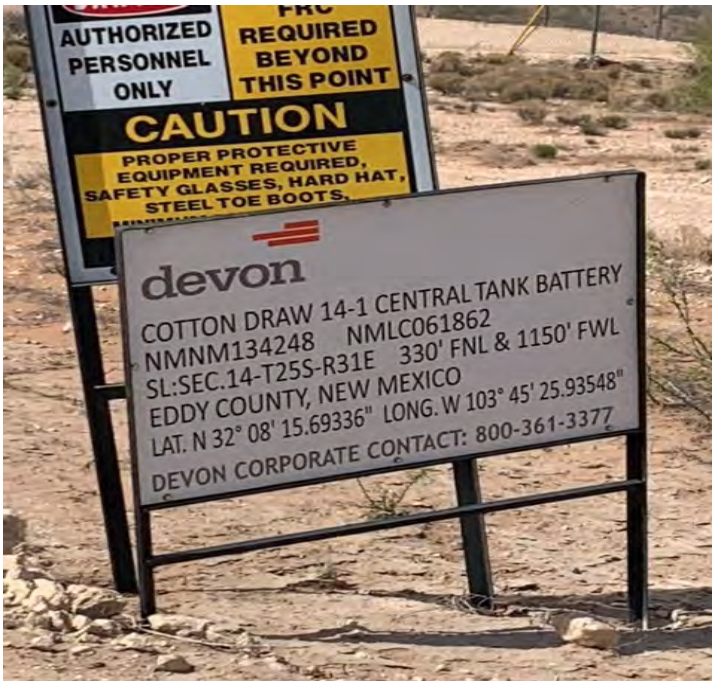
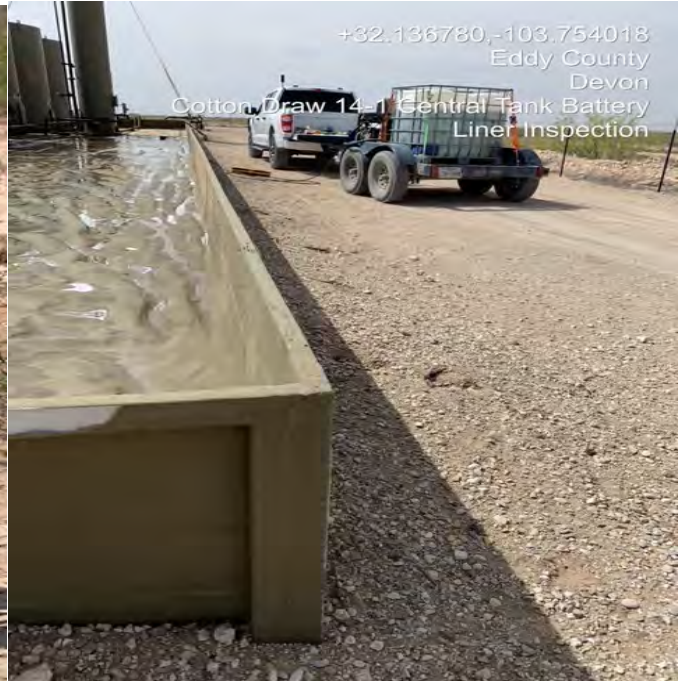
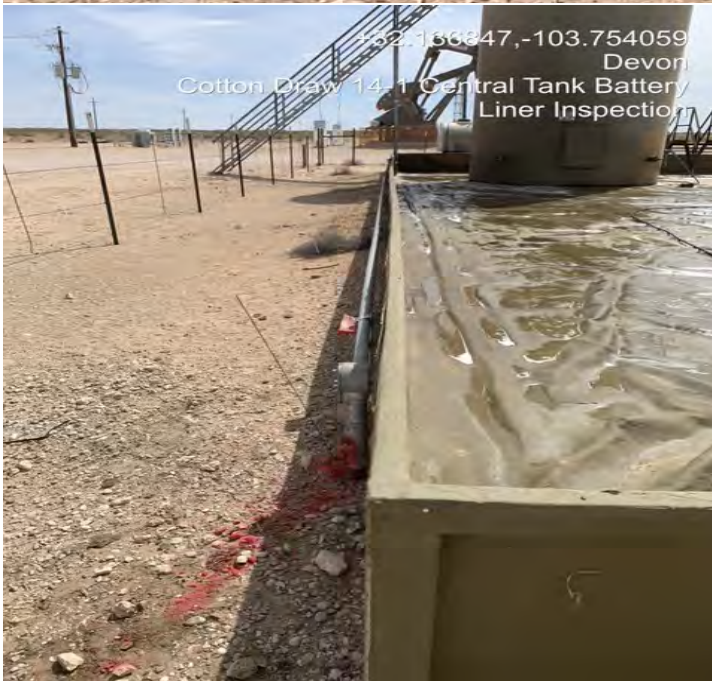
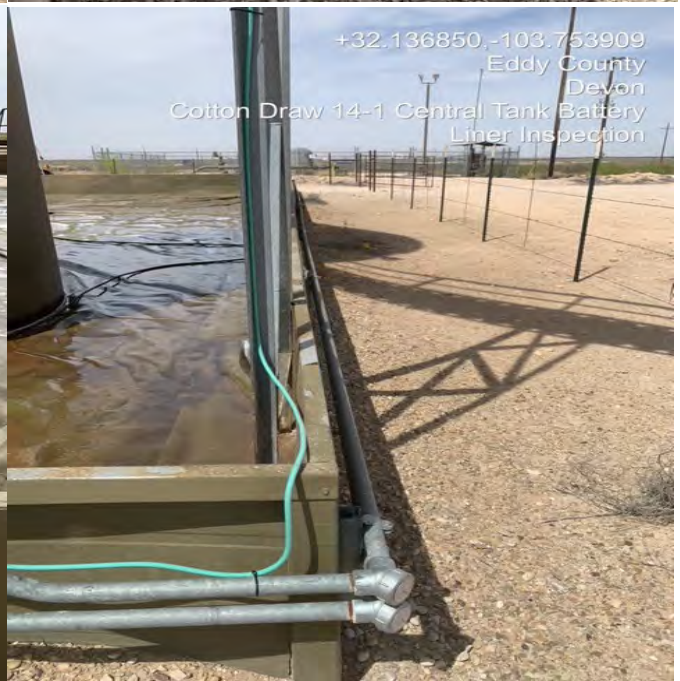
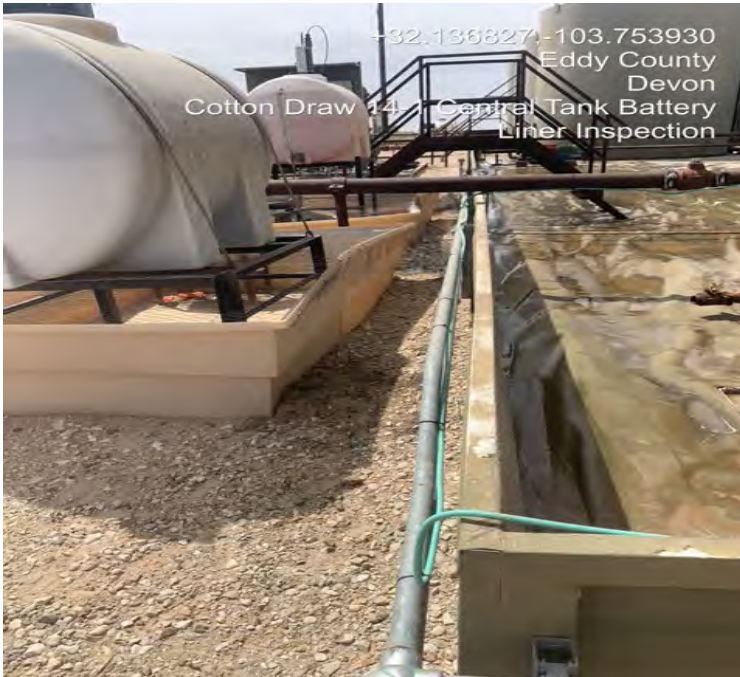
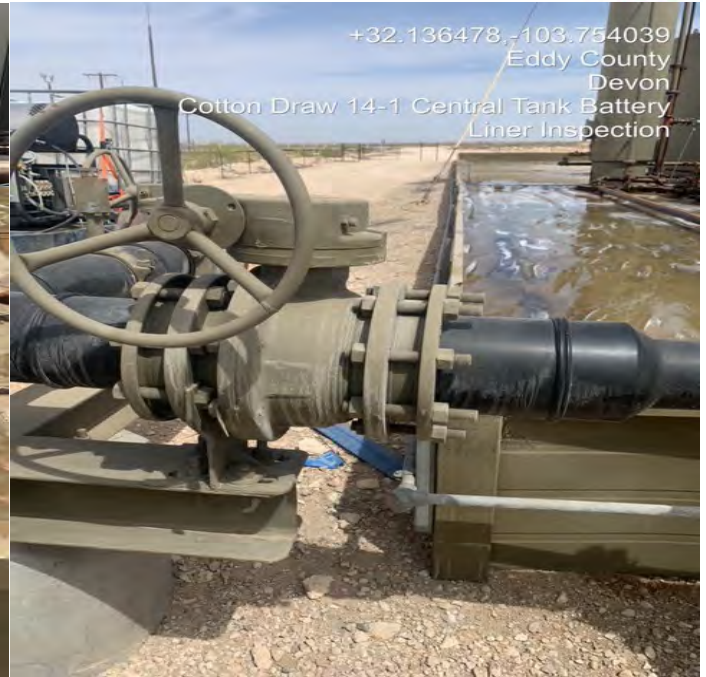
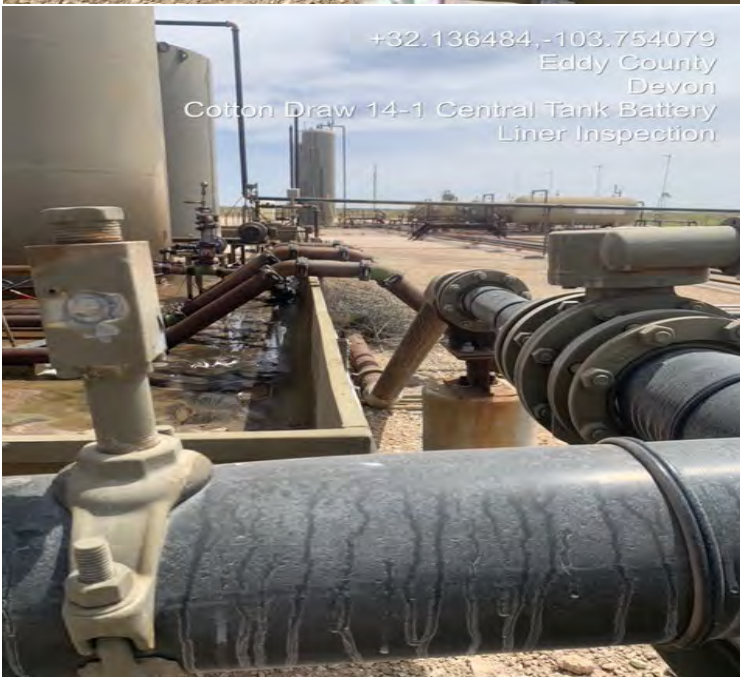
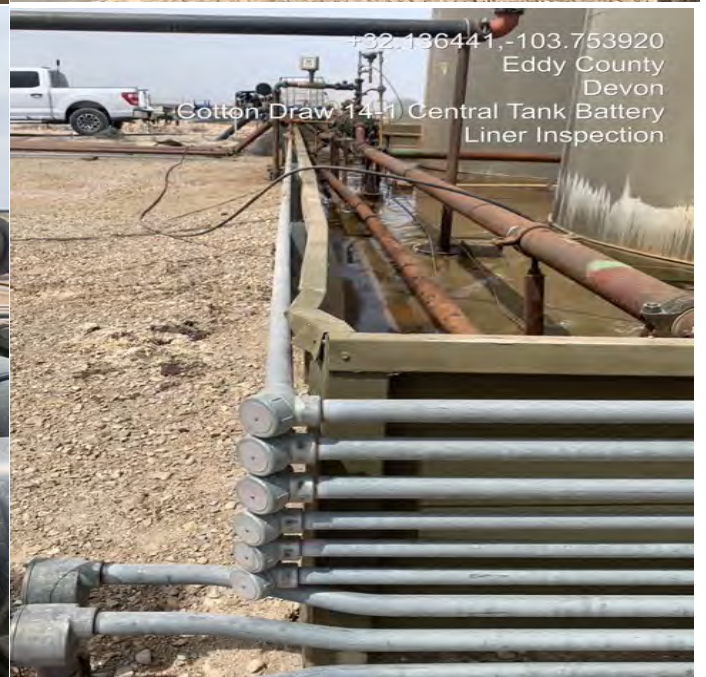
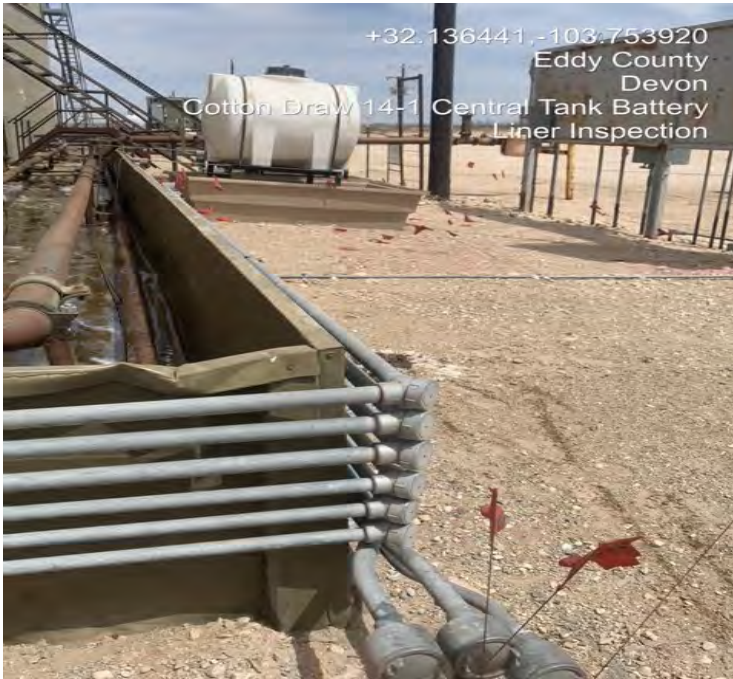
Liner Inspection

On April 19, 2024, after submitting the 48-hour notification application ID:334548 to the OCD, Pima Environmental conducted a liner inspection at this location. Pima concluded that this liner and containment maintained its integrity and was able to retain the fluids. The liner inspection form and photographic documentation can be found in Appendix C.

Visualization	Yes	No	Comments
Is there a tear in the liner?		X	
Are there holes in the liner?		X	
Is the liner retaining any fluids?	X		Fluid from power washing the Liner
Does the liner have integrity to contain a leak?	X
